BGA TECHNICAL COMMITTEE

TECHNICAL NEWSHEET 9/10/85

PART 1 AIRWORTHINESS "AGGRO" (Please add to the 1985 Green Pages)

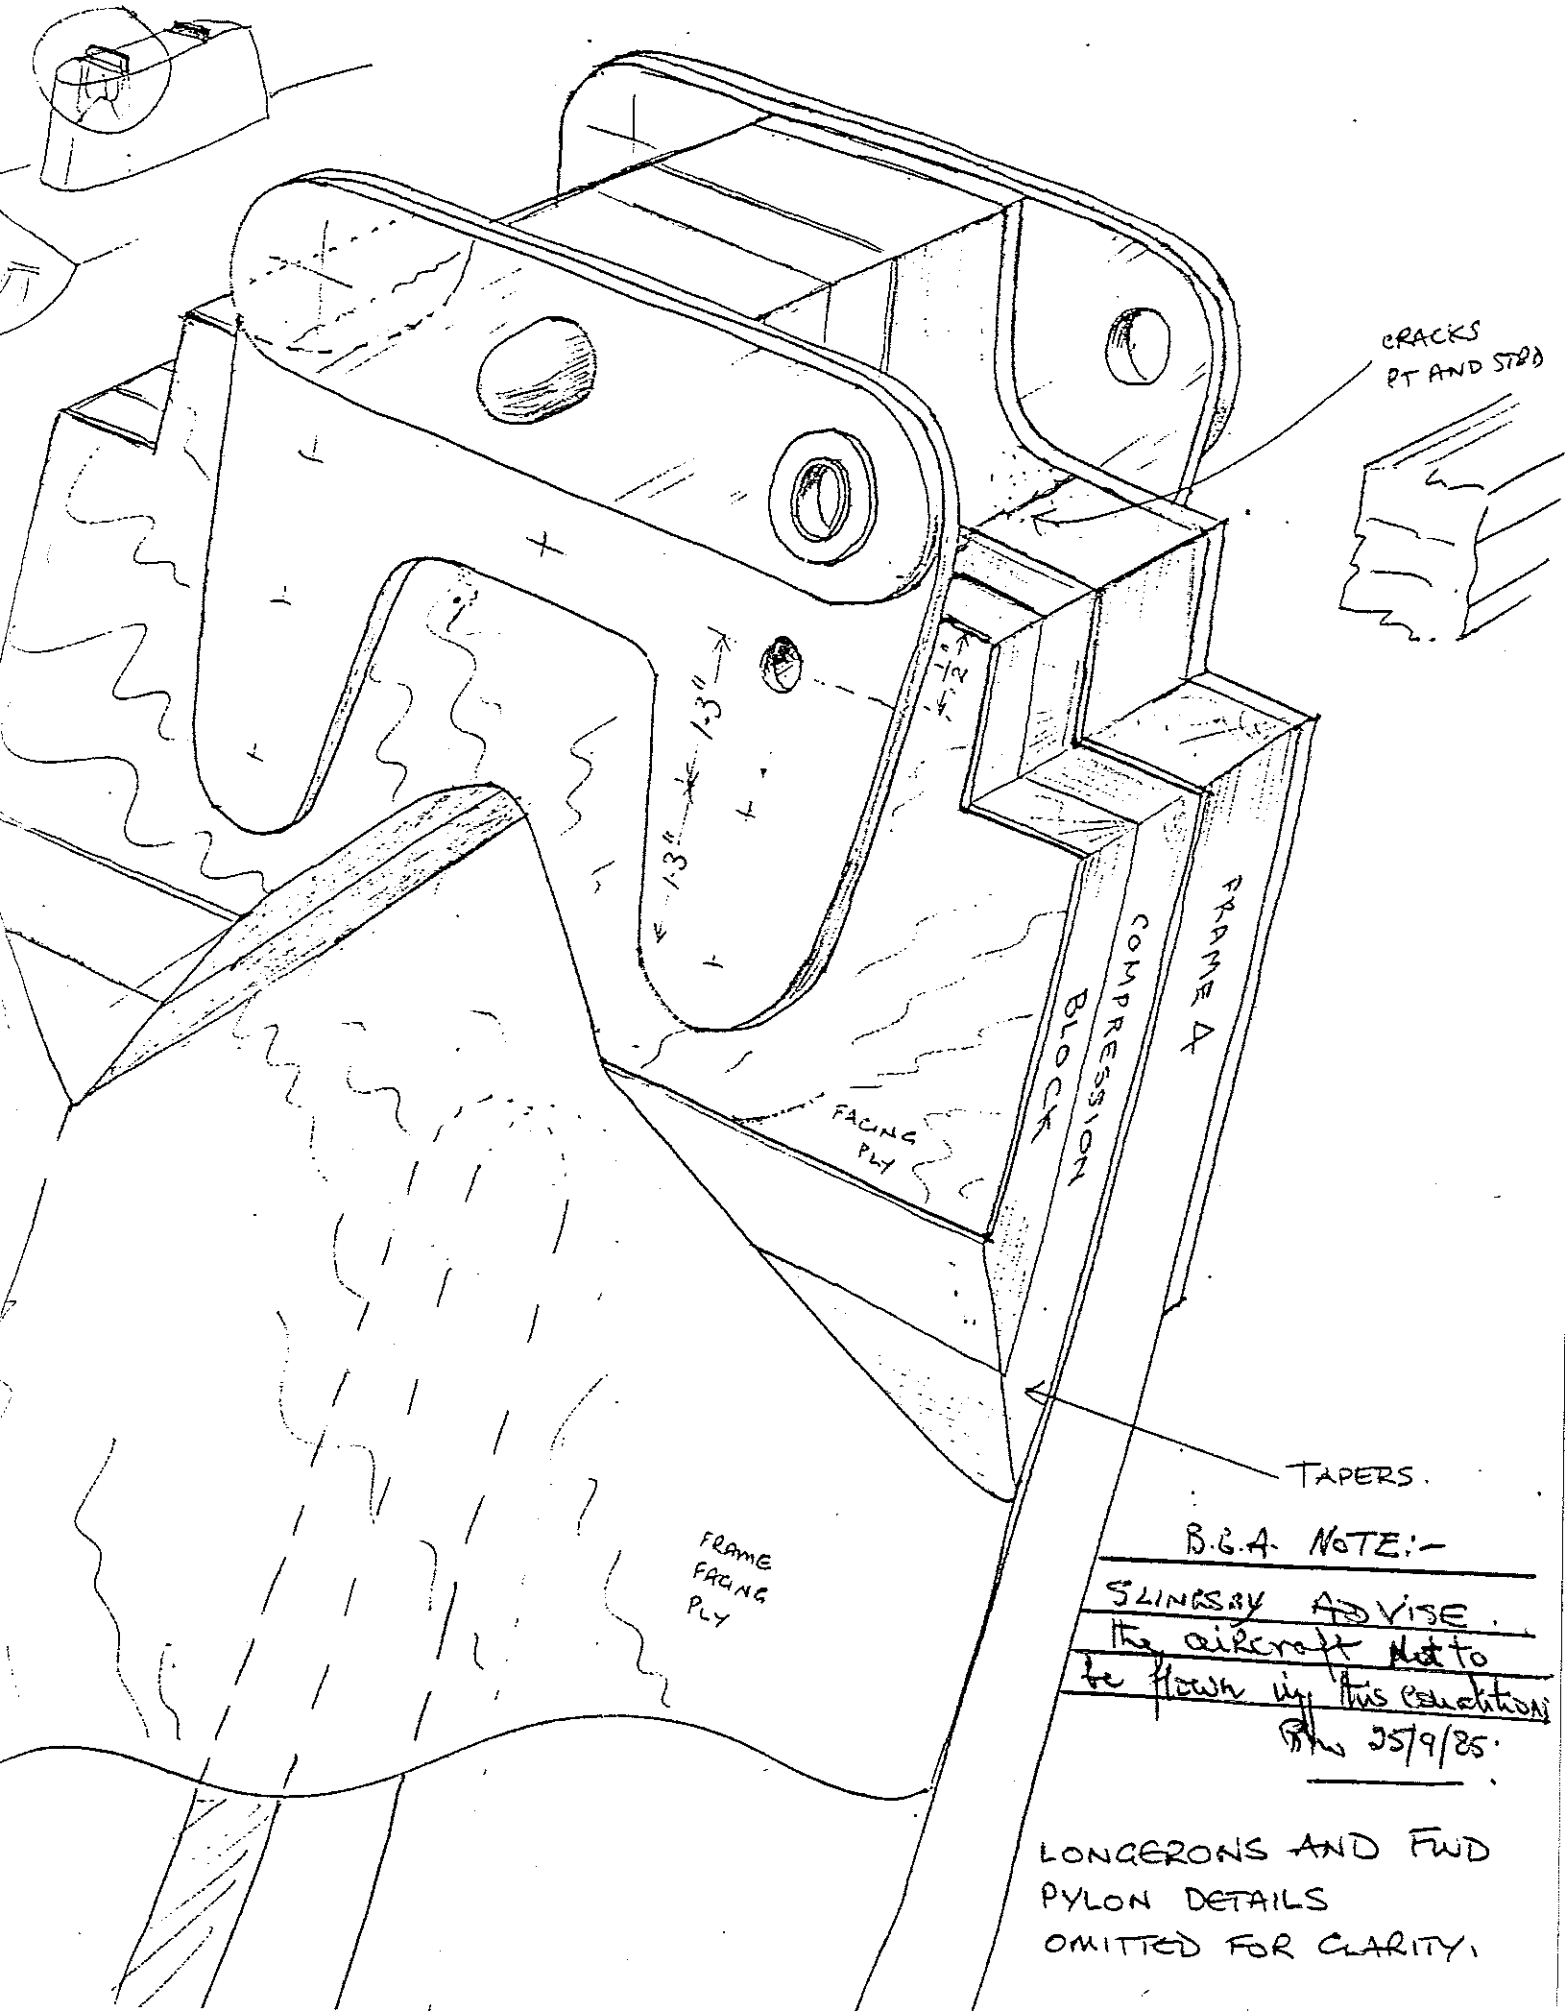
FIG 1

- 1.6 DG 300 - Tailplane Attachment Bracket. Cracks in GRP structure reported by RAFGSA (Germany) and referred to the Manufacturer. Inspect asap.
- 1.7 Slingsby T 21. Cracks in FRAME 4. (Sketch Attached). Inspect as required. Reported by RAF GC Cyprus and referred to Slingsby Aircraft Limited.

FRAME 4 AND COMPRESSION BLOCK
(PRESENT CONDITION)

CRACKS
PT AND STDB

SLINGSBY ADVISE.
The aircraft not to
be flown in this condition.
Bw 25/9/85.

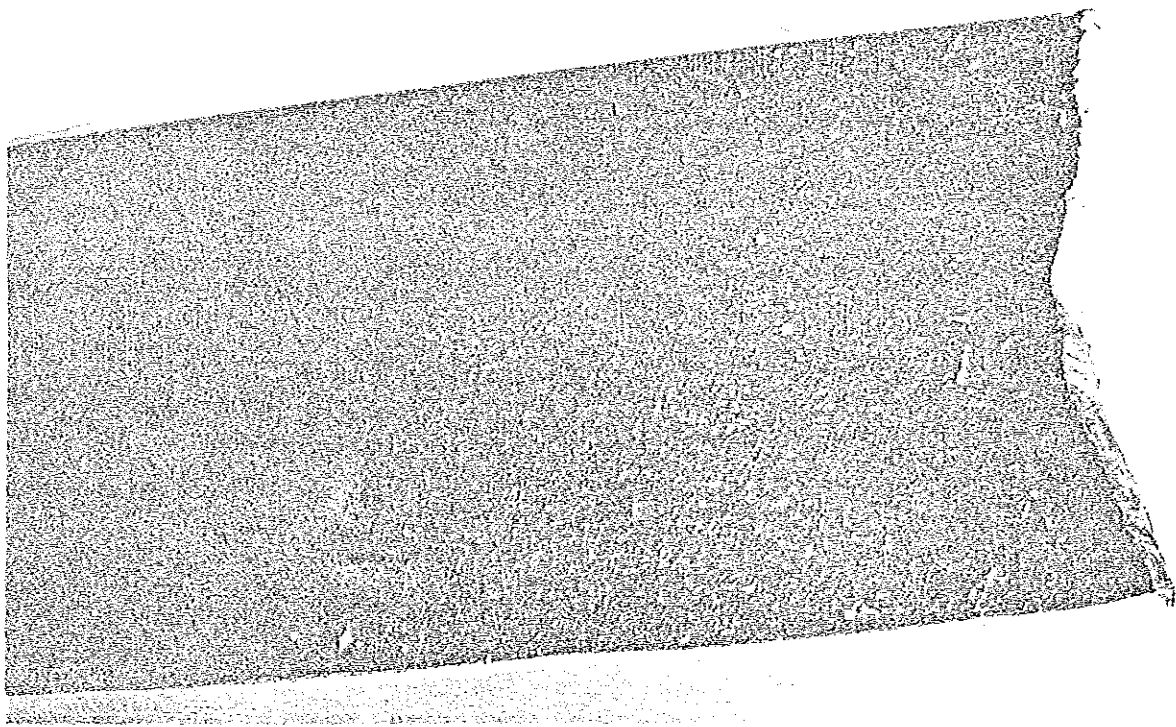
- 1.11 Propeller Blade Failures (Tugs and Motor Gliders), Extract from GASIL 6/85 (herewith) draws urgent attention to damage to the REAR FACE of propeller blades. INSPECT DAILY.
- 1.12 Tail Skid Modifications to fit replaceable "shoes" should be engineered for minimum weight. A block weighing 2½lbs has recently been removed from a KA 8B!

15. Issue 6/85 - Item 16 Fuji 200-160 Propeller Failure from Stone Damage

The photos below show in close up the stone damage to the REAR face of the propeller. The front face was newly polished and lacquered following overhaul, however the rear face contained a large number of surface blemishes any one of which could have led to fatigue fracture (and did). Pilots and engineers should note that it is the rear face of the propeller which is more critical than the easily inspected front face.
