BGA TECHNICAL COMMITTEE

TNS/10/12/85

General Aviation Safety Information

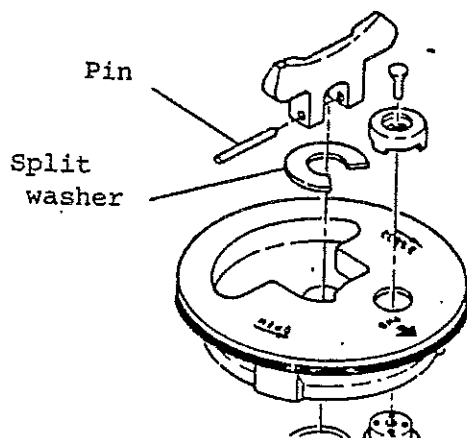
12. FUEL FILLER CAP FELL APART

During routine re-fuelling the left-hand fuel tank filler cap fell apart when removed. As a result the split washer fell into the tank. As it was non-magnetic stainless steel it could not be retrieved with a magnet. The tank had to be drained and the upper access panel removed in order to retrieve the washer. Fortunately the handle and its securing pin did not enter the tank. There is no method of locking the handle securing pin in the red plastic type cap, hence it can slide out from one end when in the "OPEN" position. The reporter has secured all the pins by deforming the cap handle plastic adjacent to the pin hole with a small soldering iron. The cap was a WISCO C156001-0106.

It appears from the Cessna Parts Catalogue that the pin used in the plastic caps has a different part number from the pin used in the metal caps.

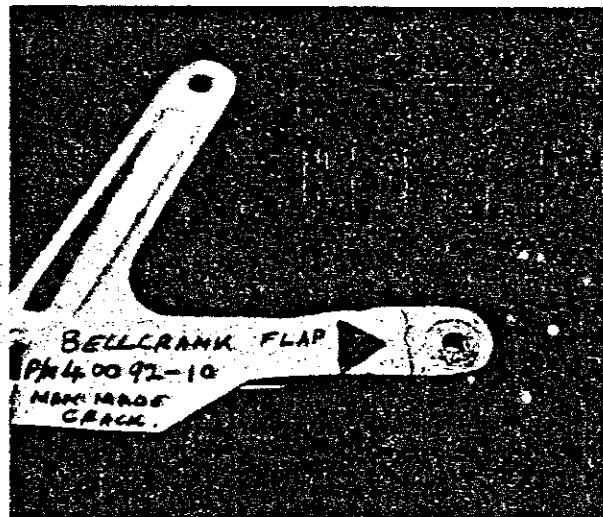
1. CRACKED FLAP CONTROL BELLCRANK

Below is a photograph of a bellcrank Part No 40092-10 from a Piper PA18 aircraft which has been cracked as a result of overtightening the bolt which attaches the control rod or cables. The same Part No is used on PA25 aircraft.

Our area office who passed the photograph to us remarked, "would you believe it".

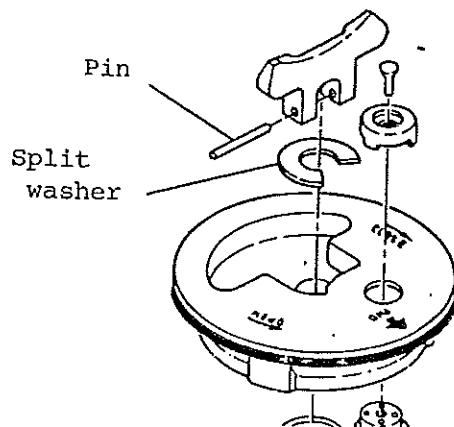
12. FUEL FILLER CAP FELL APART

During routine re-fuelling the left-hand fuel tank filler cap fell apart when removed. As a result the split washer fell into the tank. As it was non-magnetic stainless steel it could not be retrieved with a magnet. The tank had to be drained and the upper access panel removed in order to retrieve the washer. Fortunately the handle and its securing pin did not enter the tank. There is no method of locking the handle securing pin in the red plastic type cap, hence it can slide out from one end when in the "OPEN" position. The reporter has secured all the pins by deforming the cap handle plastic adjacent to the pin hole with a small soldering iron. The cap was a WISCO C156001-0106.

It appears from the Cessna Parts Catalogue that the pin used in the plastic caps has a different part number from the pin used in the metal caps.

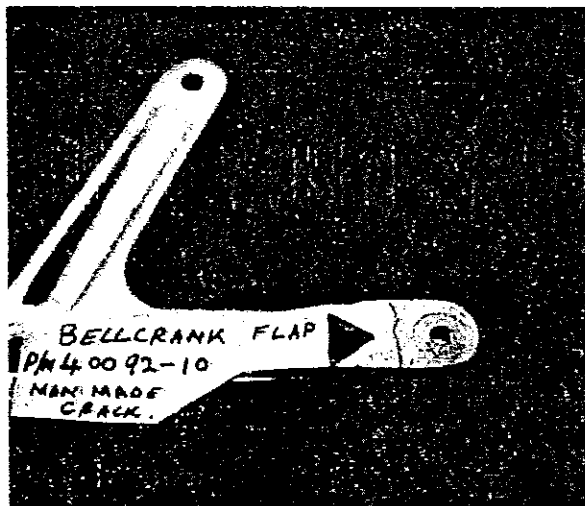
1. CRACKED FLAP CONTROL BELLCRANK

Below is a photograph of a bellcrank Part No 40092-10 from a Piper PA18 aircraft which has been cracked as a result of overtightening the bolt which attaches the control rod or cables. The same Part No is used on PA25 aircraft.

Our area office who passed the photograph to us remarked, "would you believe it". They have another identical example in their possession.
