B.G.A. TECHNICAL COMMITTEE

TECHNICAL NEWSHEET

TNS 3/4/86

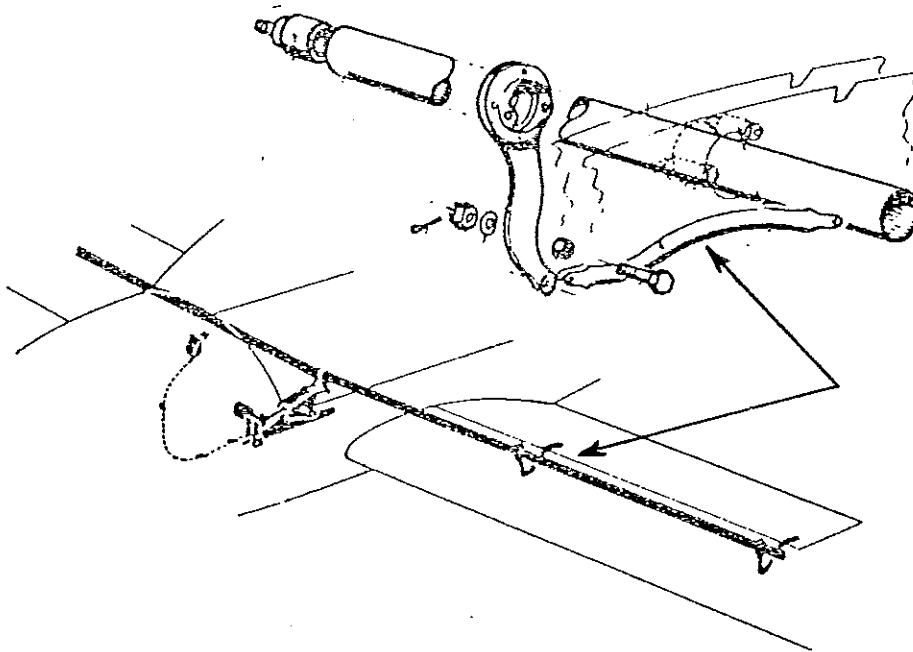
6. ASYMMETRIC FLAP

When turning finals the flaps were selected to 30° (full down) but the right-hand flap did not move. Excessive right roll was corrected by full opposite aileron. The flaps were retracted for a flapless landing. The aircraft had been flown earlier in the day without problem and the pre-flight checks had been normal. The aircraft had flown for 1299 hours with 27 since inspection. The pilot is thought to have been a student.

The cause was failure of the pushrod from the flap torque shaft, and may have been caused by people standing on the NO STEP area of the flaps. The operator has now marked the area with larger letters and a black and yellow cross hatch.

It would seem to be a good idea for all Rallye aircraft (and others) to be similarly marked. It should be noted that there is no asymmetric flap protection on most general aviation aircraft since most were certificated to US Requirements that did not contain this important feature. Airworthiness Notice No 15 "United Kingdom Certification of Foreign Aircraft of MTWA not Exceeding 5700 kg" para 2.2.1 explains the CAA philosophy on imported light aircraft. The item in GASIL 12/85 to a C172 should also be noted - the pilot had to use reduced power to regain control.
