B.G.A. TECHNICAL COMMITTEE

TECHNICAL NEWSHEET

TNS 7/8/86

August 1986

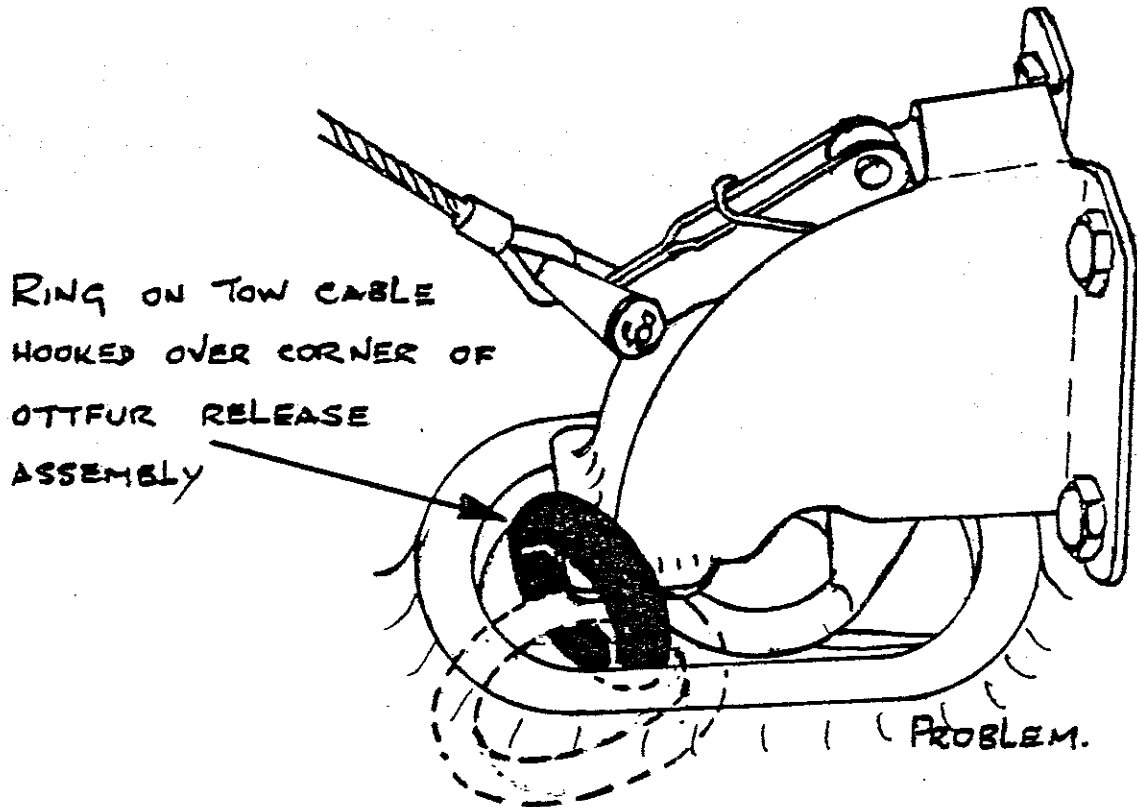
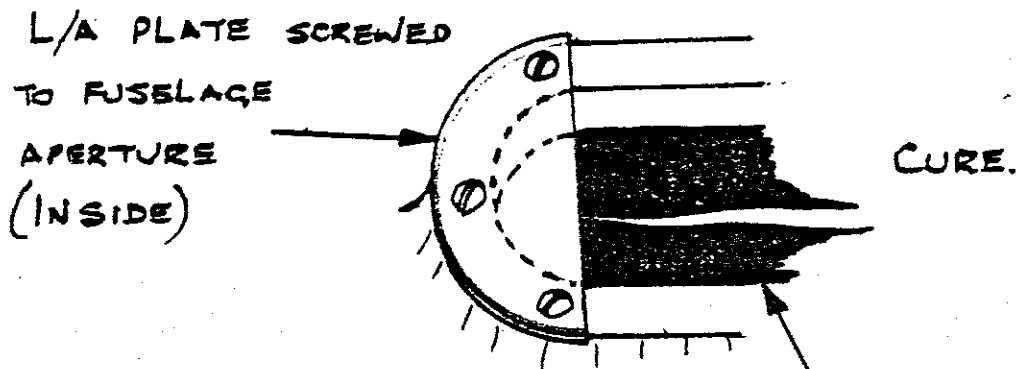
DART. HOOK-HANG-UP.

- 1.12 T 51 Dart. Hook-Hang-Up. The attached sketch clearly illustrates the problem of incorrectly inserting the ring, and recommends a cure. (Reported by P.A.Ward Midland Gliding Club).

EXTERNAL SPLIT RUBBER FAIRING INHIBITS  
VISUAL INSPECTION.

RELEASE HANG-UP - DART 17R  
P.A.WARD 1/C/300 ME. M.G.C. MAY 1986.
