B.G.A. TECHNICAL COMMITTEE

TECHNICAL NEWSHEET

TNS 5/6/86

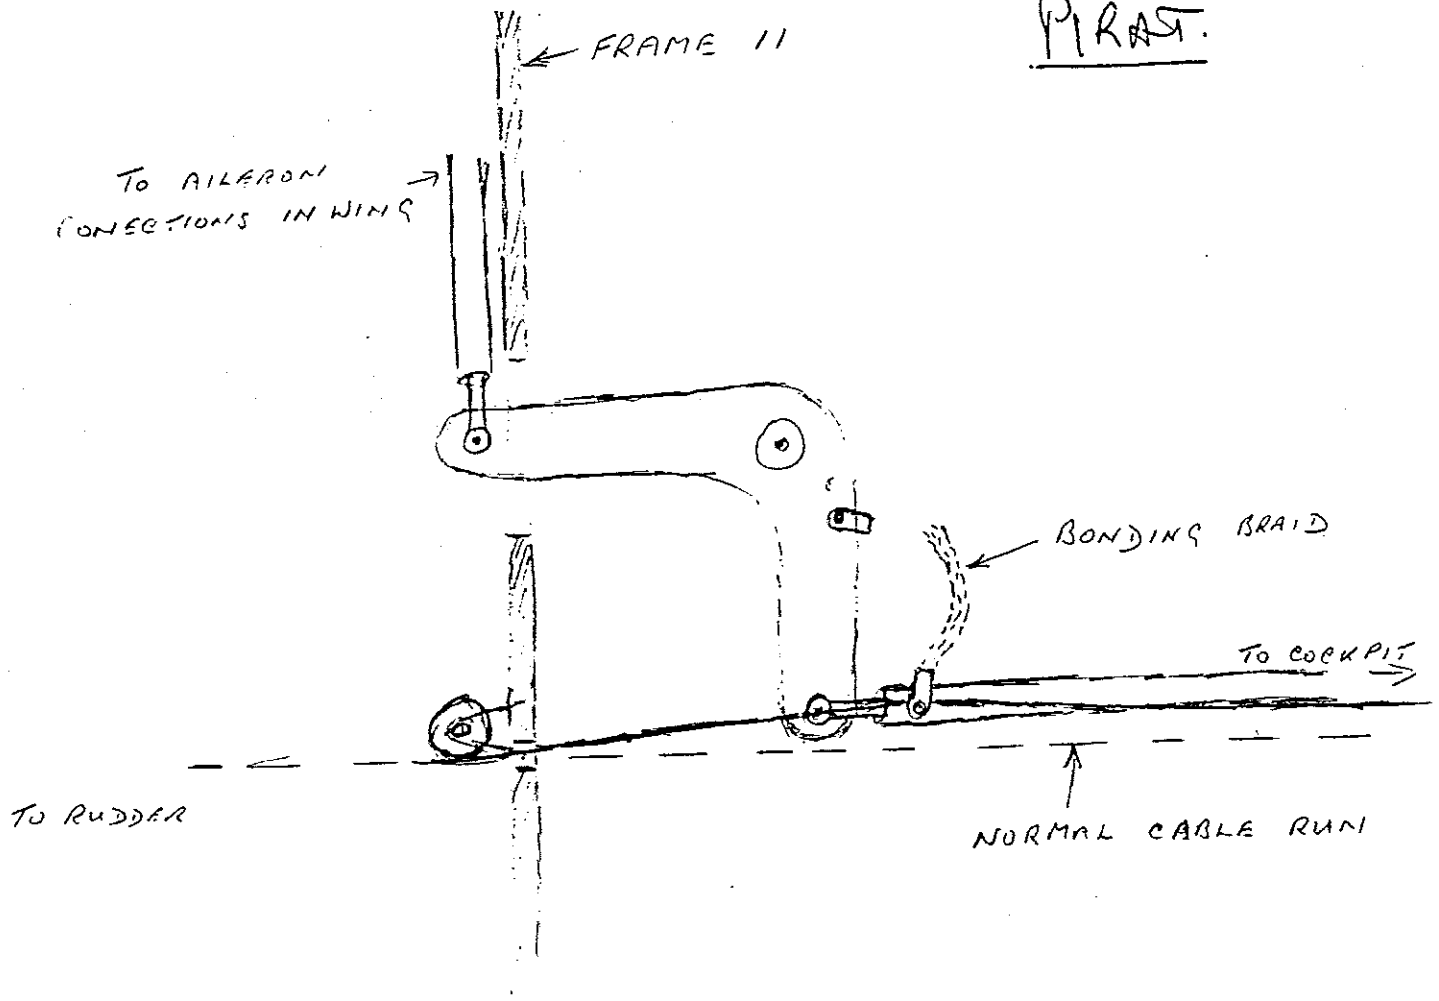
PIRAT.

- 1.3 Pirat Rudder Cables Damaged The attached sketch illustrates a foul on the aileron bell crank lever. Pirat cables should be inspected a.s.a.p. (Reported by Fred Breeze and by South Wales Gliding Club TNS/5/77 refers).

PIRAT Rudder Cable
Foul on Aileron.
