B.G.A. TECHNICAL COMMITTEE

TECHNICAL NEWSHEET

TNS 11/12/86

PART 1 AIRWORTHINESS "AGGRO"

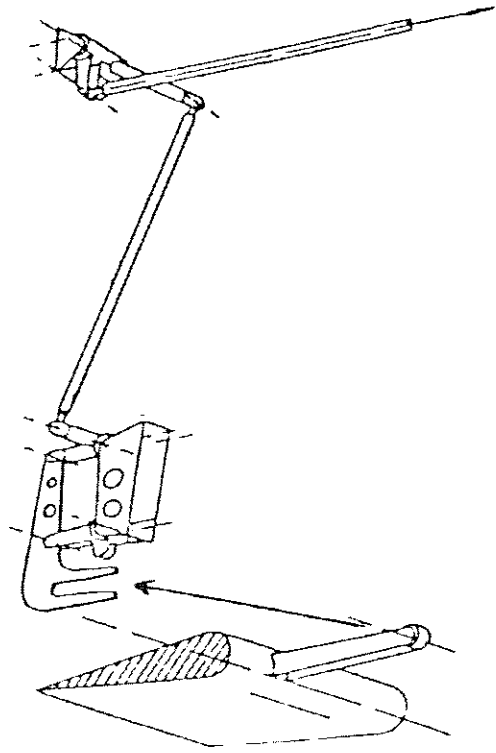
Elevator Controls in vertical Fin

On approach to land the aircraft suffered loss of elevator response resulting in a heavy landing. Permission was given for the aircraft to be returned to Germany for repair and an investigation was undertaken by the German authorities.

No technical defect was found and it is believed that during the accident flight the elevator had not been correctly attached to the push-rod in the vertical fin at its disassembly point. The elevator actuating mechanism is designed to engage automatically when the tailplane is assembled onto the fin but it was found that it was in fact possible to attach the tailplane without engaging the elevator control.

The aircraft manufacturer amended the flight manual for the aircraft to augment the controls checks and the Civil Aviation Authority issued an Emergency Airworthiness Directive (No 010-08-85) on this subject.

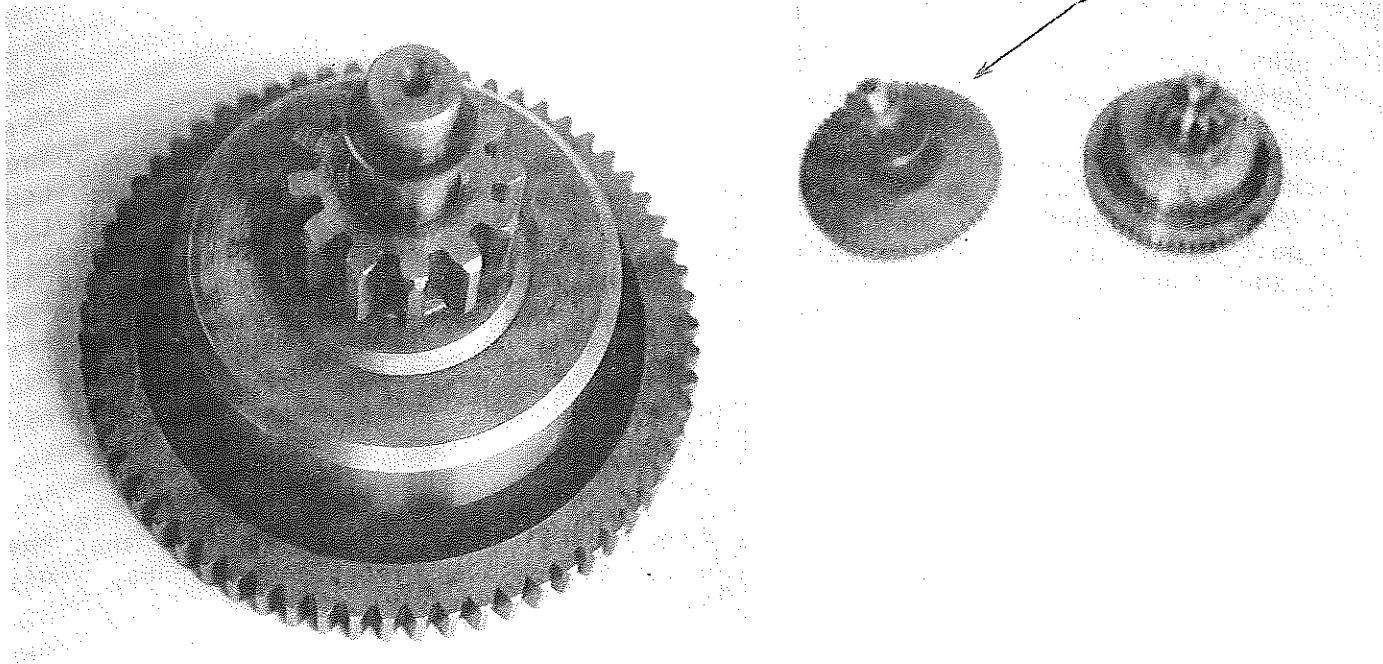
The starter and clutch assembly were removed after only a few hours of operation because of a failure to start. It was found that the clutch had failed. It did not contain a part number or a serial number and was also of a different design from the genuine aircraft part. The sprag clutch cage had cracked. There is a possibility of metal particles getting into the engine oil system which could lead to more serious (and expensive) problems. The part number of the genuine part is 639153/641500.

All maintenance personnel should be alert for these bogus parts. If any are found please report to the SDAU.
