B.G.A. TECHNICAL COMMITTEE

TECHNICAL NEWSHEET TNS 1/2/87

**PART 1 AIRWORTHINESS "AGGRO".** The 1987 "B.G.A. Compendium of Airworthiness Directives, Mandatory Modifications and Special Inspections for U.K. and Foreign Gliders and Motor Gliders" is enclosed herewith ("Green" pages for 1987).

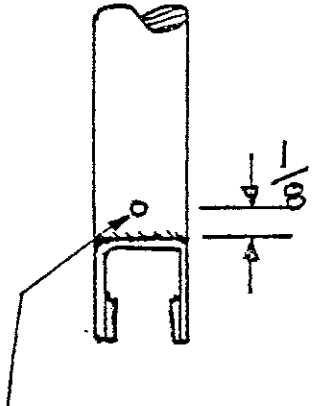
1.2. KESTREL ELEVATOR VERTICAL FINAL DRIVE TUBE Severe internal corrosion of the final drive in the fin has been detected, and an immediate inspection or replacement is required. Reported by Bob McLean to B.G.A. and to Slingsby's. Gliders fitted with a leather seal at the top of the fin are most vulnerable.

TITLE	T.I. No. 106/T59
T59 'Kestrel' Elevator Push Rod in Fin	
CLASSIFICATION	This bulletin has been classified as MANDATORY by CAA.
COMPLIANCE	To be carried out within 6 months of issue of Bulletin.
OBJECTIVE	To ensure structural integrity of the Push Rod.
JUSTIFICATION	An inspection on a Kestrel revealed internal corrosion on the push rod of the elevator, sufficiently advanced to corrode through the rod wall, due to water ingress from the top inspection hole.
APPLICABILITY	All Slingsby T59 A,B,C,D,E,F,G,H & J gliders.
CONSEQUENTIAL LIMITATIONS	Not applicable.
ACTION	<p>The Push Rod must be removed for examination. Bottom access can only be gained through the removal of the wheel well fairing. If possible inspect to check wall thickness at the bottom. See Fig. If facilities exist for ultrasonic inspection or x-ray to ensure no internal corrosion then the rod can be refitted. If structural integrity cannot be confirmed then the rod must be replaced.</p>

<p>1/16" dia inspection hole can be drilled and left open on refit if no corrosion found.</p>
PARTS REQUIRED	T59A-45-507 Push Rod - Elevator Fin.

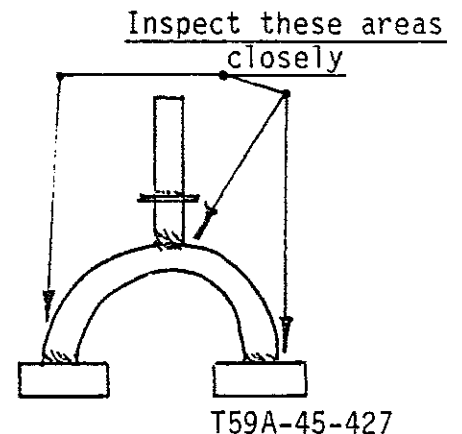
### T59 'Kestrel' Rudder Actuator Inspection

**JUSTIFICATION** Further examples of cracking in Area A have been found on German built gliders.

**ACTION** Remove the rudder in accordance with Addendum A.2.2. of the Pilots Notes. Visually examine (using a x5 magnification) the actuator for cracks especially in the area of the central weld 'A' see diagram. Should any sign of cracking be found then the existing part must be discarded and scrapped. Replace Rudder. Annotate aircraft log book showing compliance of this T.I.

If cracking is found the part must be discarded immediately and scrapped.

If inspection reveals a defective actuator, a replacement T59A-45-427 Issue 5 (one off) actuator may be obtained from SA PLC.
