**B.G.A. TECHNICAL COMMITTEE**  
**TECHNICAL NEWSHEET TNS 3/4/87.**

**PART 1 AIRWORTHINESS "AGGRO"** (Please add to the 1987 Green Pages)

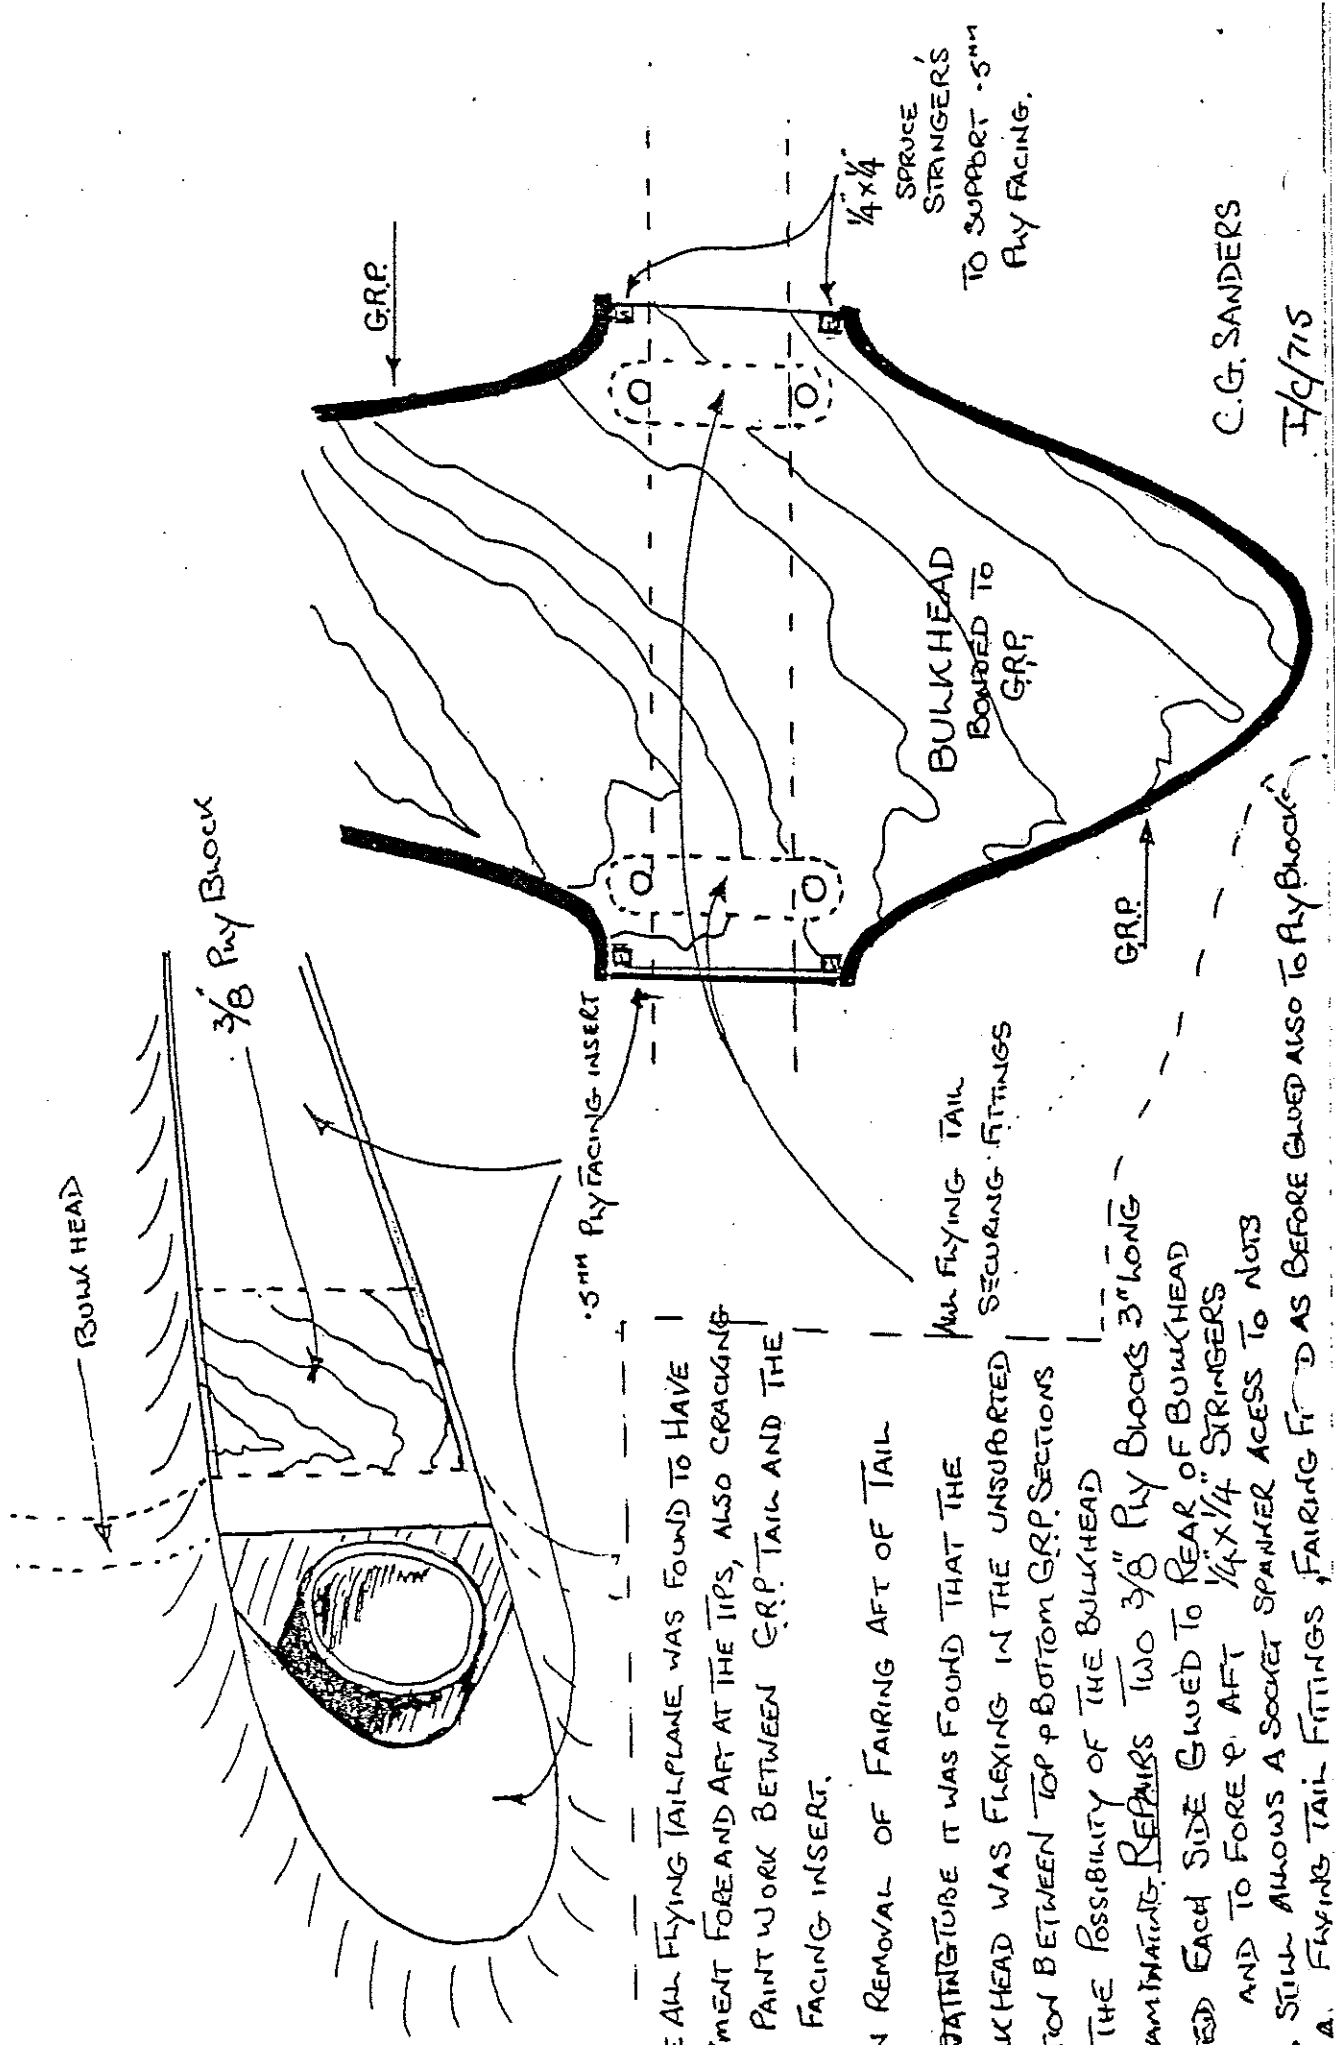
THE ALL FLYING TAIL PLANE WAS FOUND TO HAVE MOVEMENT FORE AND AFT AT THE TIPS, ALSO CRACKING OF PAINT WORK BETWEEN GRP TAIL AND THE PLY FACING INSERT.

ON REMOVAL OF FAIRING AFT OF TAIL

ACTUATING IT WAS FOUND THAT THE BULK HEAD WAS FLEXING IN THE UNSUPPORTED SECTION BETWEEN TOP & BOTTOM GRP SECTIONS

WITH THE POSSIBILITY OF THE BULK HEAD DELAMINATING. REPAIRS TWO 3/8" PLY BLOCKS 3" LONG FITTED EACH SIDE GLOUED TO REAR OF BULK HEAD AND TO FORE & AFT 1/4" X 1/4" STRINGERS

THIS STILL ALLOWS A SOCKET SPANNER ACCESS TO NUTS OF A. FLYING TAIL FITTINGS, FAIRING FITTINGS AS BEFORE GLOUED ALSO TO PLY BLOCKS

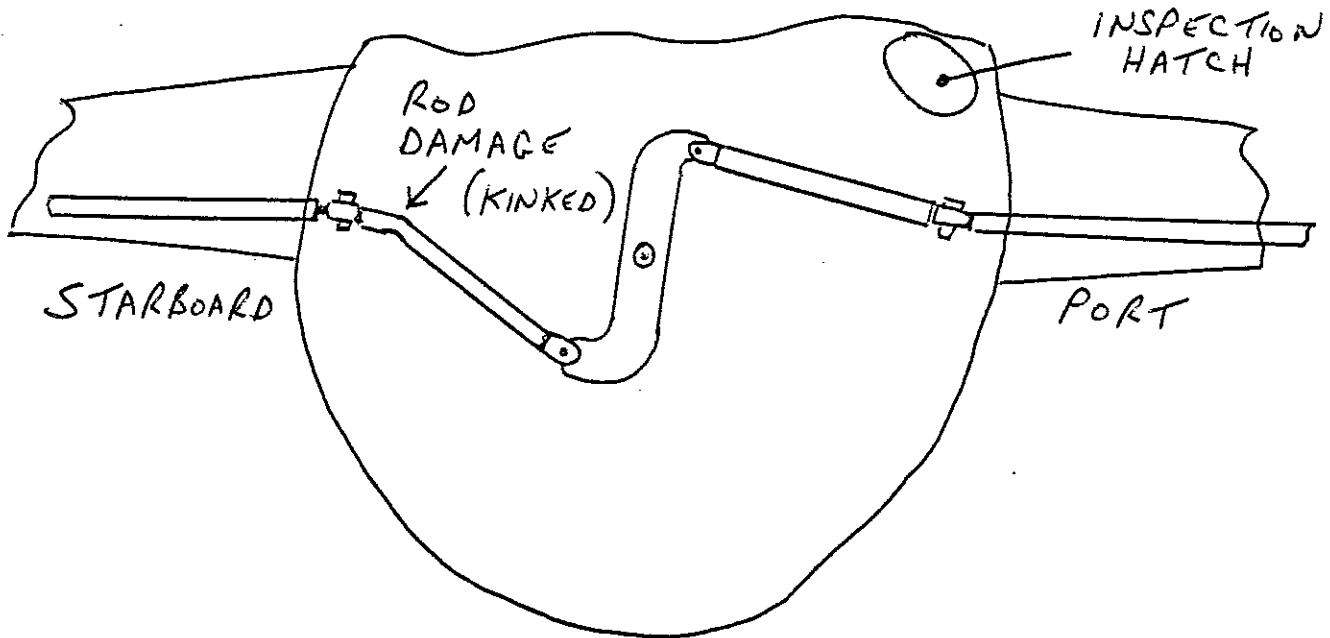
### AIRBRAKE SYSTEM IN FUSELAGE

- 1.3. T.65A - VEGA Excess free-play in undercarriage actuator arm, causes undemanded retraction ( Reported by I.D. Edwards).
- 1.4. ASTIR CS/77 AIRBRAKE CONTROL ROD in centre-section found buckled. Possibly caused by "frozen" speed-brake paddles. (Sketch attached from Cambridge G.C.).

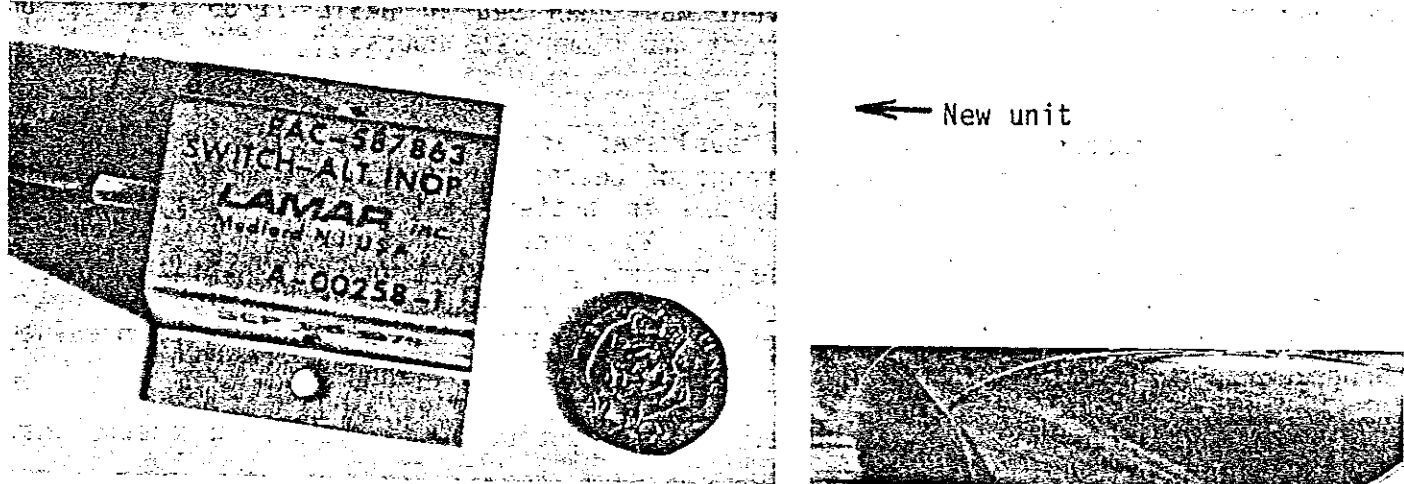
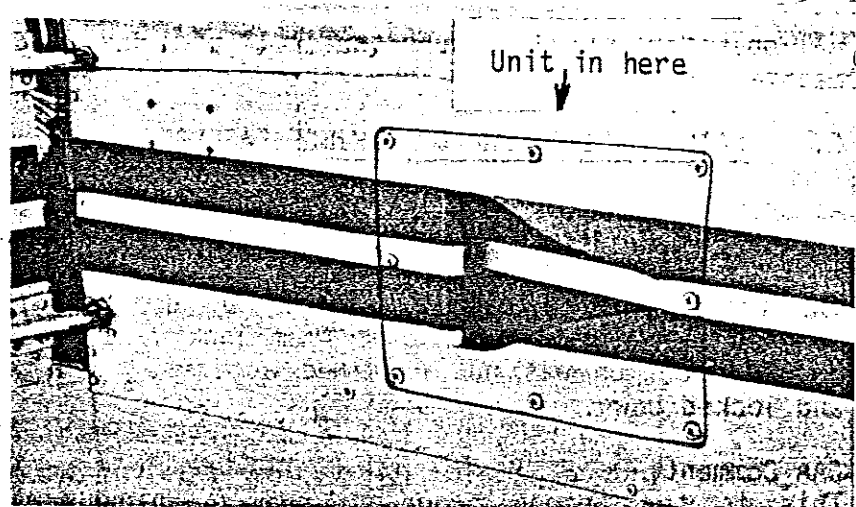
5. SMOKE FROM ALTERNATOR INOPERATIVE SWITCH UNIT

Preliminary AIB investigation found that an electrical unit, mounted on the forward lower right hand cabin wall behind the instrument panel, had overheated and burst, discharging smoke and acrid fumes into the cabin. This electrical unit was the 'Alternator Inoperative Switch', Part number 587863, manufactured by LAMAR, number A00258-1, in 1978. The function of this unit was to sense the output voltage from the alternator, via the auxiliary terminal, and trigger the alternator inoperative warning light in the cockpit when the voltage dropped below a preset value. The unit was solid state, encapsulated in a form of epoxy resin and approximately the size of a matchbox. Tests on the resin showed that it produced very toxic fumes when heated to a temperature that would cause the discolouration and charring as seen on the failed unit.

The 5 amp in-line fuse between the alternator and the switch was of the correct rating and had blown.

CAA Comment: It should be borne in mind that smoke and fumes may often be the result of an electrical fault and therefore the master switch should be put to off as quickly as possible to see if the smoke and fumes clear or reduce. Fumes may be toxic and therefore maximum ventilation either through DV window or air vents should be made available. SDAU records do not indicate any other failures of this small "potted" unit used in the alternator failure light circuit. A similar unit is known to be fitted in the Piper PA46 Malibu.

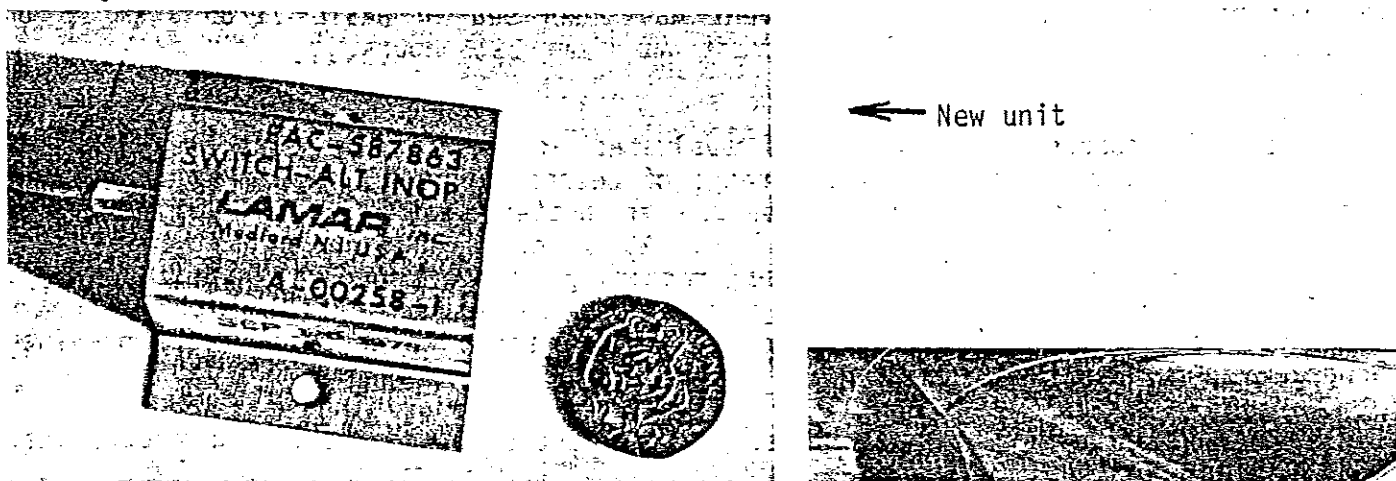
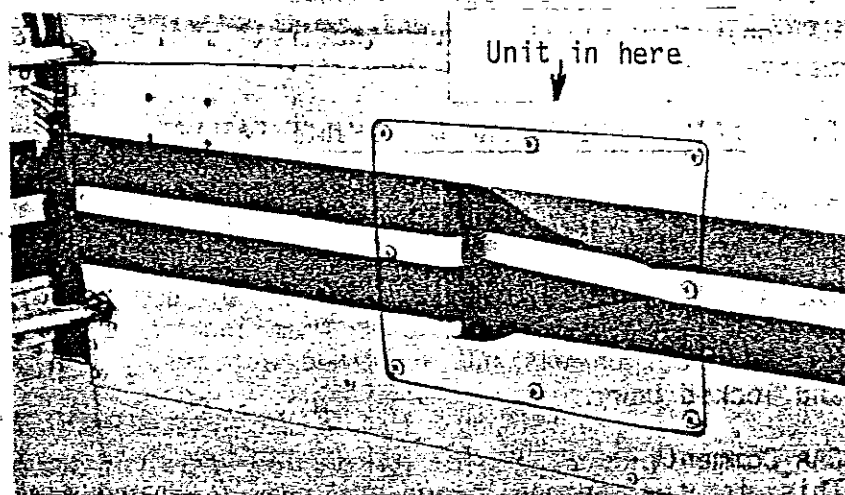
5. SMOKE FROM ALTERNATOR INOPERATIVE SWITCH UNIT

Preliminary AIB investigation found that an electrical unit, mounted on the forward lower right hand cabin wall behind the instrument panel, had overheated and burst, discharging smoke and acrid fumes into the cabin. This electrical unit was the 'Alternator Inoperative Switch', Part number 587863, manufactured by LAMAR, number A00258-1, in 1978. The function of this unit was to sense the output voltage from the alternator, via the auxiliary terminal, and trigger the alternator inoperative warning light in the cockpit when the voltage dropped below a preset value. The unit was solid state, encapsulated in a form of epoxy resin and approximately the size of a matchbox. Tests on the resin showed that it produced very toxic fumes when heated to a temperature that would cause the discolouration and charring as seen on the failed unit.

The 5 amp in-line fuse between the alternator and the switch was of the correct rating and had blown.

CAA Comment: It should be borne in mind that smoke and fumes may often be the result of an electrical fault and therefore the master switch should be put to off as quickly as possible to see if the smoke and fumes clear or reduce. Fumes may be toxic and therefore maximum ventilation either through DV window or air vents should be made available. SDAU records do not indicate any other failures of this small "potted" unit used in the alternator failure light circuit. A similar unit is known to be fitted in the Piper PA46 Malibu.

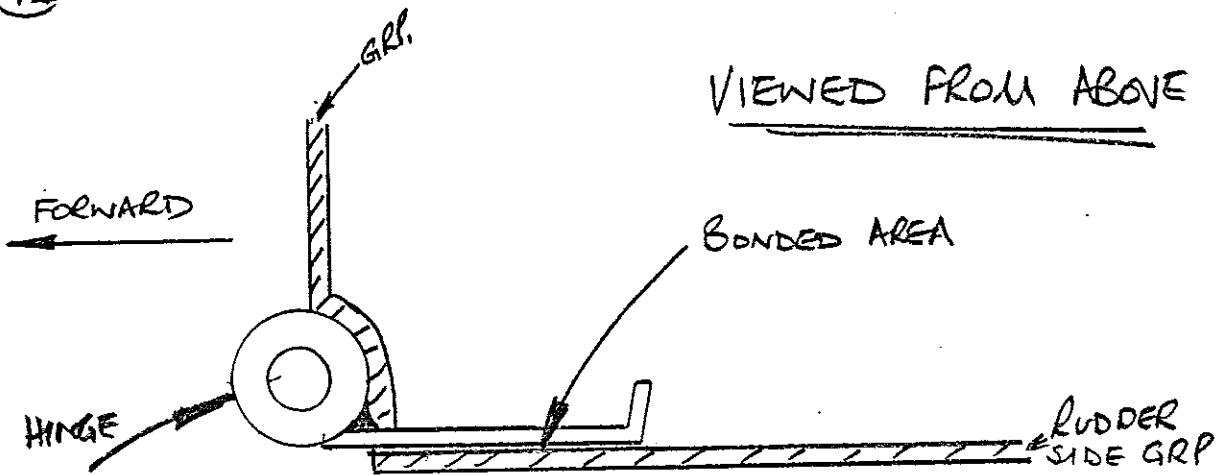
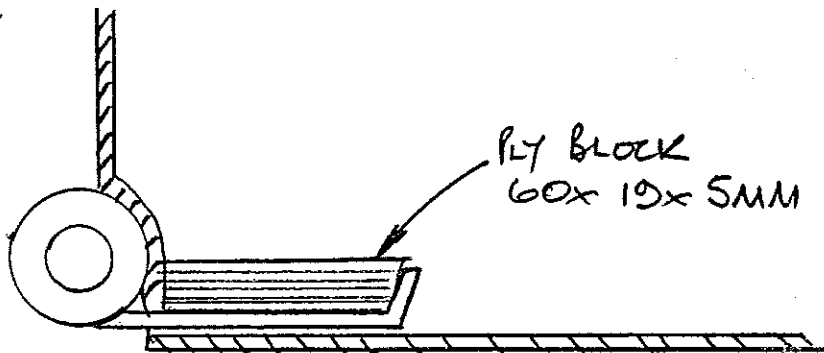
ASTIR CS. Rudder HINGE - BOND FAILURE.

- 1.9. ASTIR CS (Wks No. 1023) Rudder hinge unbonded. Repaired as per attached sketch. Reported by Peterborough Sailplanes.
- 1.10. PIONEER PARACHUTES as listed in attached F.A.A. A/D 86-24-03, may be defective.
