B.G.A. TECHNICAL COMMITTEE

TECHNICAL NEWSHEET

TNS/5/6/87

PART 1 AIRWORTHINESS "AGGRO" (Please add to the 1987 Green Pages)

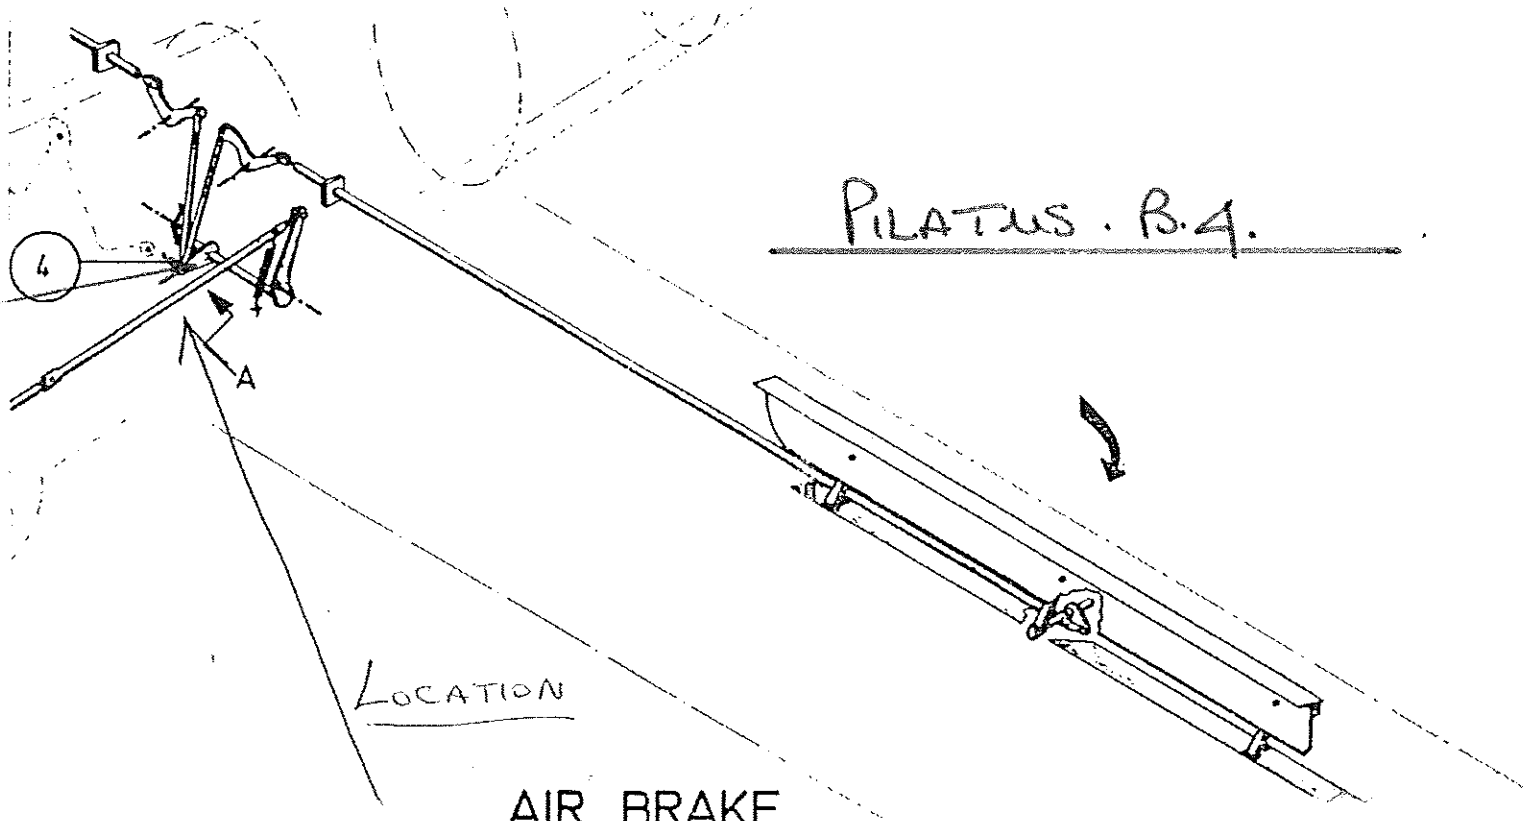
PILATUS . B. 4.

- 1.3. PILATUS B.4. Loose Rivets in the Air Brake lever in the centre-section. (Sketch attached).
- 1.4. MINI NIMBUS Release Hook Thin metal protective shroud partially compressed on to the hook by contact with the seat pan. (Reported by Ian Barnes). May cause hook malfunction.

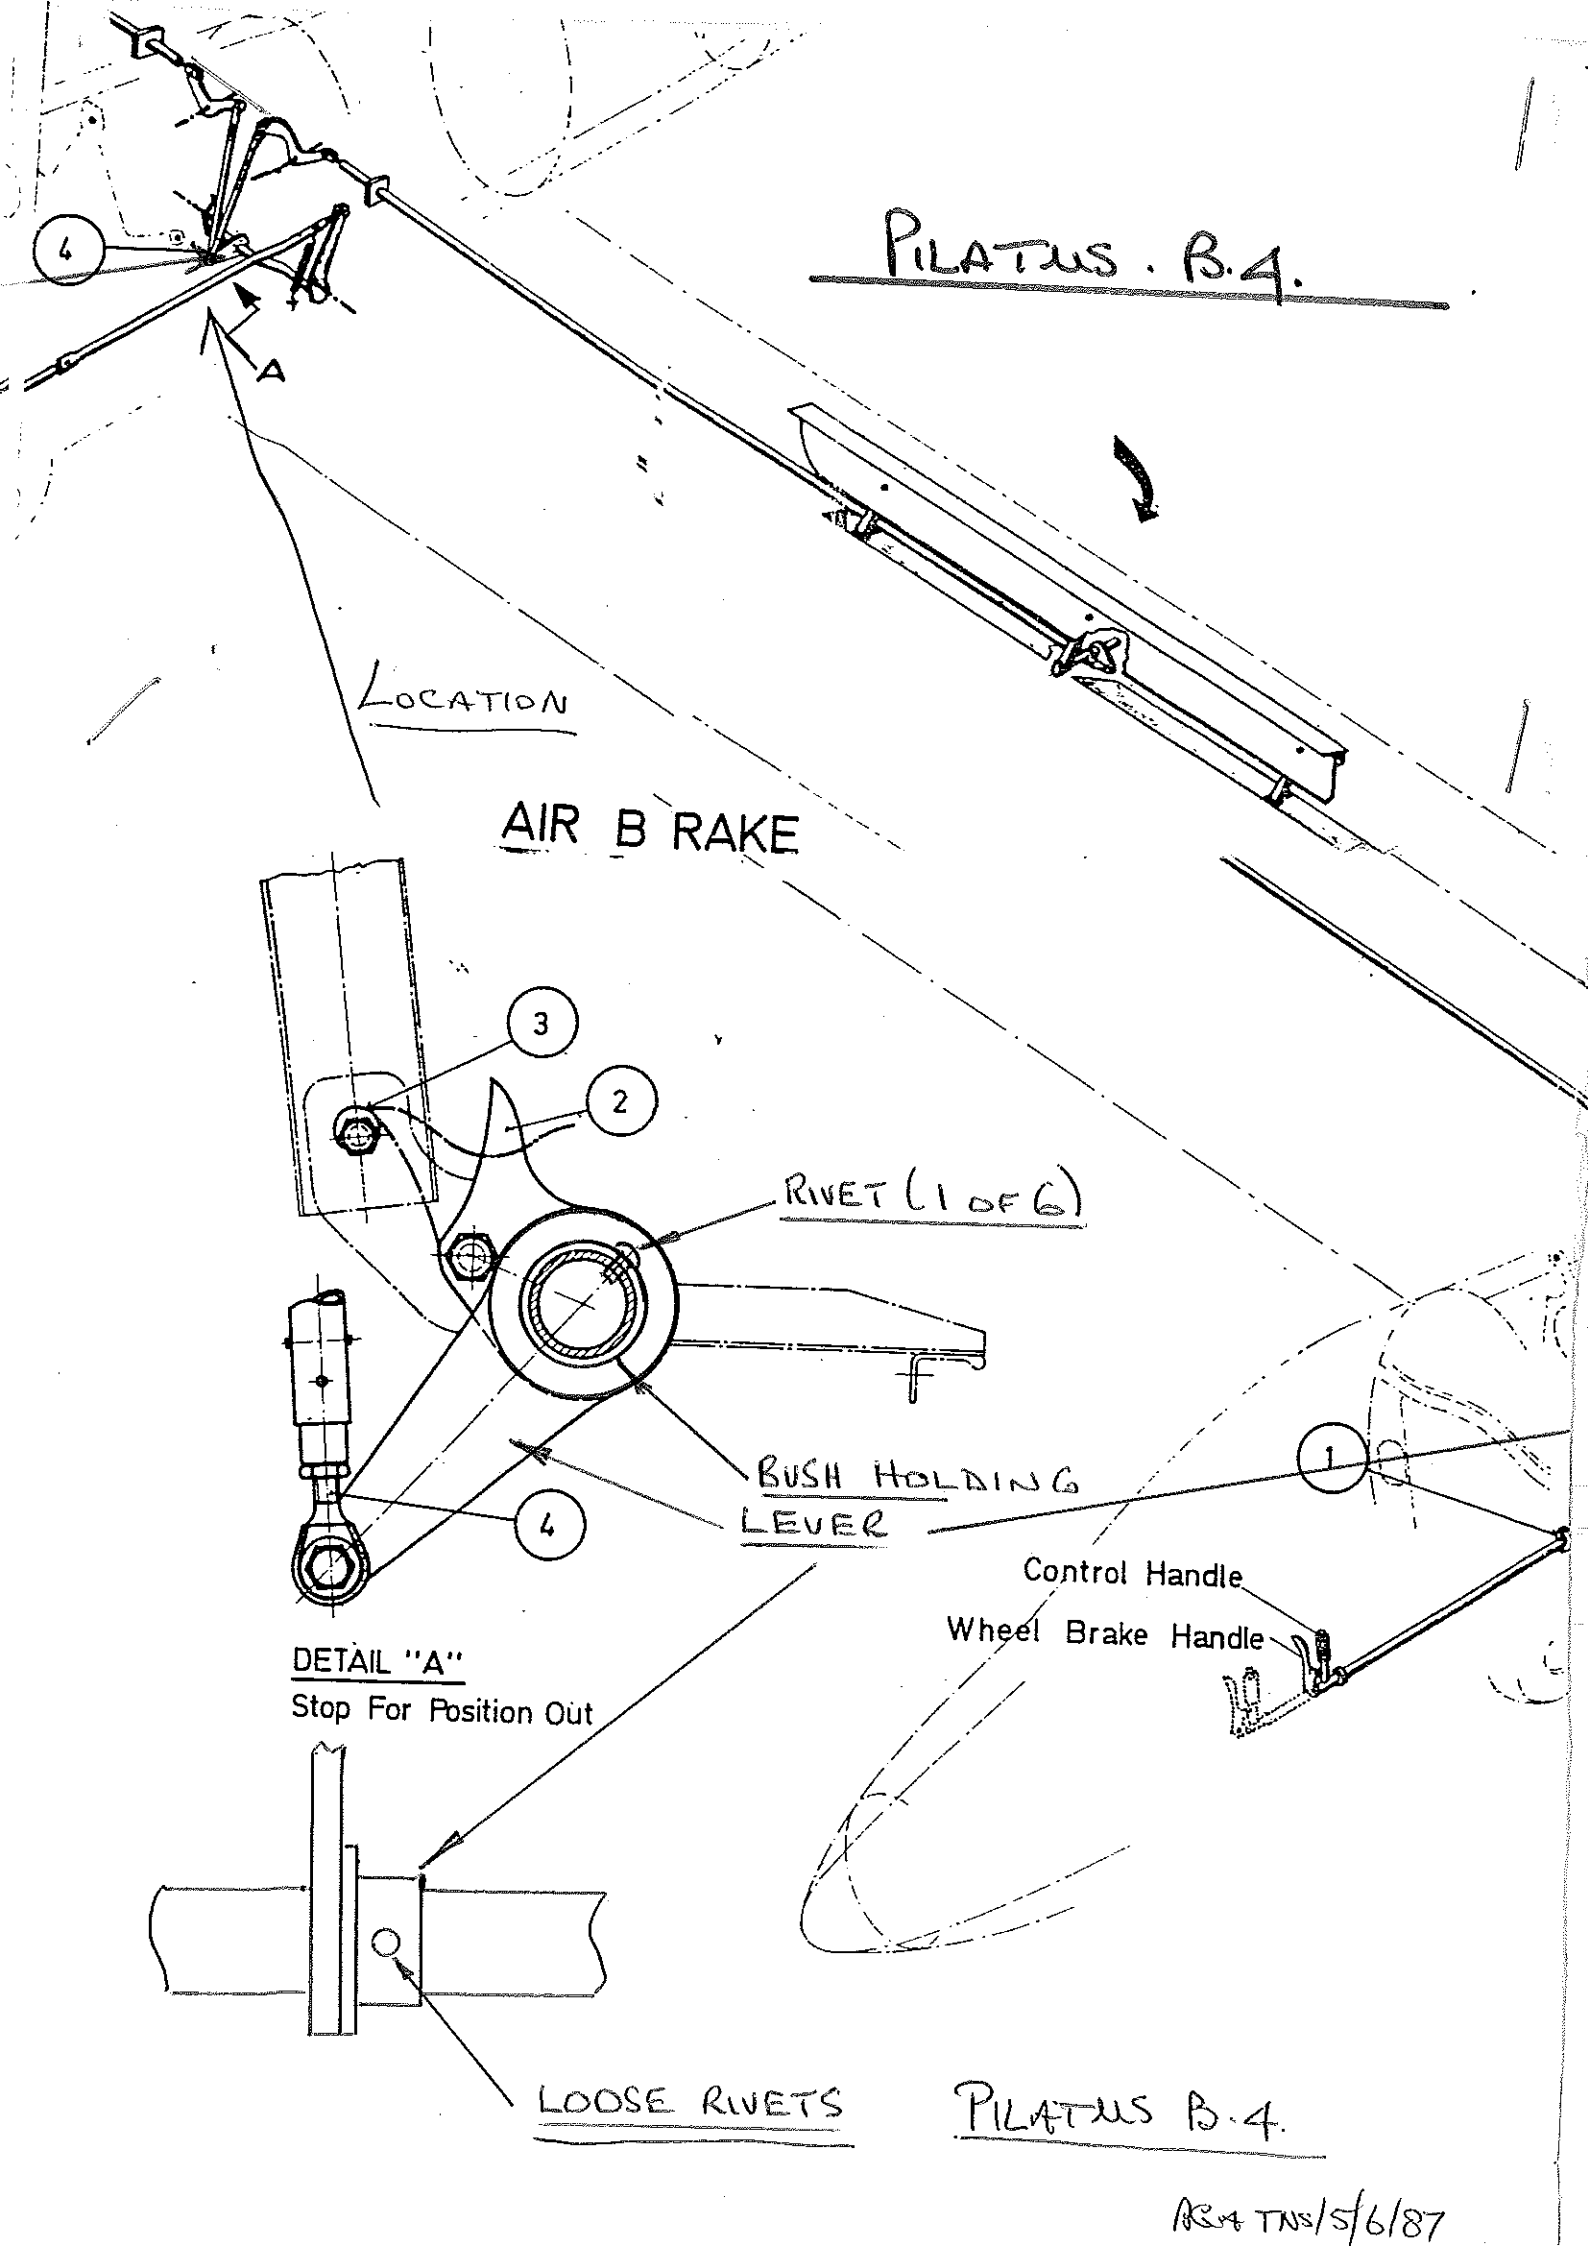
PILATUS B.4.

RIVET (1 OF 6)

LOOSE RIVETS

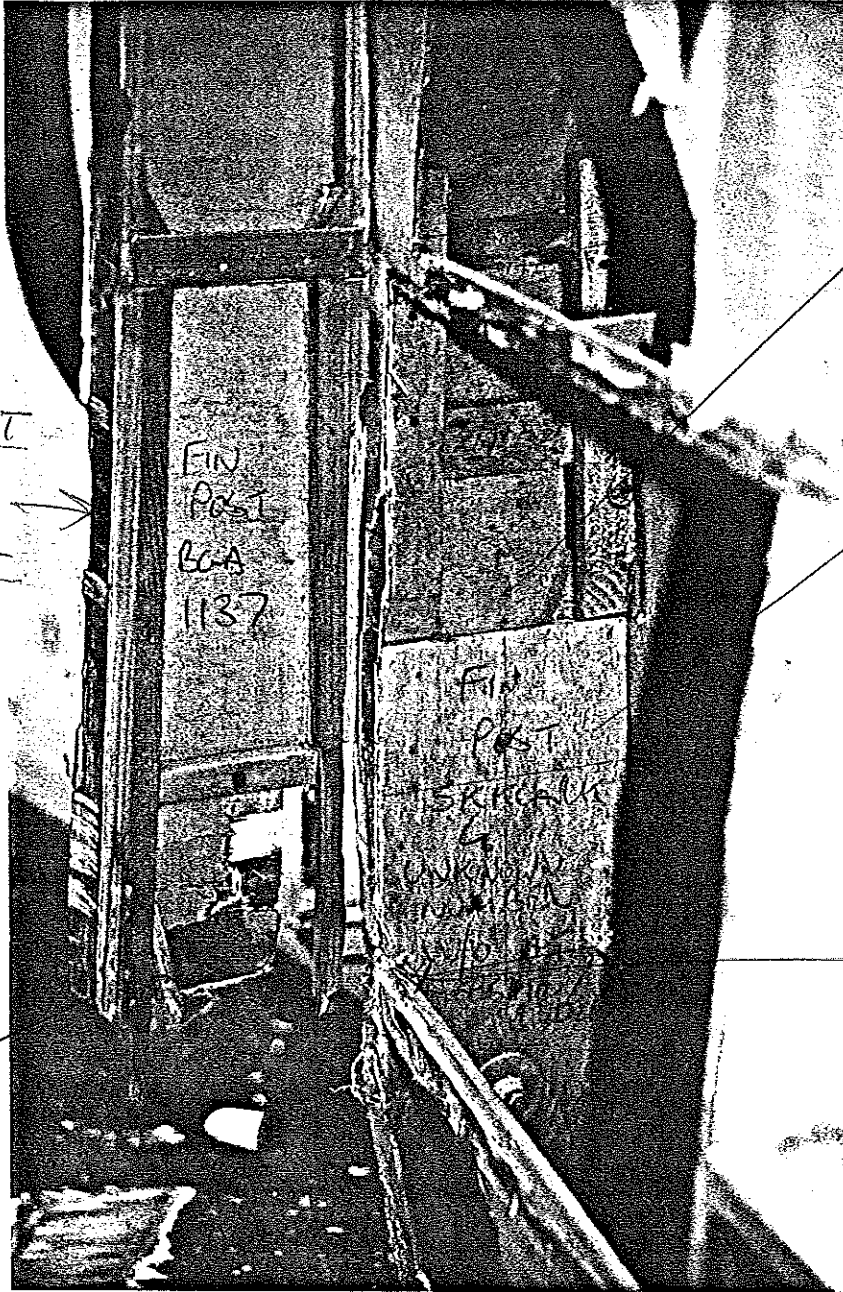
FIN FAILURE INSPECTION.

indicated that the aft fin spars had failed where cutaways are provided for the longerons. The Sternpost, carrying the rudder, failed, followed by separation of the fin.

A Slingsby modification (No 50/1/2T/2 dated 9/5/62) deleted a plywood block from the area of the lower rudder hinge, on the front face of the Sternpost, because it was redundant. It had previously supported a pulley assembly, which formed part of the elevator drive. Later modifications re-positioned the elevator drive (see diagram).

Since it can be shown that there was no design, modification or construction deficiency in this area, it can only be assumed that some dormant damage had occurred.

It is possible that accumulated damage may have occurred over a prolonged period of operation in which repeated strikes by the tailskid may have induced compression shakes in the Sternpost. It is also possible that some damage may have occurred in this glider's one and only major accident. (With the deletion of the elevator drive pulley, the inspection facilities were also removed). (The B.G.A. have on record the separation of the rear fuselage of an OLY 1 - B.G.A. 512 due to a tail skid strike at Dunstable in 1961).

RE-ENFORCEMENT
Deleted
By Modification
9/5/62.

Failure
BGA 1137.

LONGERON
CUT-OUTS.

- a) Apply a transverse load to the top of the fin and check for movement or noises in the affected areas.
- b) Inspect the Sternpost in the area of the lower rudder hinge, for signs of plywood separation, compression shakes, debonding, or damage inflicted by overtravel of the rudder.
- c) Check that the Rudder Stops limit the travel at full pedal deflections, such that the rudder does not transfer loads to the fin post.
- d) Inspect the forward fin structure in the area of the tailplane cut-away, for signs of plywood separation or compression shakes etc.
- e) Gain access to the forward face of the base of the Sternpost, to inspect for damage generally, and specifically where the longerons pass through the fin spars. (see diagram.
- f) Applicable also to Skylark 3s.

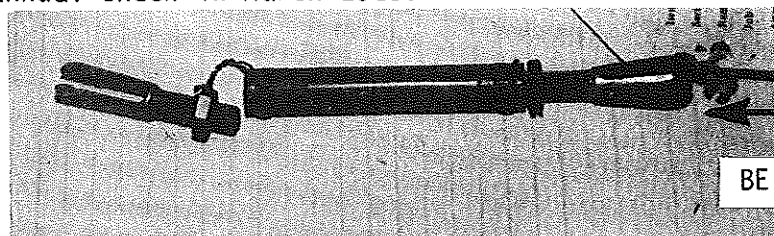
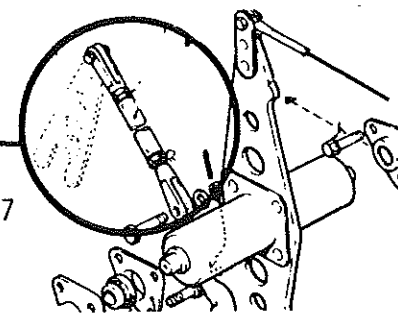
BE.45.10047

During the approach to land all elevator control was lost, the aircraft struck the ground in a nose down attitude shearing off the nose leg and damaging the propeller. Subsequent investigation revealed that control tube, Part No BE-10047-1 of the elevator controls in the rear fuselage had come undone and one fork end had dropped out. It appears that both lock nuts had loosened off and the locking wire, which was still intact, was insufficient to prevent the centre barrel from rotating due to vibration, until one fork end dropped out. The aircraft had flown 1430 hours and had been maintained to the LAMS Schedule with 62 hours flown since the previous annual check in March 1986.

On aircraft with an "independent" trim system (i.e. not a spring bias system) it should be possible to land the aircraft without undue skill by use of the trimmer.
