B.G.A. TECHNICAL COMMITTEE
TECHNICAL NEWSHEET TNS 7/8/87

BGA/TNS/7/8/87.

INSPECTION OF SKYLARK GLIDER AFT FIN SPARS AT
LONGERON CUTOUTS

TITLE	INSPECTION OF UNIVERSAL JOINT AT FLAP/AIRBRAKE HANDLE FORWARD ATTACHMENT	T.I. No.	108/T65
-------	--	----------	---------

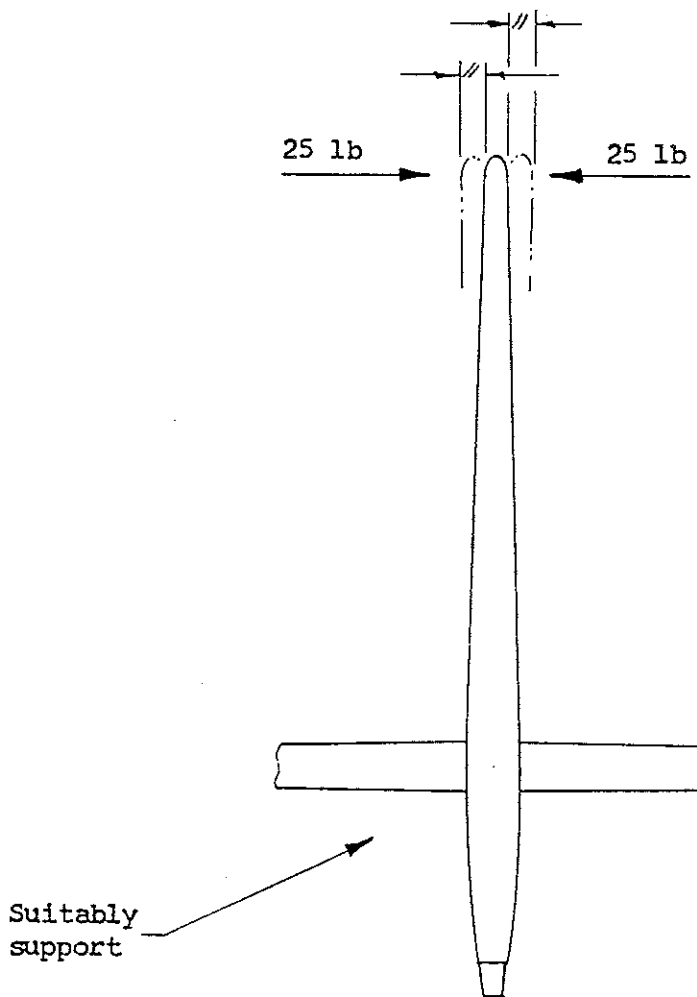
FIG. 2

- b) Apply an equal transverse load (approx. 25 lbs) ref. Fig.2 Sheet 4, alternatively in both directions to the top of the fin and check for equal movement each side. Also check for movement or noises in the affected areas, particularly on fin spar longeron connection. See Note 1.
- c) Inspect the sternpost in the area of the lower rudder hinge, for signs of plywood separation, compression shakes, de-bonding or damage inflicted by overtravel of the rudder. See Note 1.
- d) Check that the rudder cable stops limit the travel of the rudder at full deflection, port and stbd see relevant manuals for correct movement, and not the rudder contacting the fin post thus transferring loads into the fuselage. In particular inspect for signs of contact between lower rudder hinge mounting block on fin post and rudder leading edge.

- Note 1) If there are any indications of structural damage or excessive fin movements the aircraft must be grounded until repair is carried out.
- 2) If rudder is contacting fin and or rudder stops suspect aircraft must be grounded until rectification action is carried out.

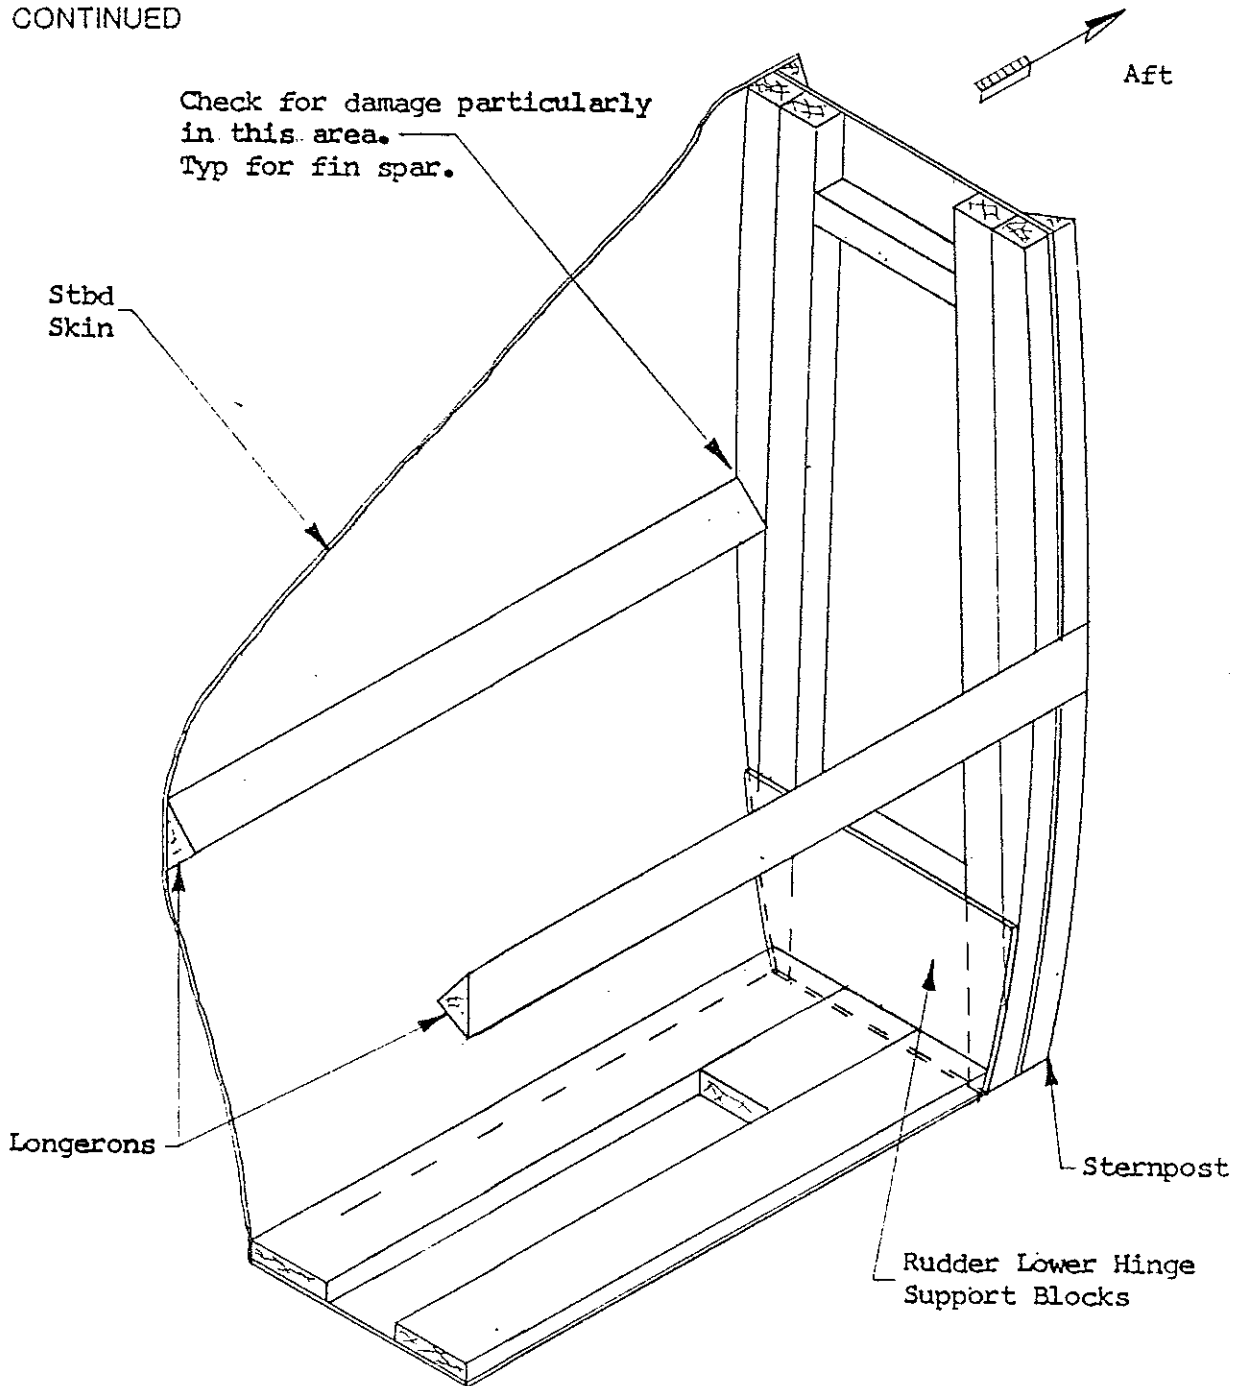
FIG. 1

Following an accident to Skylark 4 Works No.1403 (BGA No. 1137) (BGA New Sheet TNS/5/6/87 (Item 1.6) refers) where during a winch launch the fin separated from the fuselage. On subsequent investigation it appeared that the sternpost had failed where the longerons are reset into the sternpost members.

- a) Gain access, see Fig. 1, Sheet 3, to the forward face of the base of the sternpost, to inspect for damage generally and specifically where the longerons pass through the fin spars. See Note 1.

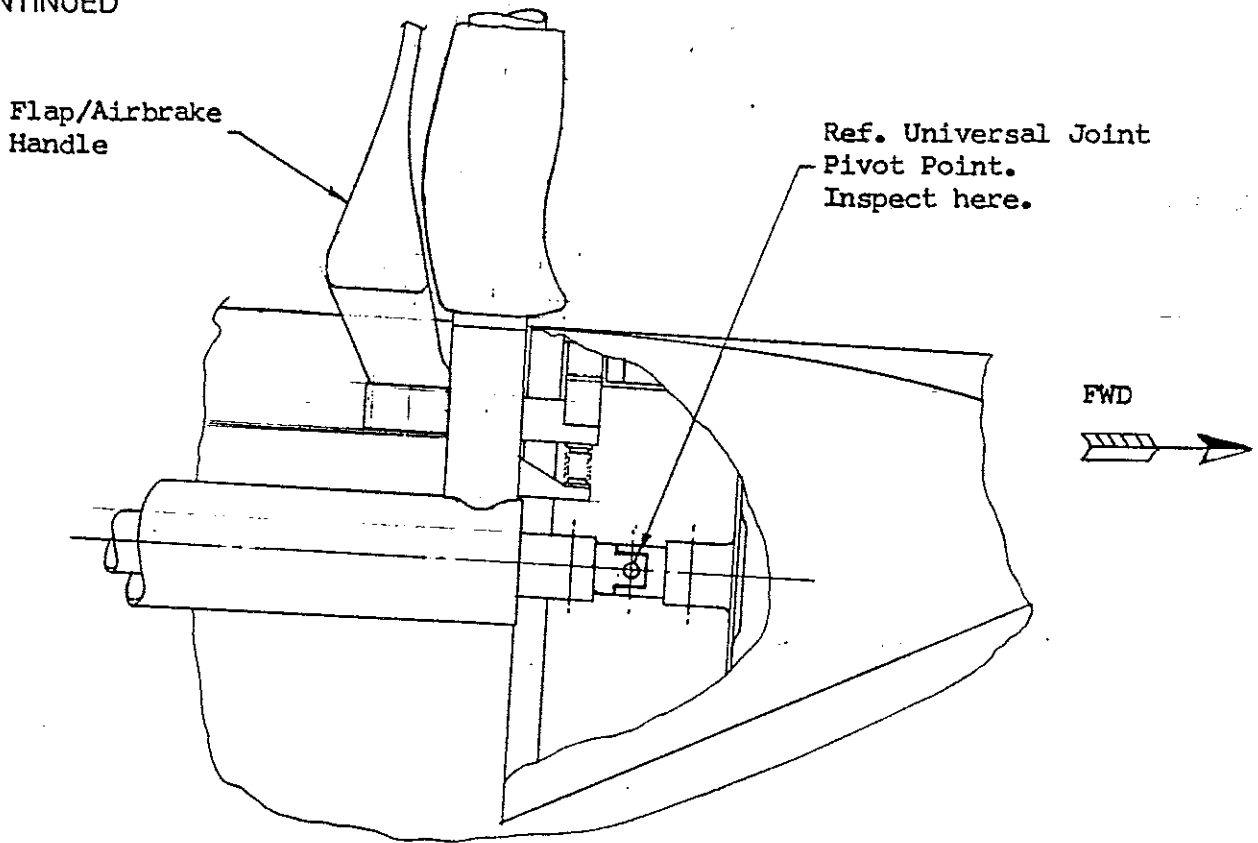
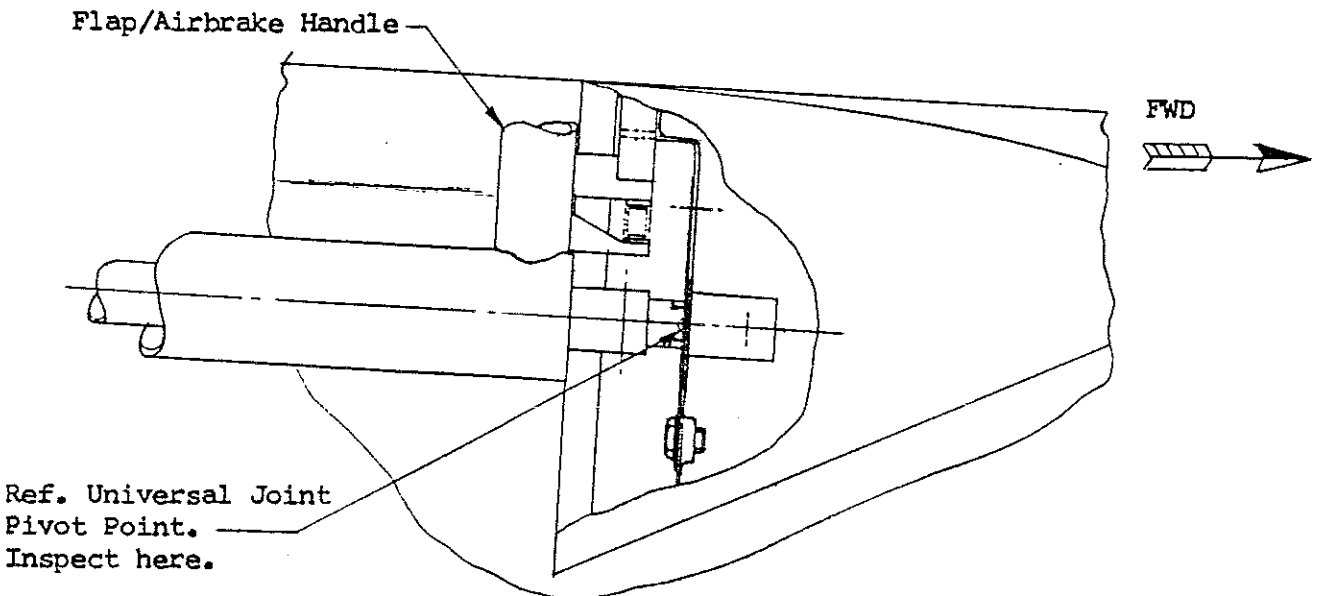
FIG. 1

JUSTIFICATION: Following an incident to T65A Vega Works No.1908 (BGA No.2497) where, during launch, one of the universal joint pivot pins sheared. The flap/airbrake handle then became detached from its forward mounting thus fully activating the airbrakes. Ref. Fig.1

ACTION: Visually inspect universal joint for: loose and deformed pivot pins, splayed jaws or any abnormal wear.

CONSEQUENTIAL LIMITATIONS: If there are any indications of the above defects, aircraft must not be flown until new universal joint is fitted or Mod M16 is incorporated. Refer Slingsby Aviation for details.

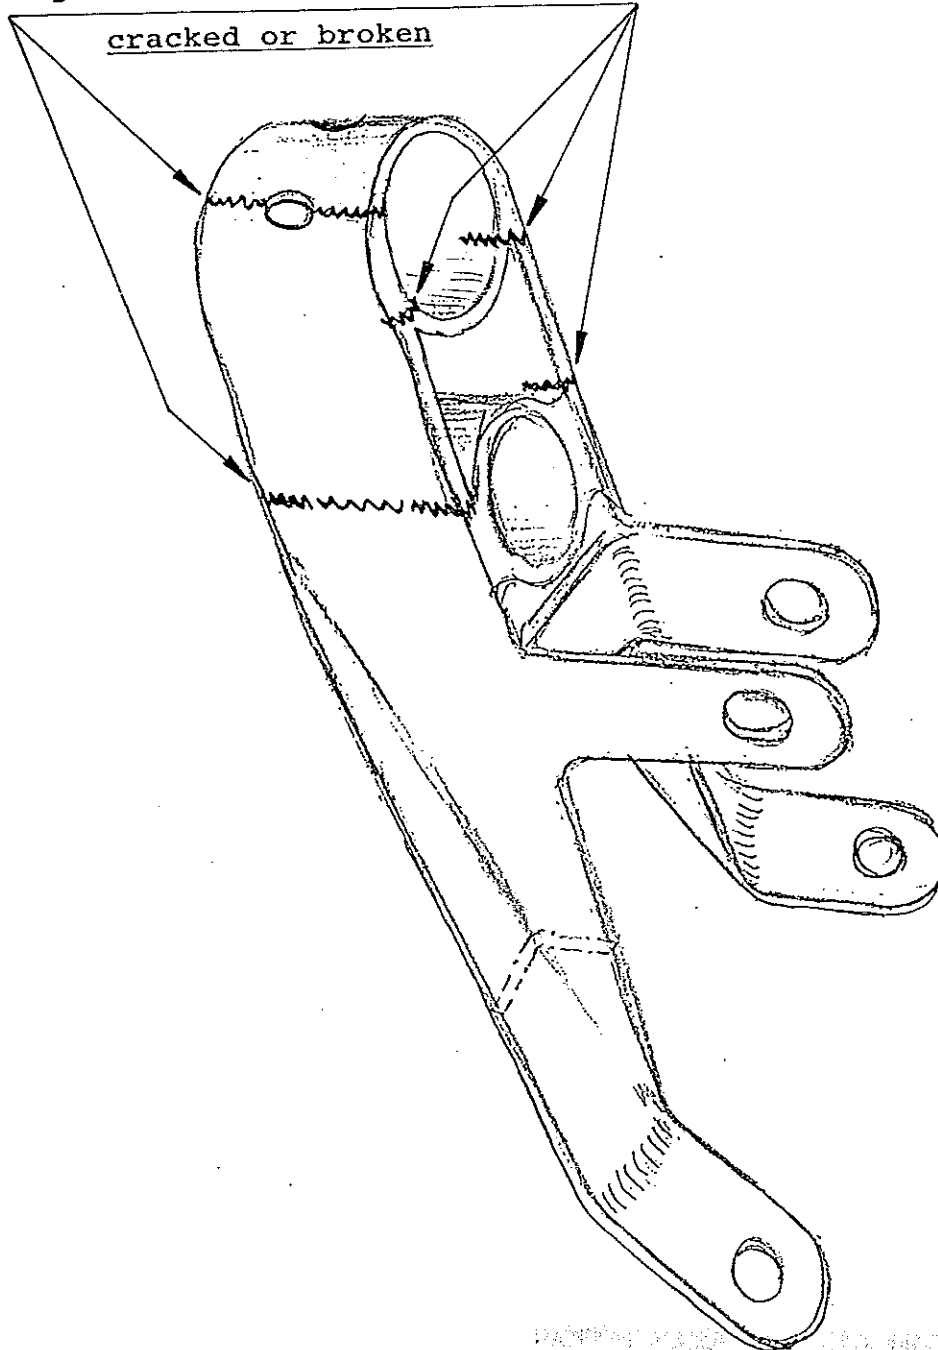
Fig. 1

Reason: On three ASK 21s which each have flown more than 1300 hours and more than 6000 take-offs respectively, this support fitting showed cracks or was broken (see Fig.1).

cracked or broken

1. Check the rudder pedal support fitting prior to the next take-off.
2. If cracks are found in this fitting, it must be immediately exchanged for a new one. If cracks are not yet visible, the support fitting must be exchanged in any case by April 1, 1987.

1. Order a new support fitting from the manufacturer; P/N 99.000.2174.
2. Remove the old support fitting; for this purpose the $\phi 4$ mm blind rivets must be drilled off.
3. Measure the position of the $\phi 4$ mm rivet holes on the removed fitting and transfer them accordingly onto the new fitting.
4. Install the new fitting and fix the upper pedal guide tube to the fitting using $\phi 5$ mm blind rivets.

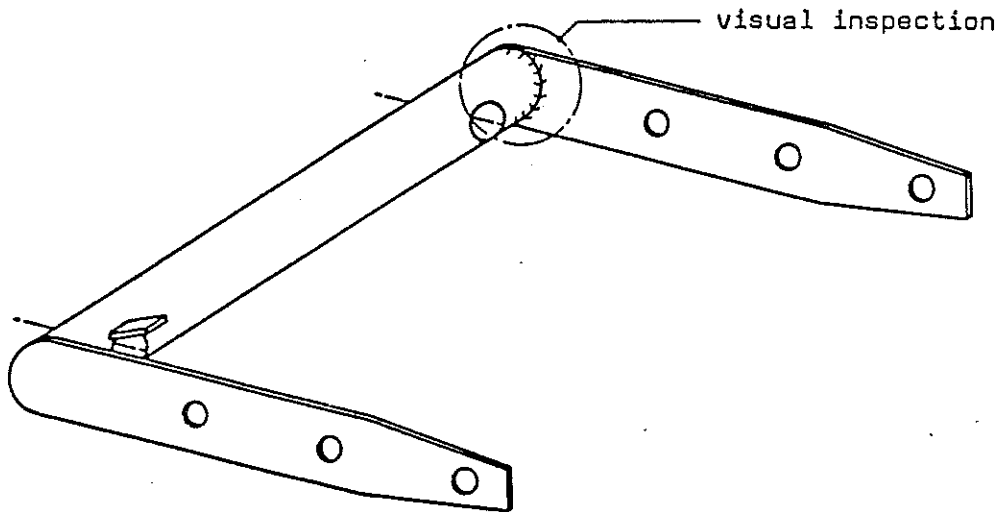
SKETCH 1

earlier type elevator drive bracket

Reason : Difficulties in the control of the sailplane were
encountered when an earlier type elevator drive
bracket broke on one side in flight.

Actions : 1. On sailplanes having an earlier type elevator drive
bracket according to sketch 1, a visual inspection
for possible cracks must be carried out while
twisting the two elevator halves against each other.

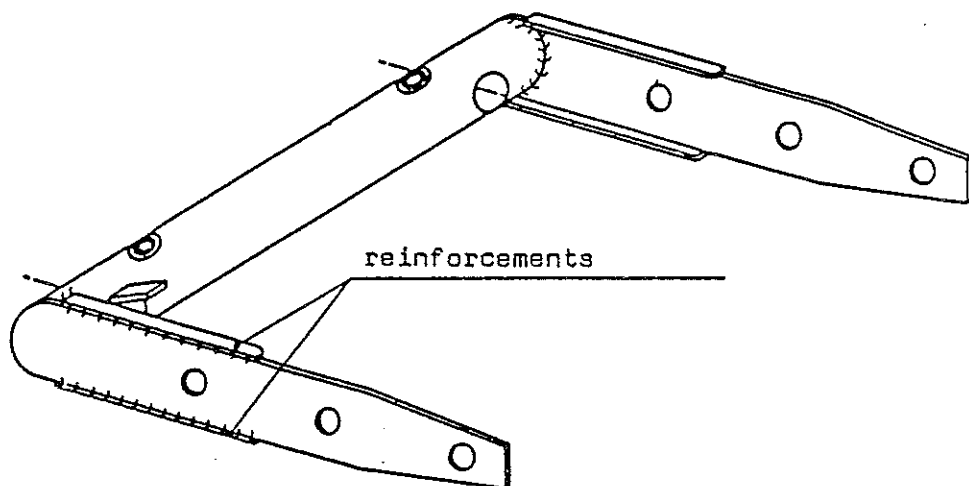
SKETCH 2

reinforced elevator drive bracket

2. The earlier type elevator drive bracket must be
replaced by a reinforced bracket as shown in
sketch 2.
The installation must be done in accordance with
page No. HSS-30.055/1.

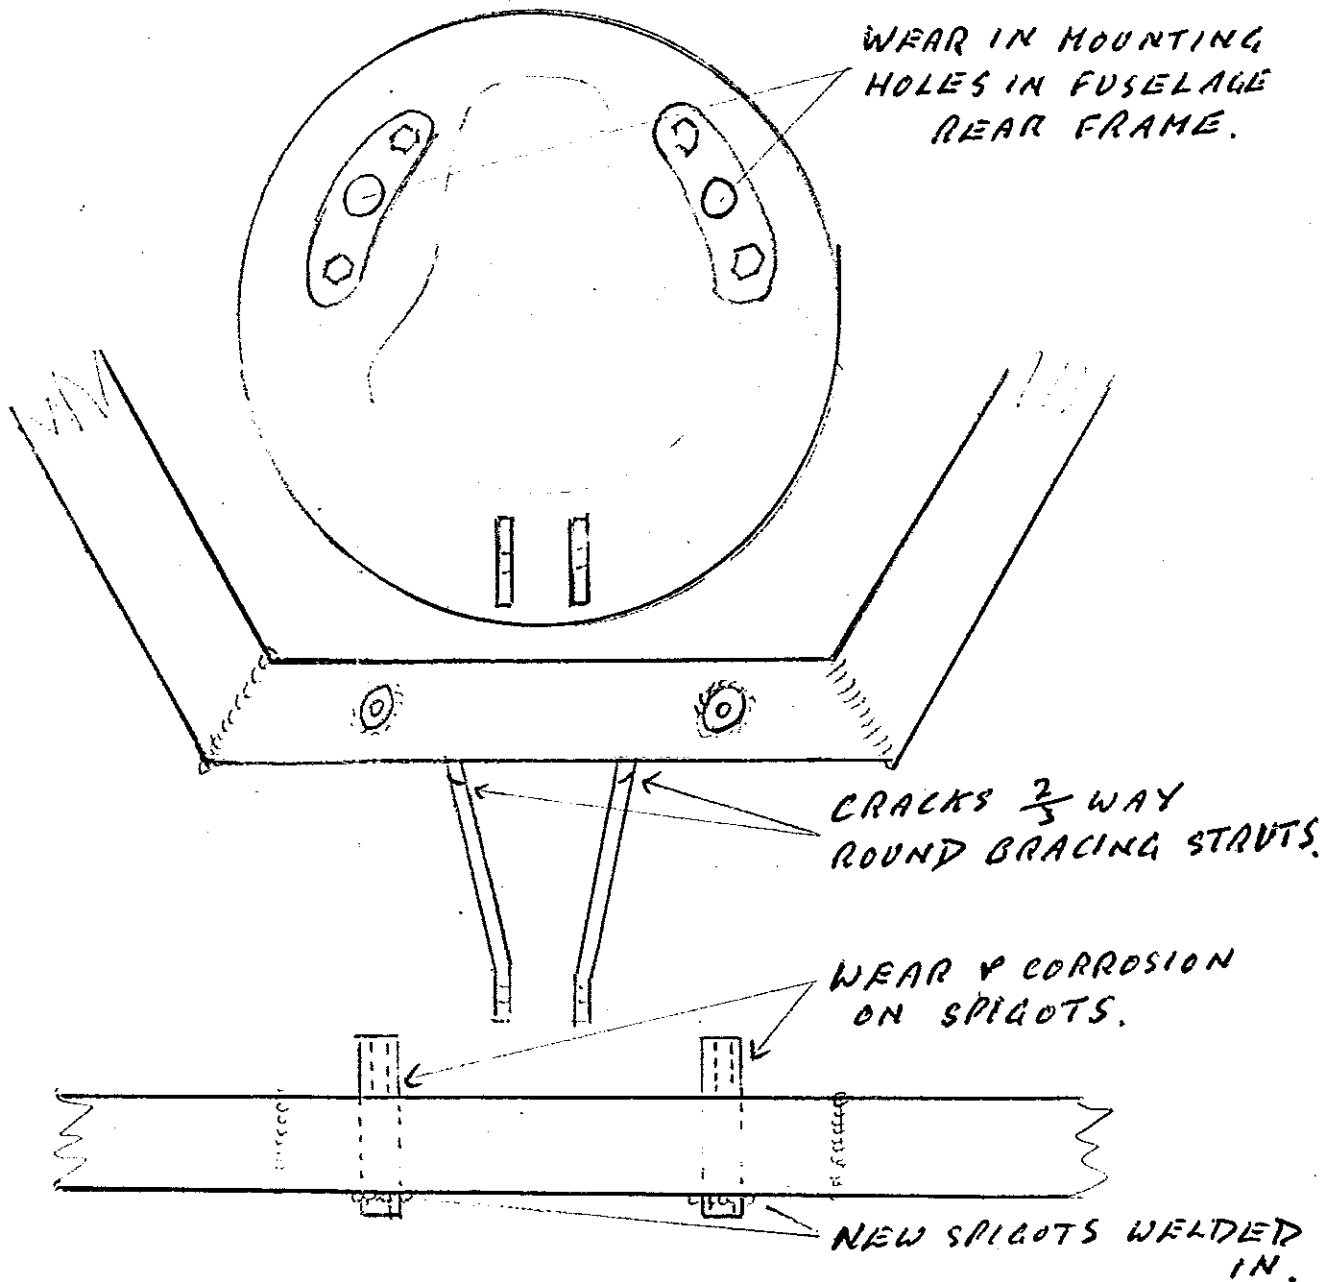
SHK 1 WORKS/AB LOOSE RUDDER/ELEVATOR ASSY.

- 1.9. SHK LOOSE RUDDER/ELEVATOR ASSEMBLY due to wear in the mounting holes in the rear fuselage frame. Mounting (bracing) struts found cracked. (Sketch attached).

Excessive fore & aft movement noticed in elevators. When fairing was removed excessive movement found in mounting spigots and both bracing struts were cracked $\frac{2}{3}$ way through. New spigots .020" oversize fitted - fuselage plates & frame reamed to accept new spigots & bracing struts welded.

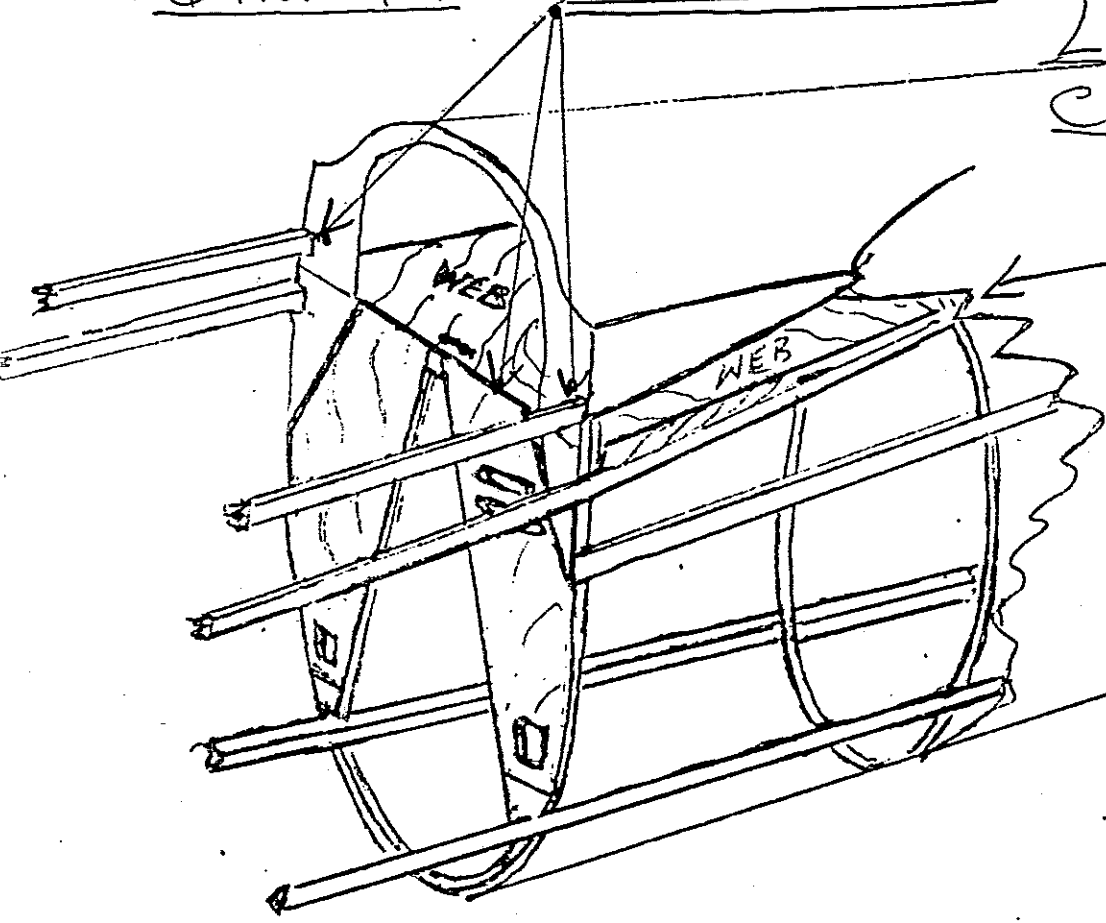
- 1.4. ASK 21 ^{RUDDER} PEDAL SUPPORT FITTING - CRACKED T/Note 19, herewith requires inspection and/or exchange.
- 1.5. T.51 DART HEAVY LANDING INSPECTIONS OF LONGERONS Ref TNS 3/85. Inspections of longerons both forward in (the cockpit) and aft are required. (Sketch attached). Strongly recommend all Darts be inspected (Reported by D. Masterson).

INITIAL FAILURE POINTS.

CRACKS
Ref TNS/3/85

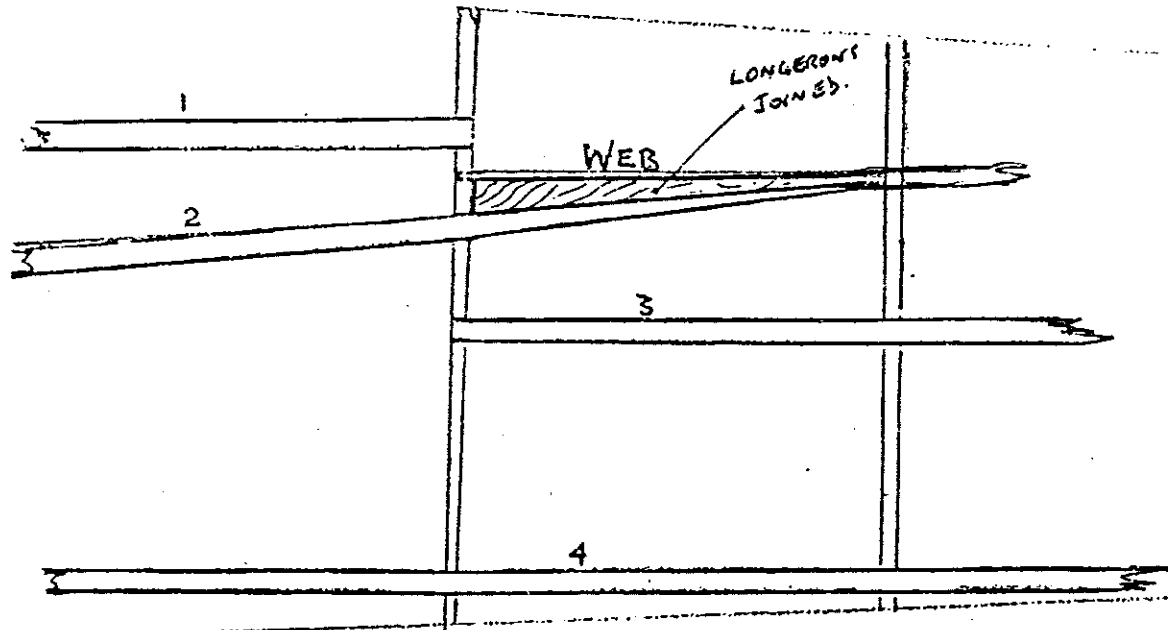
LONGERONS' ARRANGEMENT

LONGERONS 1 & 3 - NON-CONTINUOUS.
" 2 & 4 - CONTINUOUS.

APART FROM OUTER SKIN. INTEGRITY OF WEB TO FRAME TOP GLUING AND LONGERON "NOTCH" GLUING MUST BE SOUND. FAILURE IN TENSION COULD OCCUR.

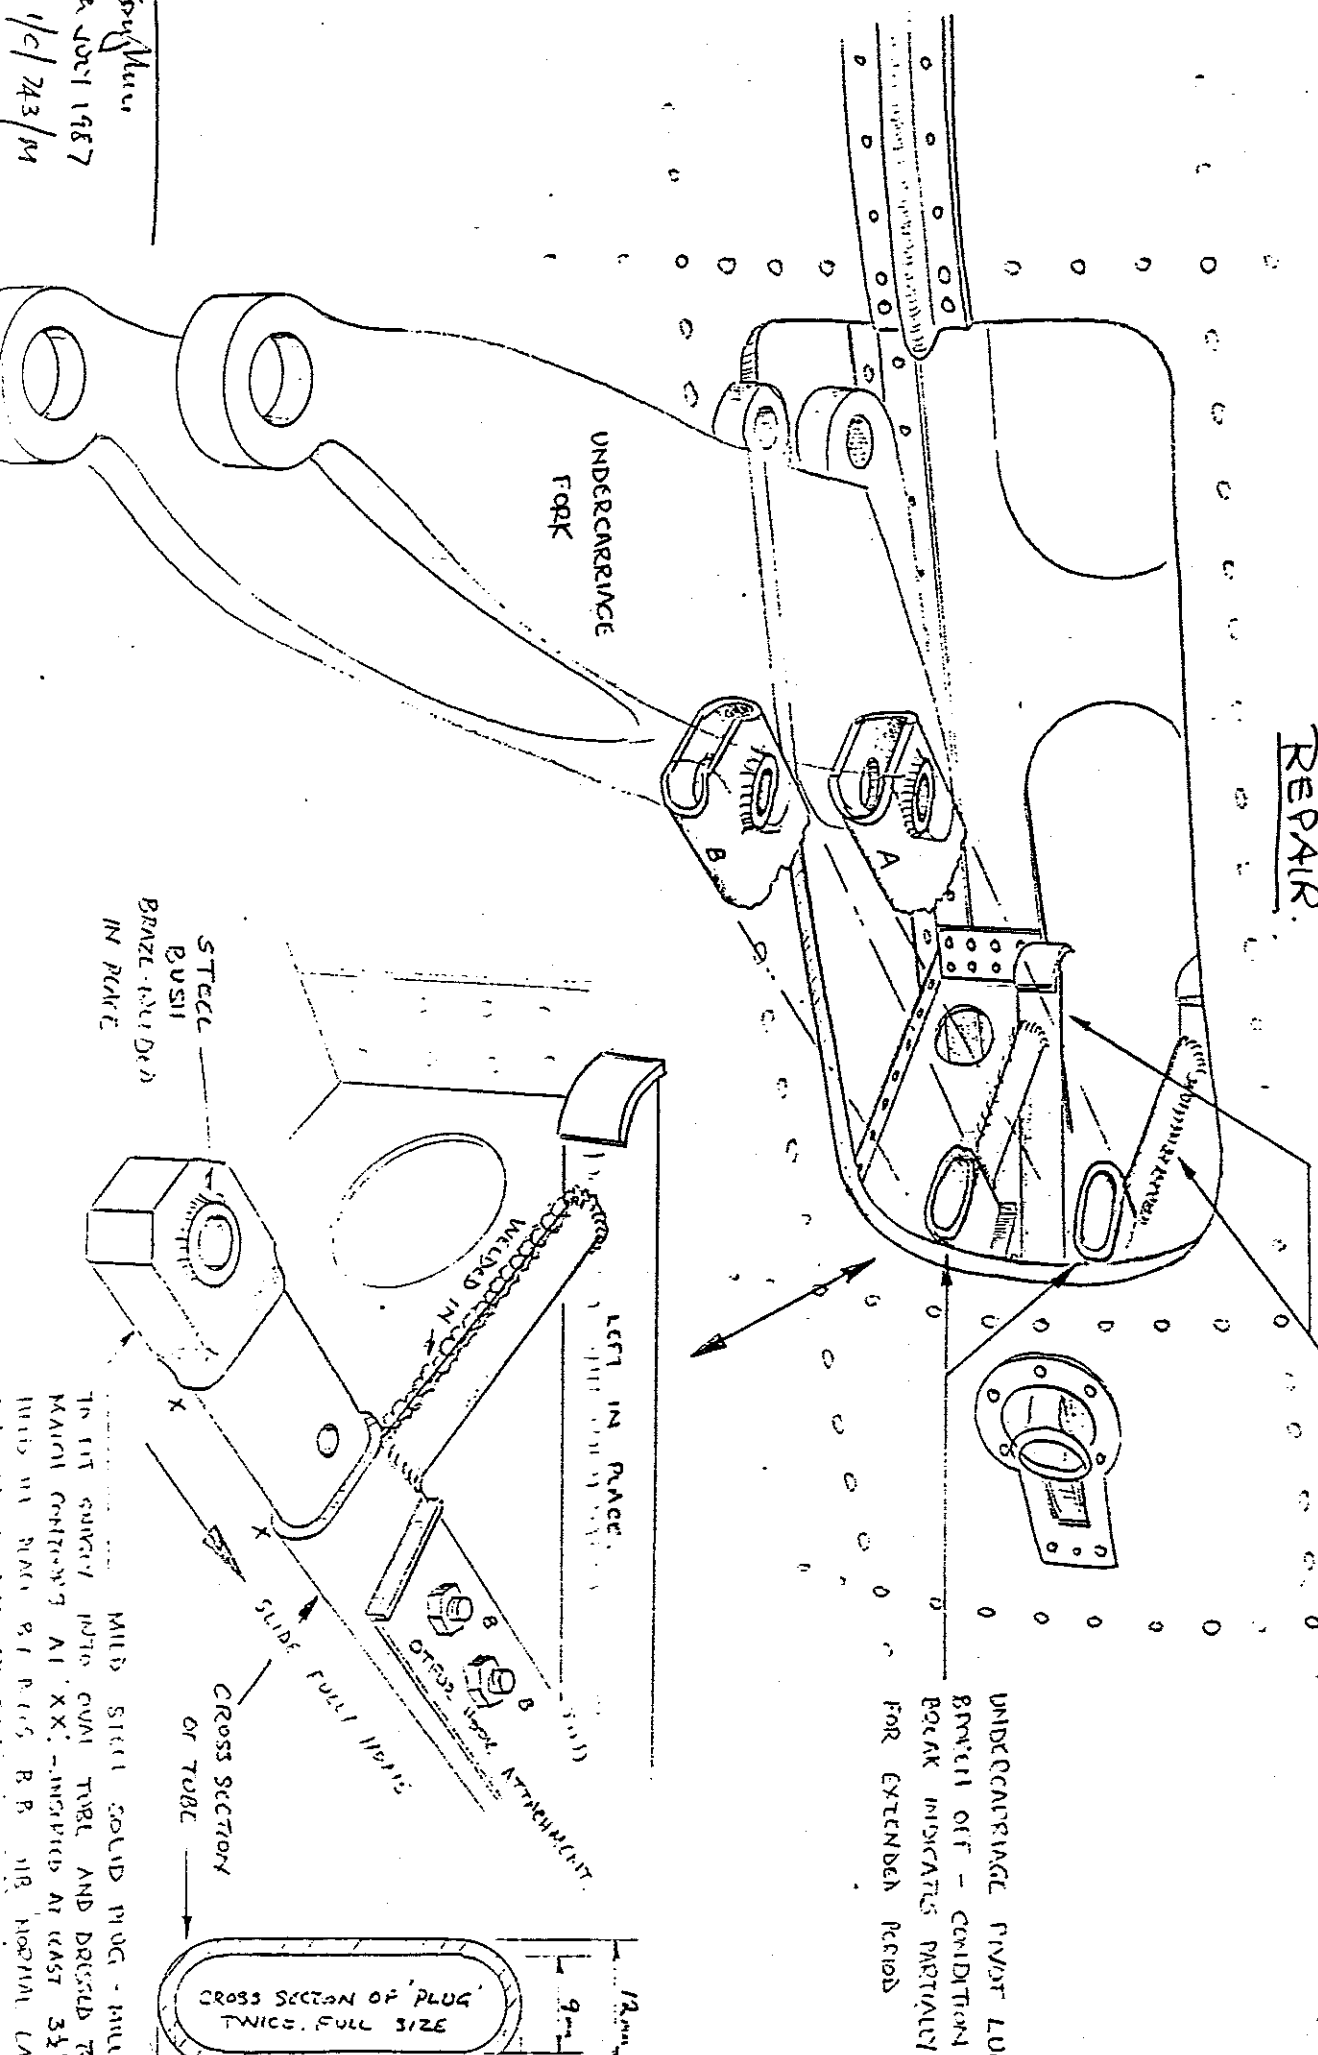
BLANK UNDERCARRIAGE REPAIR.

BLANK - BORDERS GLIDING CLUB - MILFIELD, SUGGESTED MOD/REPAIR
 FOLLOWING UNDERCARRIAGE CLEANSE AFTER NORMAL LANDING.

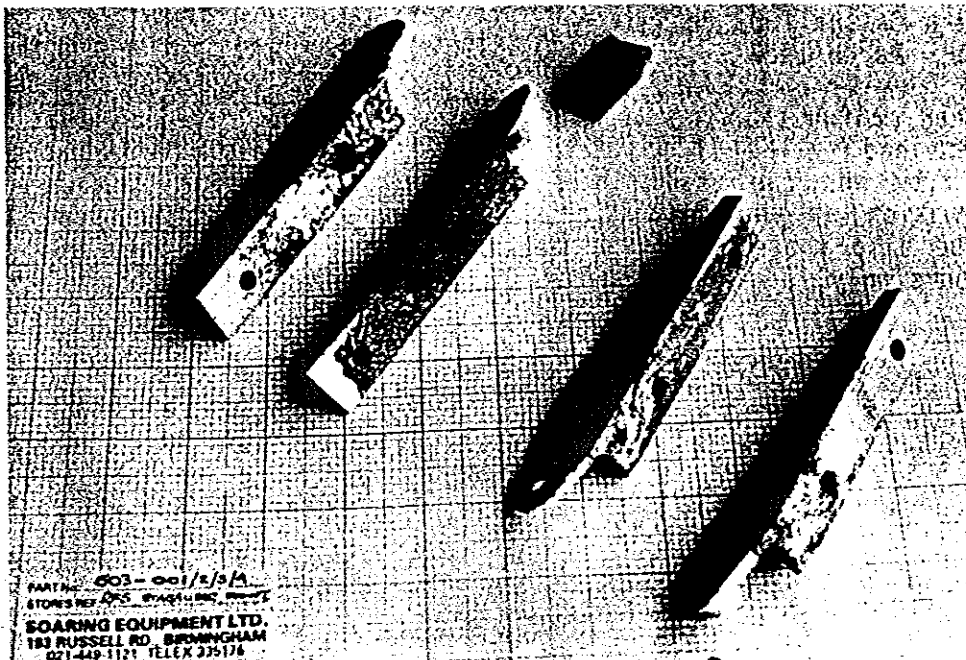
2. SEVERE TAILPLANE MOUNT BRACKET CORROSION

Severe layer type inter-crystalline corrosion was found on all four attachment brackets, one of which has been so badly affected as to reduce the web thickness of the alloy extrusion from 3mm to 1mm, with substantial pieces detached. The Part Nos are 503-001, 002, 003 and 004. It should be noted that only a part of the bracket can be seen even when the tailplane is removed and access must be gained to enable the extrusion within the tailplane to be checked. The worst corrosion is on the face in contact with the wood. The reporter strongly suggests that the parts be removed and inspected for corrosion, as a visual inspection without disassembly may not show the problem. Two similar cases have been reported previously and a Service Bulletin S-01-85 was sent to all RF5 owners on the UK Register in October 1986 by Soaring Equipment Limited.

All owners should check for this serious fault. The tailplane attachment brackets on the RF4 and RF5B should be of steel and therefore not affected by this problem.

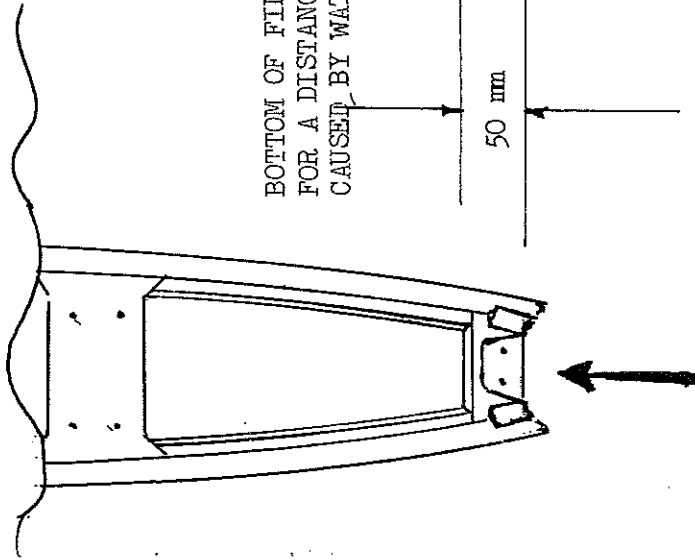
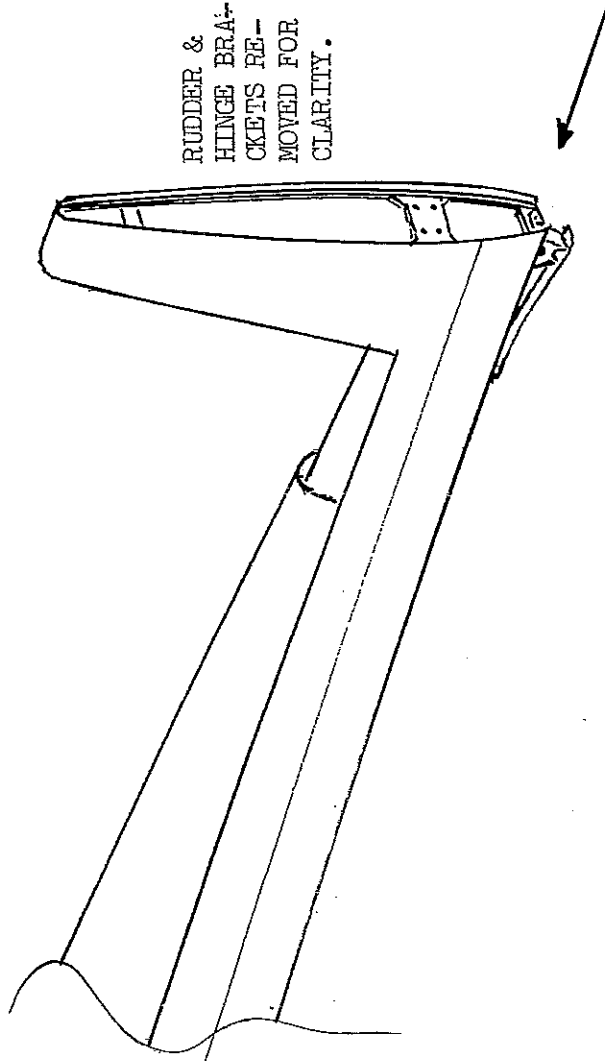
- 1.7. KA 13 FIN SPAR ROTTEN AT THE BASE The attached sketch from the Stratford-on-Avon G.C. is self-explanatory. Drainage & ventilation is required.
- 1.8. ASTIRS - Elevator control rods corroded in the rear fuselage. Reported by Southdown Aero Services .

BOTTOM OF FIN POST ROTTON
 FOR A DISTANCE OF 50mm
 CAUSED BY WATER INGRESS
