B.G.A. TECHNICAL COMMITTEE

TECHNICAL NEWSHEET

TNS 9/10/87

PART 1. AIRWORTHINESS AGGRO (Please add to the 1987 Green Pages)

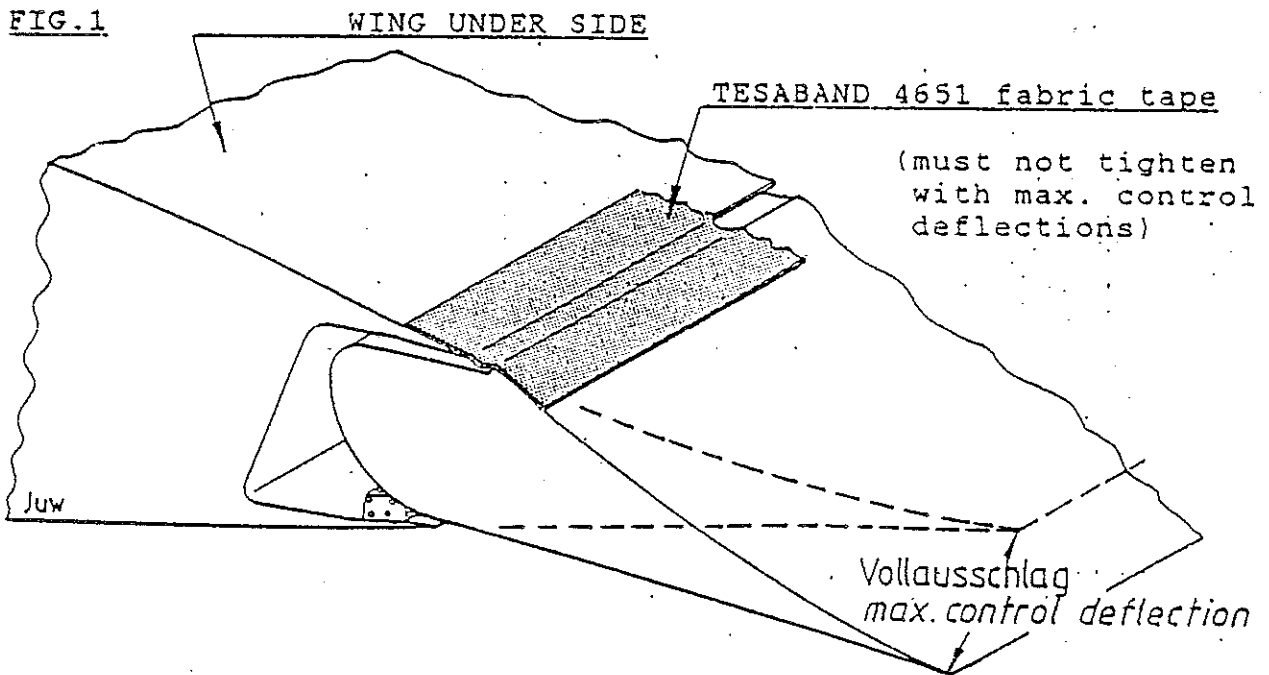
FIG.1

Recently two ASW 20s had aileron flutter in flap position 1 at a speed of about above 200 to 210 km/h. The said ASW 20s were improperly equipped with an elastic plastic tape to seal the gap between wing and flaps/ ailerons on the under sides; they used strips of tape which were insufficiently curved, and above all the teflon strip which has to lie underneath for sealing the gaps, was missing. Owing to this, air exchange between wing upper side and under side is possible which causes - depending on the control surfaces' deflection - periodical separation of airflow and this unusual kind of aileron flutter. These latest findings also account for earlier flutter incidents which occurred mainly in countries with warm climate (see TN no.12). In those cases the gliders used insufficiently stiff plastic tape (partly even without fabric stiffening) which softened under high temperatures and therefore could crease periodically inwards and outwards thus causing varying airflow separation on the control surfaces under side and thereby leading to aileron vibrations. But also the factory-standard TESA fabric-tape (which is adequately plastic-treated) gets worn out after some time and then it has no more sufficient stiffness and may lead to the above described flutter incidents.

1. Prior to the next take-off it must be checked whether the control surface gap on the wing under side is equipped with a sealing, i.e. either
  - 1.1 with the factory-standard, plastic-treated fabric-tape TESABAND 4651, white, 38 mm wide (see Fig.1); in that case the plastic coat on the fabric must not be damaged, discolored or even weather-worn; the tape must not tighten with full control surfaces deflections.
  - or
  - 1.2 with the pre-curved steel strip (0,07 mm thick) or the pre-curved plastic tape (MYLAR 0,25 mm thick) respectively; in that case check that both require absolutely a Teflon sealing tape underneath for the purpose of sealing the gap and reducing the friction (see Fig. 2).

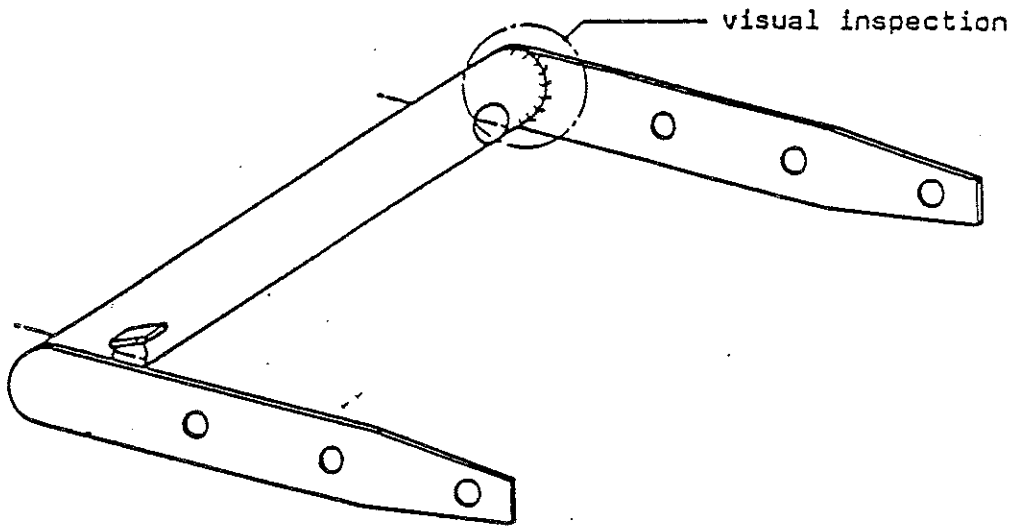
SKETCH 1

earlier type elevator drive bracket

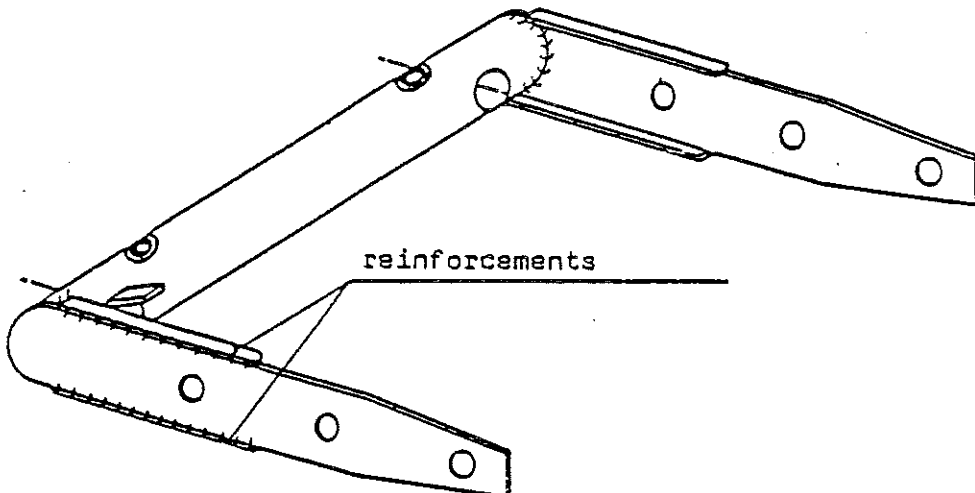
SKETCH 2

reinforced elevator drive bracket

- 1.20 Schempp-Hirth Gliders (Janus B, Nimbus 2B, Mini-Nimbus HS.7. and Mini-Nimbus B). - REINFORCED ELEVATOR BRACKETS (see attached sketch). As a matter of URGENCY (and before November 30th 1987). Manufacturer recomends reinforcement or replacement. T/Notes 328-8 Mini-Nimbus, T/Note 295-19 Janus B, 286-24 Nimbus 2B, Refer - (Sample sketches attached). Details from U.K. Agents.

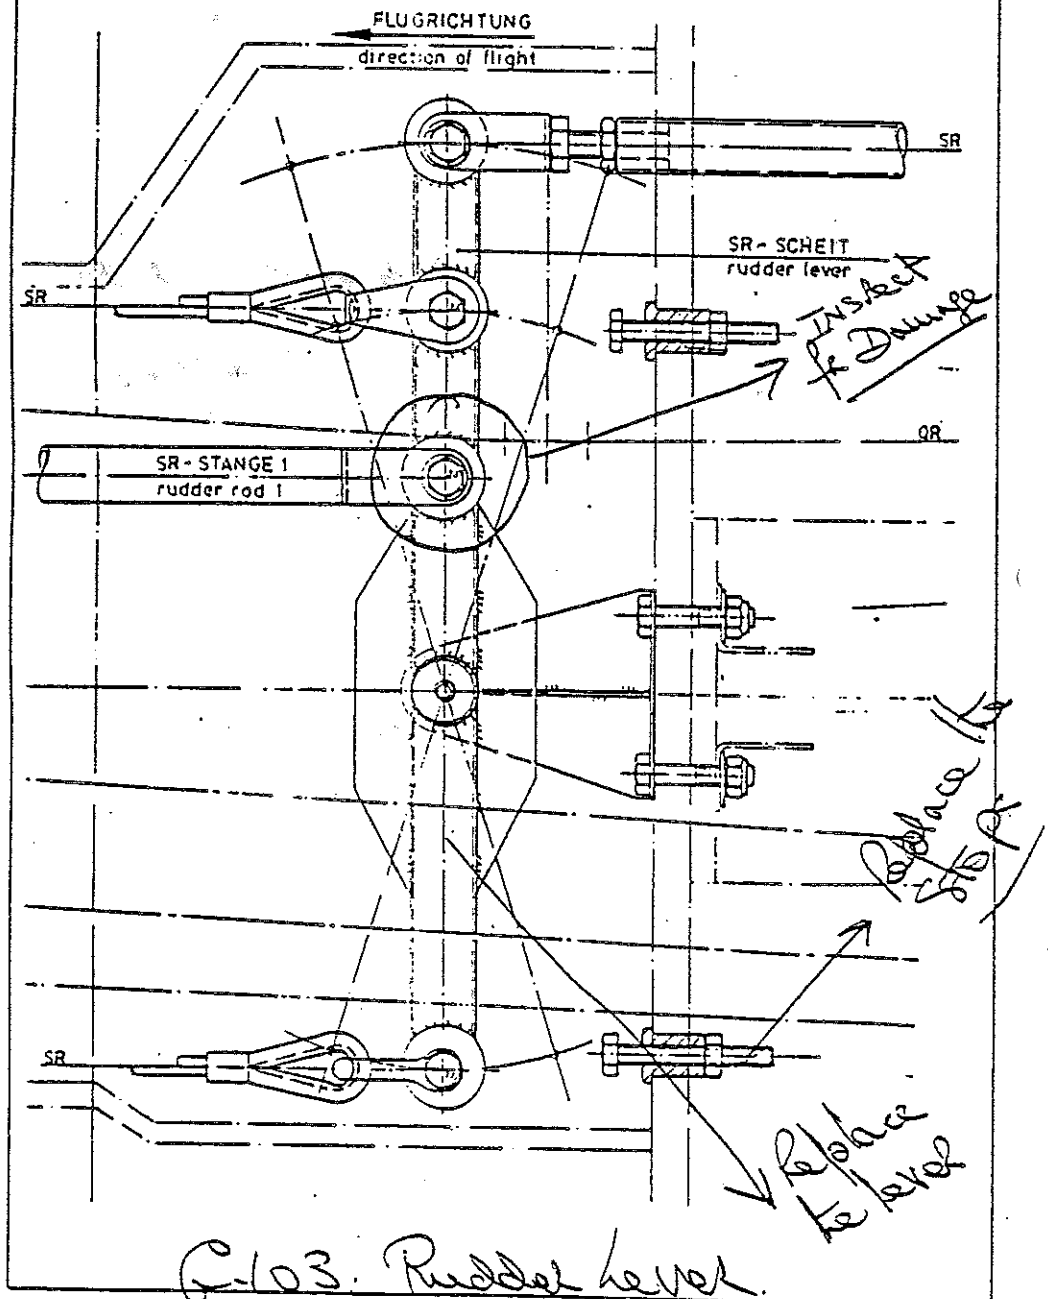
Abb. 1  
fig. 1

**Reason:** This Service Bulletin was prompted by breakage of the rudder lever 103B-4430 in the area of the connecting bearing for the rudder rod I (connecting the rudder lever to the rear pedal unit). Predamage is announced by widening of the bearing ring.  
As a precautionary measure the rudder lever is being replaced by a stronger lever (103B-4430/1) and the stop screws are being replaced by stops with rubber buffers.

- Instructions:**
1. Instruction: Checking the rudder lever for signs of predamage.
    - 1.1 Visually inspect the complete rudder lever prior to next take-off for signs of predamage. Checking the lever requires implementation of the Repair Instruction No. 315-33/1 which is a component of the present Service Bulletin.
    - 1.2 When no damage to the lever is discernible there is no need to repeat Instruction 1 until the rudder lever is replaced according to Instruction 2.
    - 1.3 Should predamage be evident, Instruction 2 must be implemented before next take-off.
  2. Instruction: Replacing the rudder lever
    - 2.1 Changing the rudder lever and the stops shall be implemented in accordance with Repair instruction No. 315-33/2 not later than 31.01.1988.

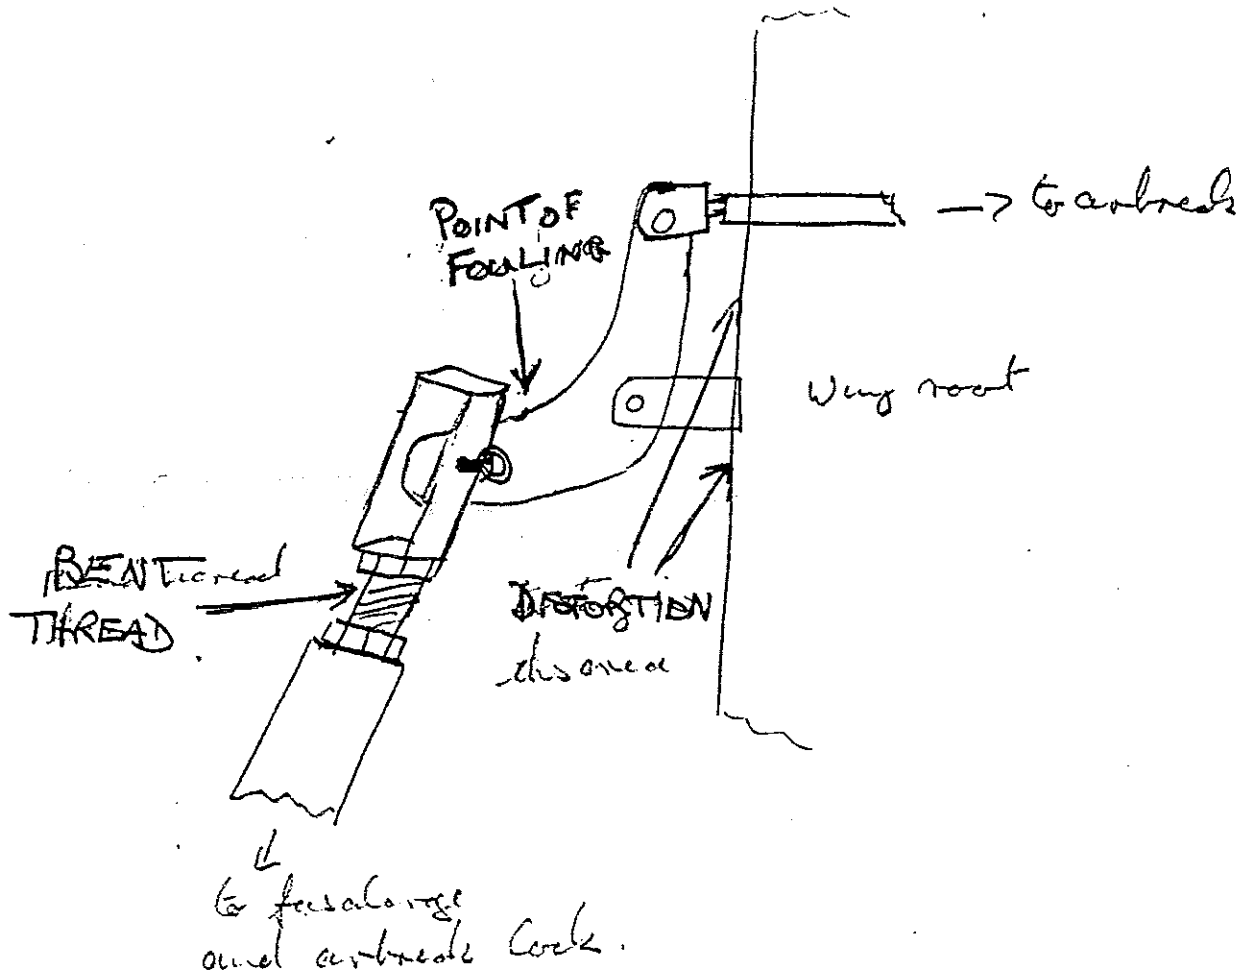
- 1.5. Bocians - cable systems too tight Aileron cable tensions were found to be excessive, and likely to cause damage. (Reported by Highland G.C.).
- 1.6. Ka6GR Airbrake push-rod bent and excessive load applied to bellcrank at root end. (Reported by Highland G.C. & sketch attached).

K6CR PUSH ROD FOLLOWING BELL CRANK.

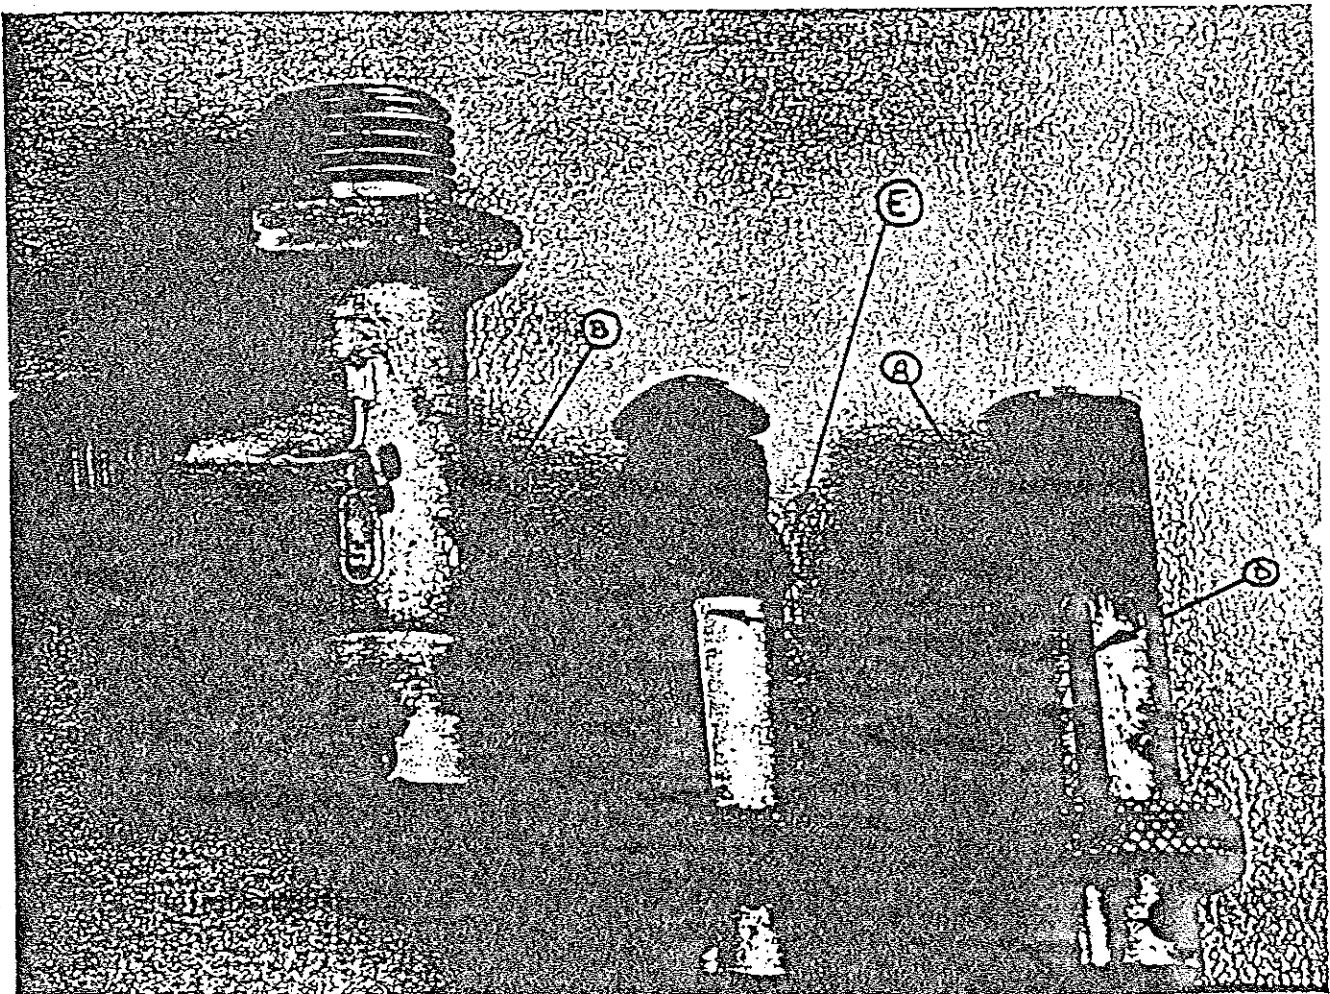
Investigation of this accident has revealed a problem with the fuel cock, which is located immediately under the fuel tank and operated by reaching forward under the instrument panel. The operation is that the plunger (a) is moved downwards, within the barrel (b) to allow fuel to flow to the carburettor; the travel of the plunger is restricted only by a grub screw (c) located within a slot (d) on the plunger. On the accident aircraft however, the plunger (e) was found separated from its barrel and it was apparent that the top of the slot (f) had been worn away, allowing the plunger to extend further, and the grub screw to wear a groove along the cork plug. It could not be demonstrated conclusively that the plunger had been displaced from the barrel in flight (or in the impact) but the physical evidence suggests that even a light disturbance would have been sufficient to provoke a leakage of fuel. These fuel cocks were originally manufactured by LE BOZEC in France. The aircraft was manufactured in 1958.

CAA Comment:  
 A CAA AD is under consideration.

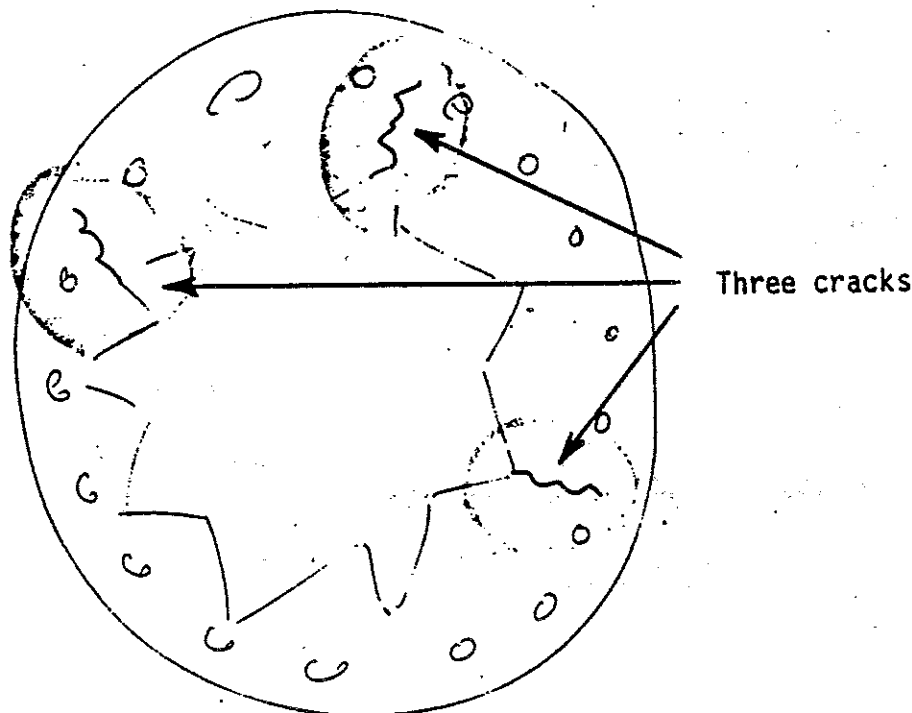
The prop was being inspected to FRP001 (a mandatory requirement at 300 hour intervals). The crankshaft nut vernier locking plate was found to have three cracks in it.

The reporter then checked on another (foreign registered) Chipmunk which was nearby and found that the plate was also cracked having been inspected 200 hours previously by the reporter. A third aircraft looked as if it was satisfactory. The reporter suggests that this item should be die penetrant checked in addition to the prop and hub.

Three cracks
