B.G.A. TECHNICAL COMMITTEE

TECHNICAL NEWSHEET

TNS 11/12/87

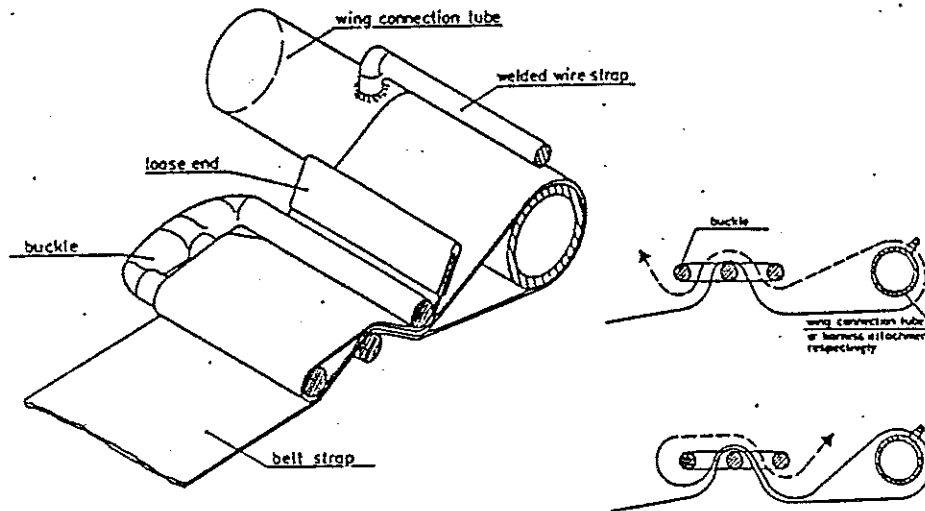
We noticed in the maintenance- and repair service that the attachment of the shoulder harness was more and more done in the wrong manner at the sailplanes of the series ASTIR CS, CS 77, CS JEANS, STANDARD II and III and Club II and III(b) as well as SPEED II and II b.

The harnesses were only put through the welded wire strap on the front wing connection tube. These wire straps prevent only an axial slipping of the harnesses.

The attachment is inadmissible and can lead to dangerous injuries already at minor accidents.

The correct attachment of the harnesses is made as per the following sketch:

Special attention has to be paid to putting the harnesses correctly through the buckle. At harnesses of Autoflug, the loose end should be folded backwards through the upper strut.

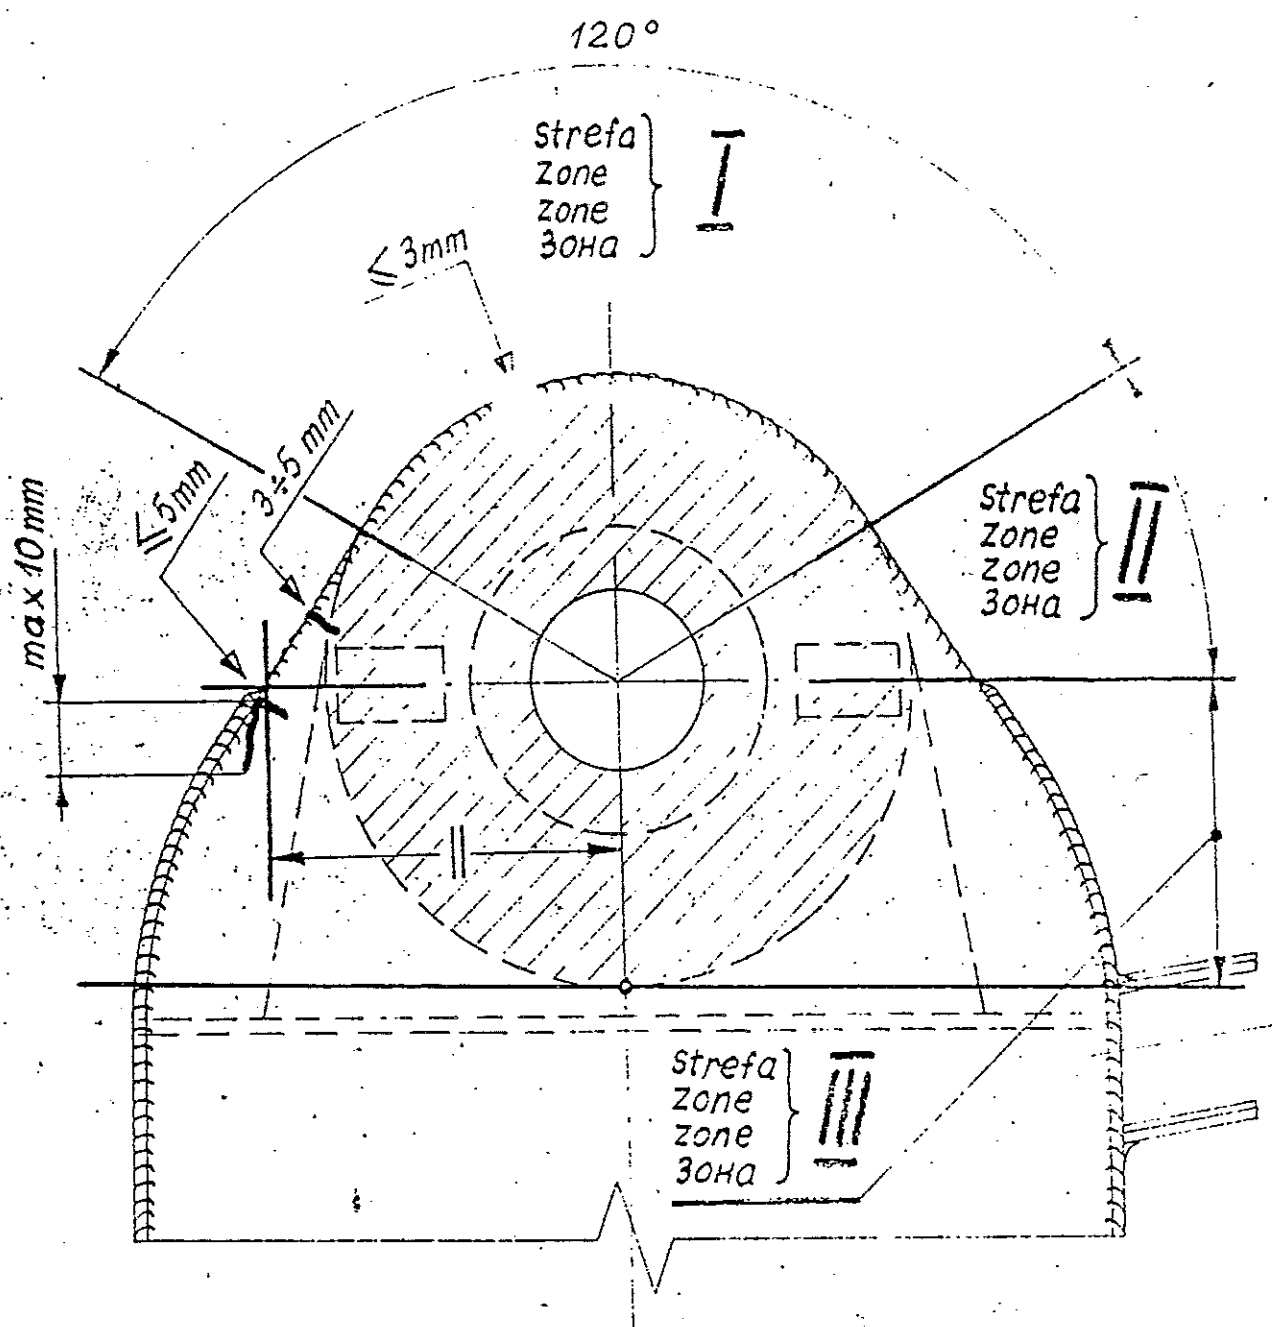
BOCIAN D/IE. ALLOWABLE REPAIRS. MAIN FITTINGS

- 1.5. Boclan ID & IE MAIN WING FITTINGS The following bulletin has been received:  
BE-020-86 authorises repairs as per sketch attached. (copies from Anglo Polish Sailplanes).

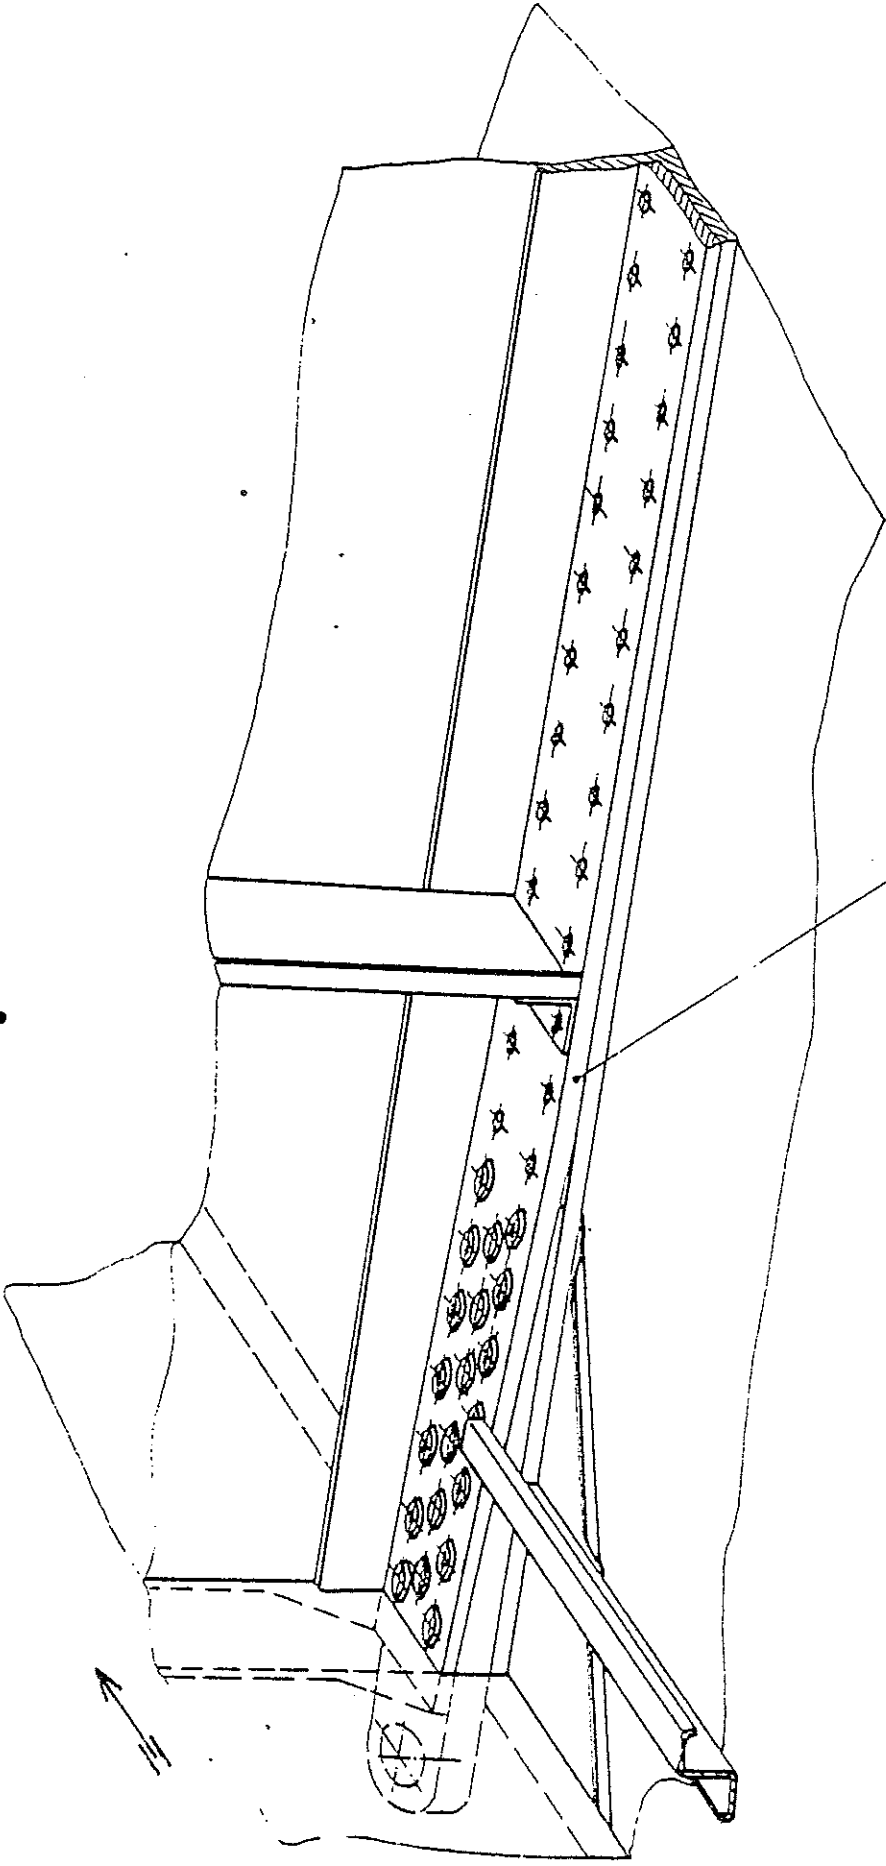
L13/062

Reason: On one glider was during the operation investigate a crack fissure on the flange strap situated on the wing's main spar lower flange in the area of the hinge.

Description: An inspection of the flange strap and the visible parts of the wing span have to be carried out.

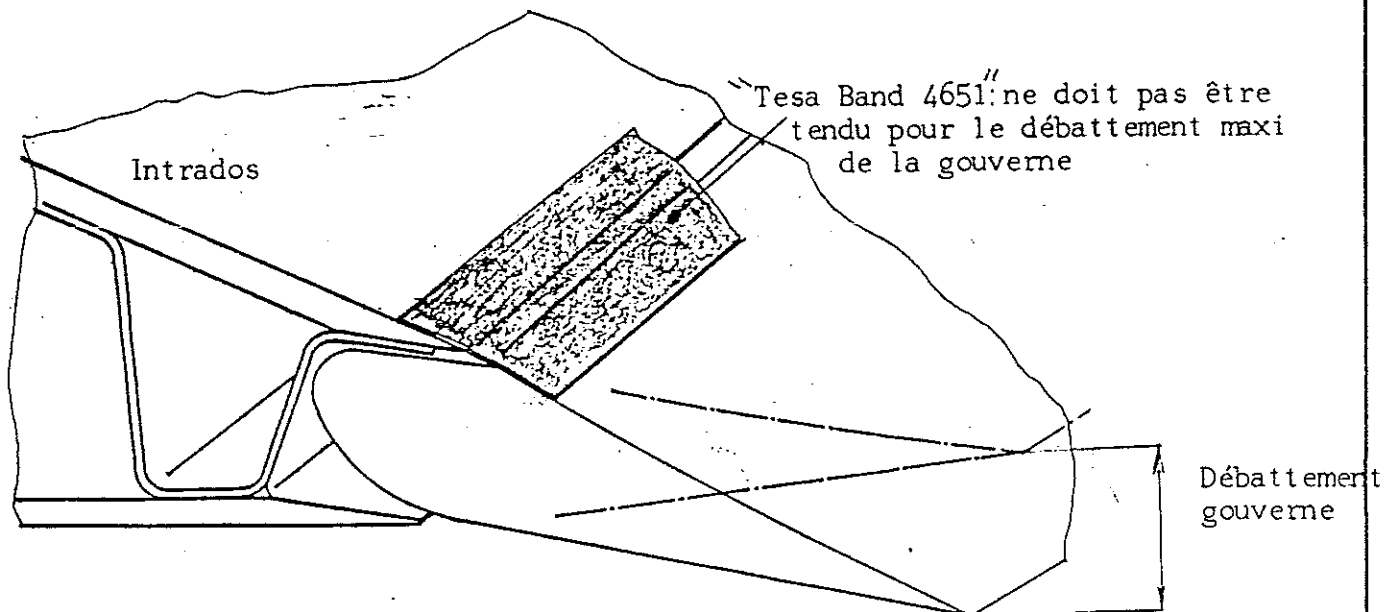
Des problèmes de vibrations d'ailerons à des vitesses supérieures à 200/210 km/h, les volets en position 1, ont été rencontrés sur des planeurs ASW20. Les bandes adhésives colmatant les fentes d'ailerons ont été mises en cause, objet du bulletin de service Schleicher n° 31.

Avant tout nouveau vol, s'assurer que les fentes d'aileron sont correctement colmatées :

- 1) avec du ruban adhésif Tésaband 4651 (blanc largeur 38 mm)

Dans ce cas, le montage doit être réalisé suivant le croquis ci-dessous.
