B.G.A. TECHNICAL COMMITTEE.

TECHNICAL NEWSHEET.

TNS/3/4/88..

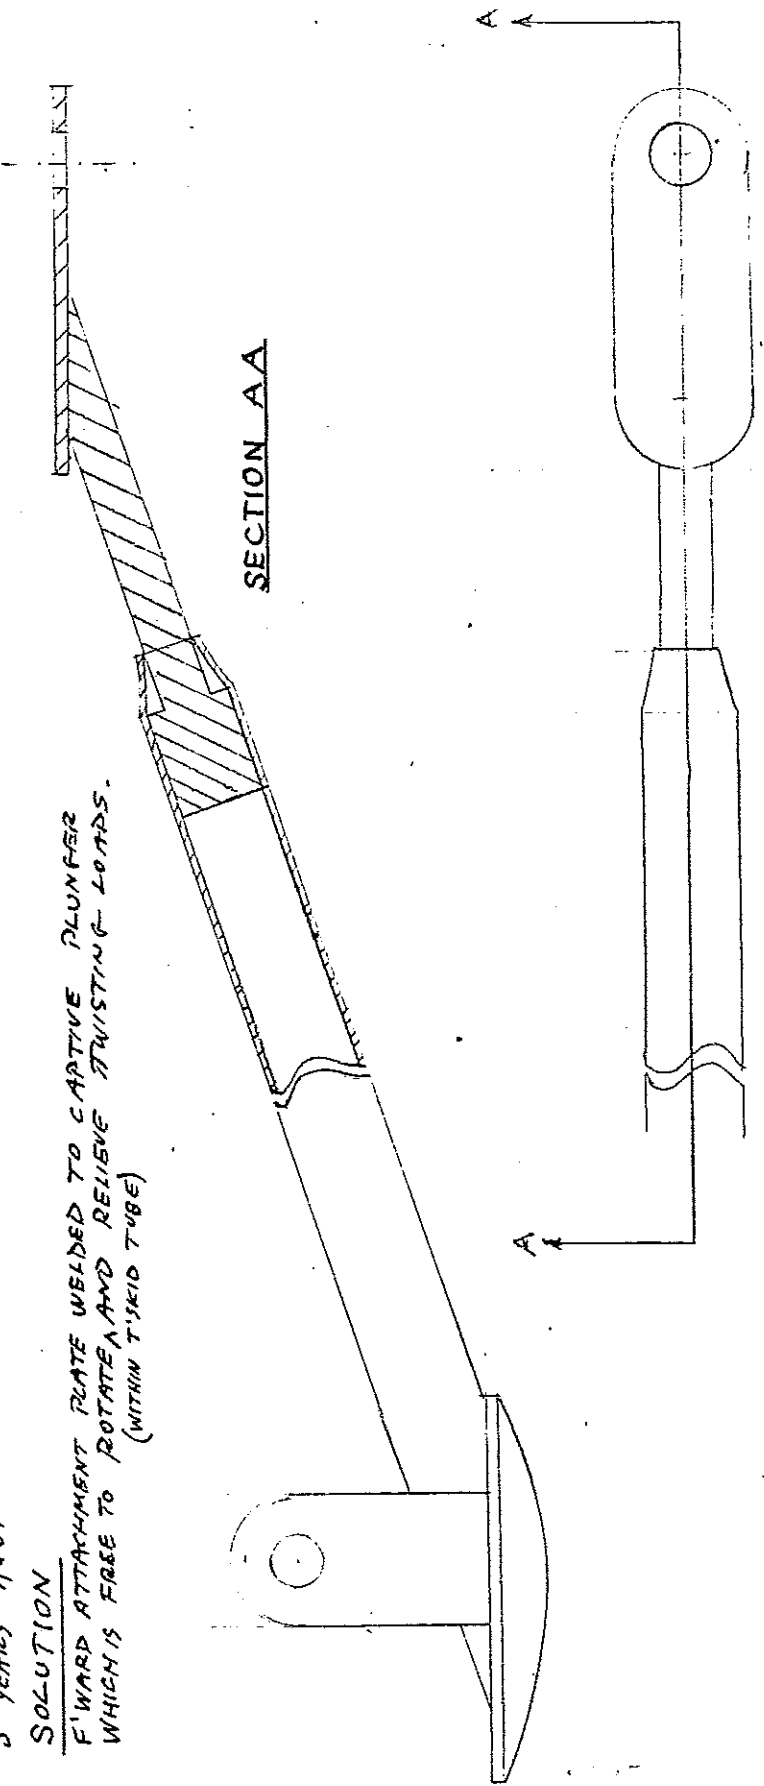
K13 TAILSKID (Product Improvement Modification)

YAW ON TOUCHDOWN TWISTING FORWARD ATTACHMENT PLATE AND FUSELAGE ATTACHMENT BOLT. (BOLT FAILED 5 YEARS AGO)

F'WARD ATTACHMENT PLATE WELDED TO CAPTIVE PLUNGER WHICH IS FREE TO ROTATE AND RELIEVE TWISTING LOADS. (WITHIN T'SKID TUBE)

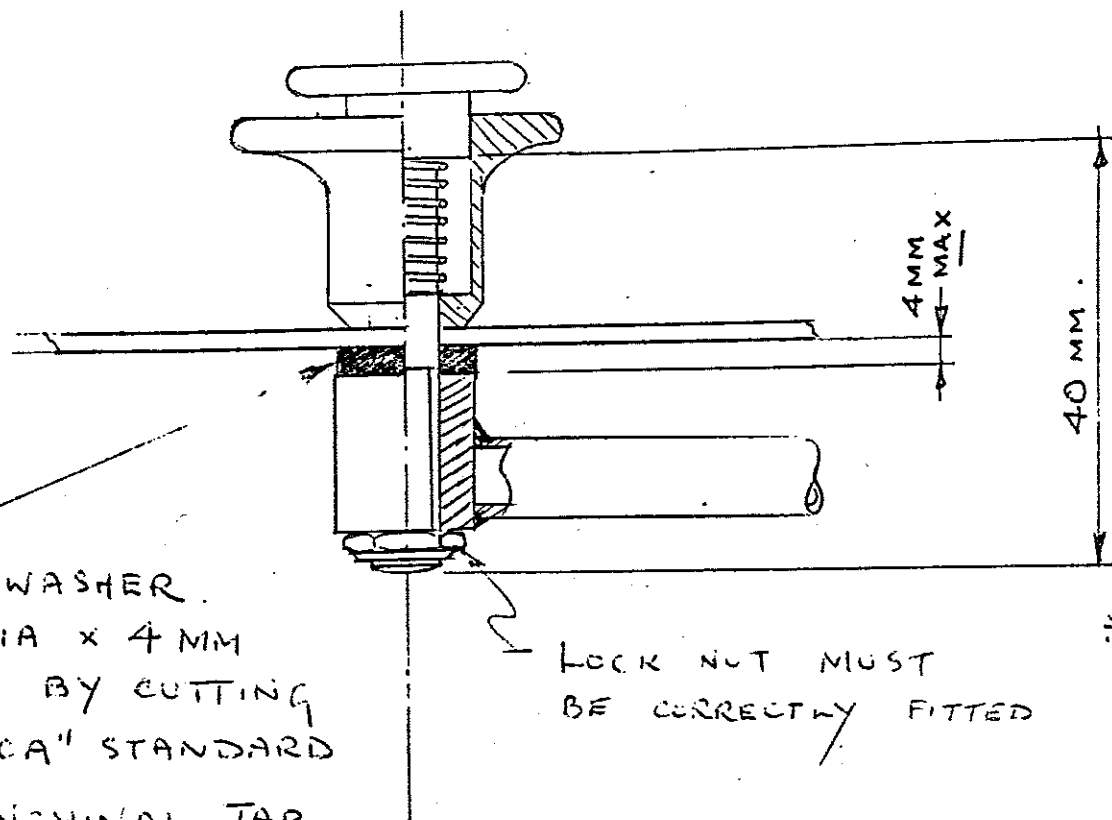
COULD BE IMPROVED BY INCREASING TO SAY 43 MM TO ALLOW LESS SPRING COMPRESSION WITH LOCK NUT FITTED.

HARD RUBBER WASHER.
14MM MAX DIA X 4MM THICK, MADE BY CUTTING DOWN "VACCA" STANDARD BLACK 1/2" NOMINAL TAP WASHER.

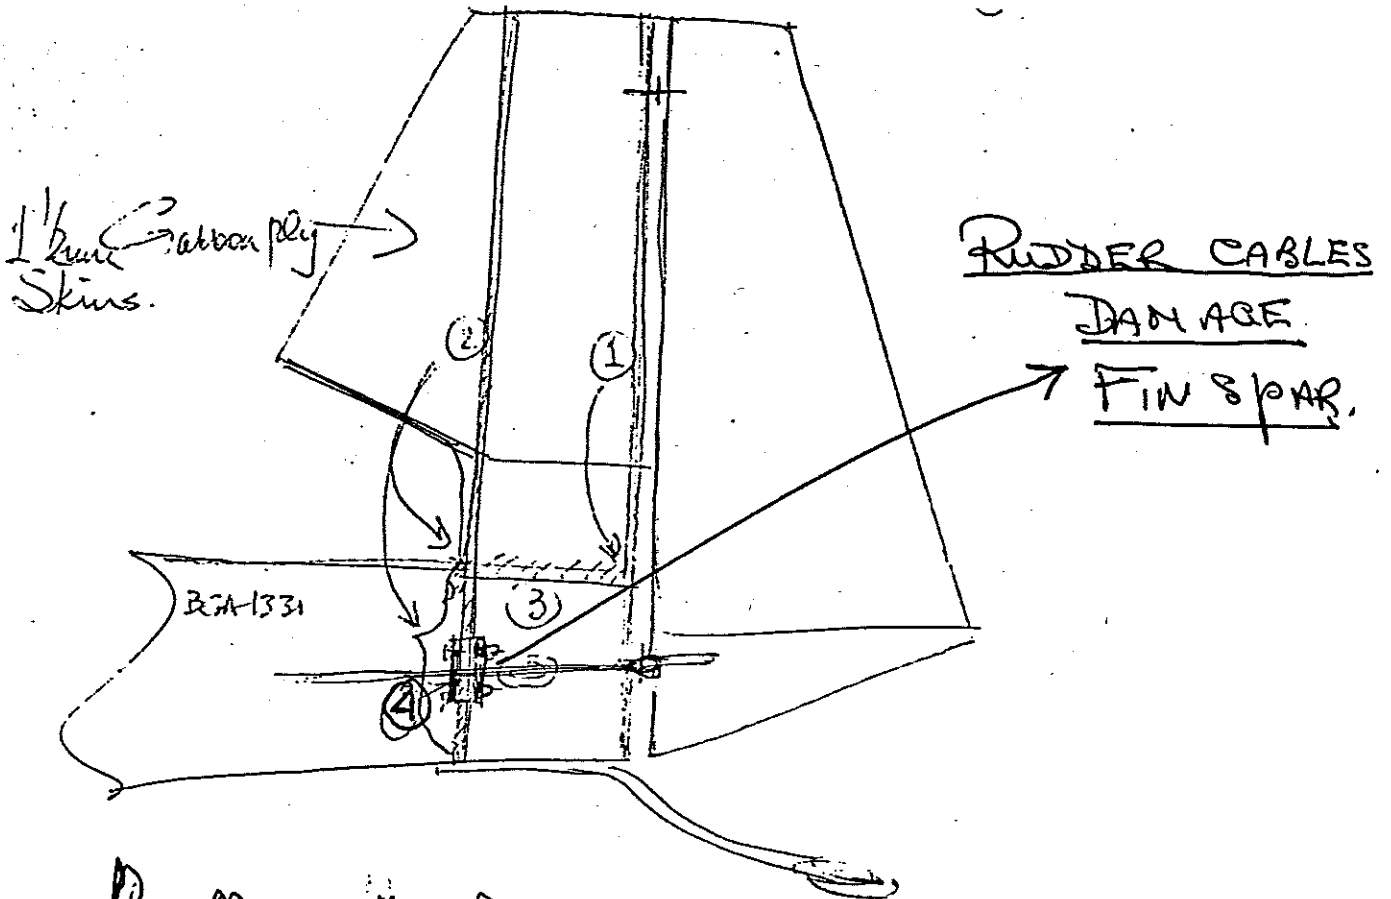
SWALLOW

If cable cuts through at (4), anchorage front fin spar structure weakened.

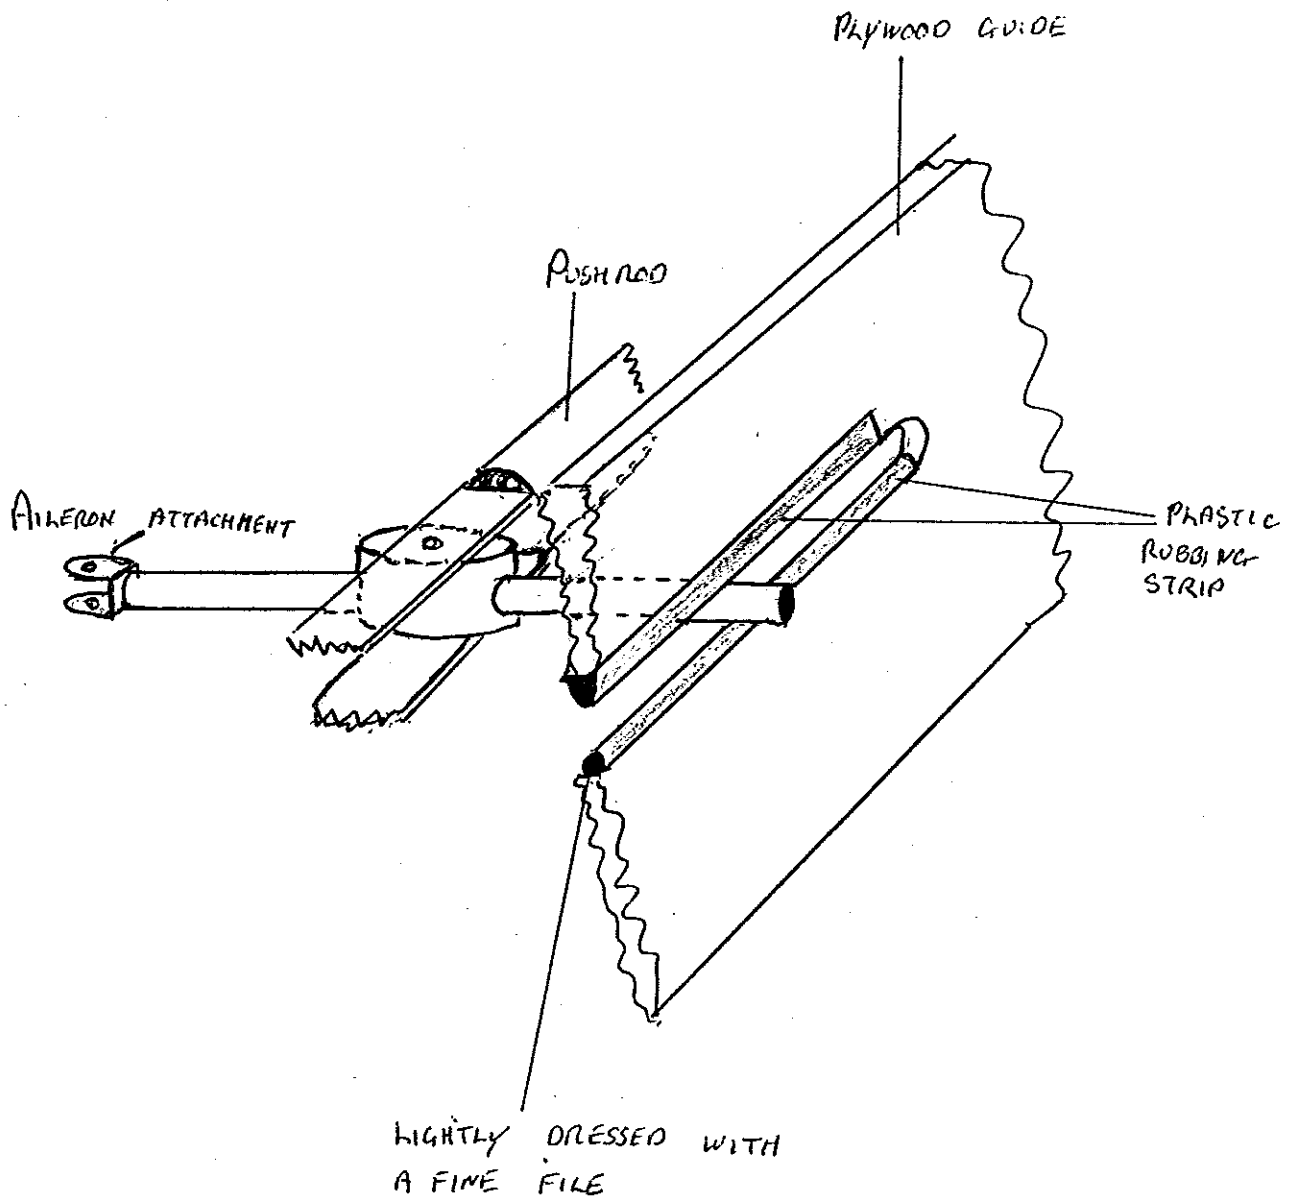
NIMBUS 2. Rib Control

Restriction at Rubbing Strip

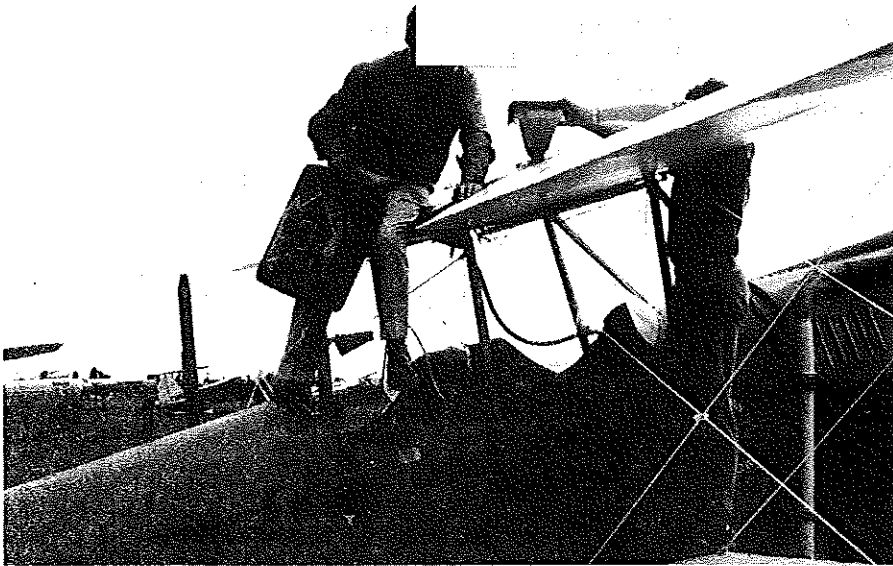
In this case there was a good operational reason for supplying the aviation fuel in a can. Note - a metal can and chamois leather being used.

There is always a risk of fire when refuelling from cans due to static electrical discharge. The following is part of a letter published in the November 1987 EAA magazine in the United States.

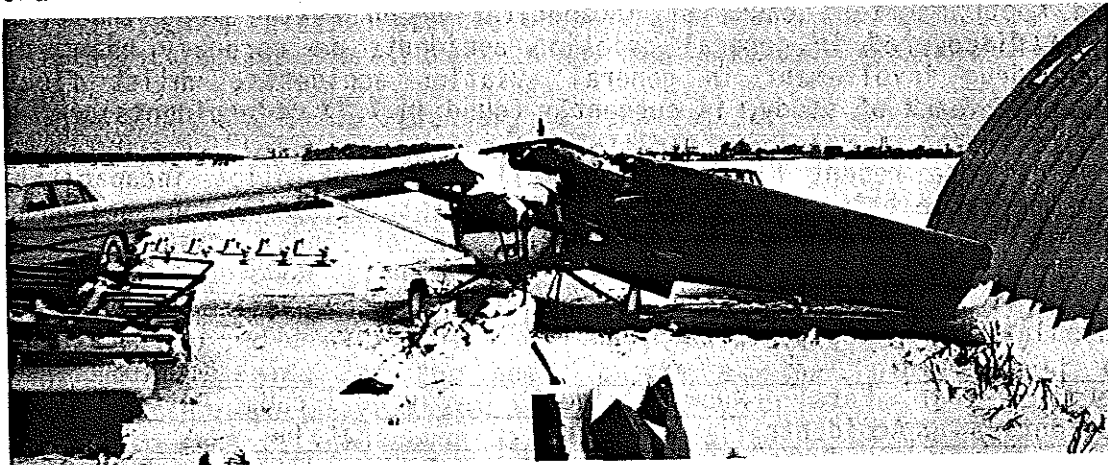
However, when an attempt was made to start the engine, prior to taxiing, it immediately burst into flames and although the occupant managed to escape unhurt, the aircraft was almost destroyed.

It transpires that an engineer had removed the carburettor because of a fault but the aircraft had not been placarded unserviceable.

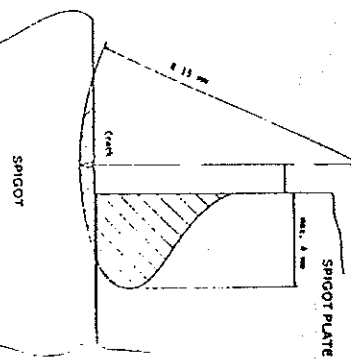
- * crack on one side not deeper than 0.75 mm
- * cracks on both sides not deeper than 0.5 mm each

Sketch mentioned below shows a cross section of blending out a crack.

Blending out should be done with grinding caps or equivalent. The grinded surface has to be polished.

Finally apply a coating of resin to the exposed area (wood and metal).

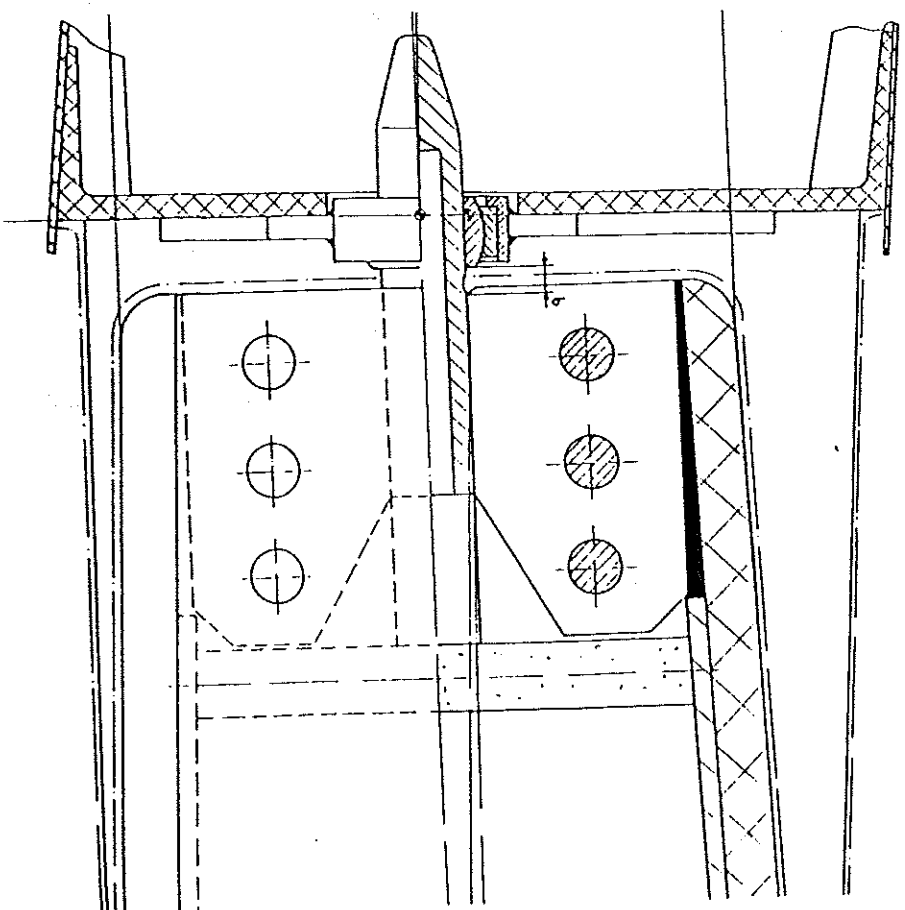
Definition of the distance b

If a crack is discovered and if the distance between spigot plates and swivel bearing is $b \leq 10$ mm, the crack may initially be blended out (refer to page 4 for procedure):

If a crack is discovered and if the distance between spigot plates and swivel bearing is $b > 10$ mm, Action 2 must be carried out immediately.

2. Replacement of the spar spigot assembly
Replace the spar spigot assembly in accordance with Installation Instruction No. 306-29/320-5.

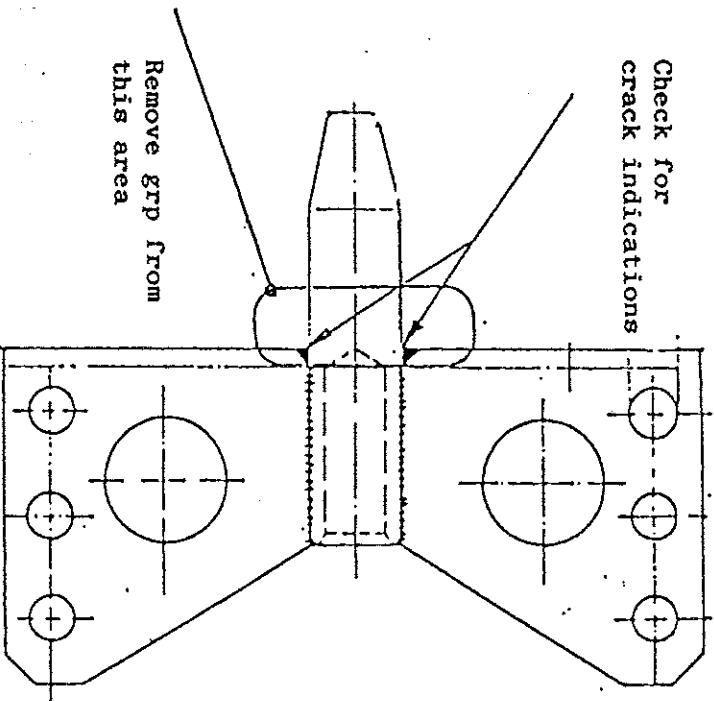
G109 SPIGOT FITTING

006-10-88		Spar stub end fittings - Cracks at or near the toe of the weld on the top and bottom surface of the spigot.	Applicable to all G109 and G109B Series motor gliders. Compliance is required not later than 50 flying hours from the receipt of this Directive.
-----------	--	---	--

- (1) Remove the wings in accordance with the Flight Manual instructions.
- (11) Remove the glass reinforced plastic (GRP) or the protective lacquer covering the spar stub extremity, avoiding any damage to the metal parts, sufficient to expose the top and bottom weld ends and the weld transition into the spigot body - see Figure A.
