B.G.A. TECHNICAL COMMITTEE

TECHNICAL NEWSHEET

TNS/5/6/88

PART 1 AIRWORTHINESS "AGGRO". (Please add to the 1988 Red Pages)

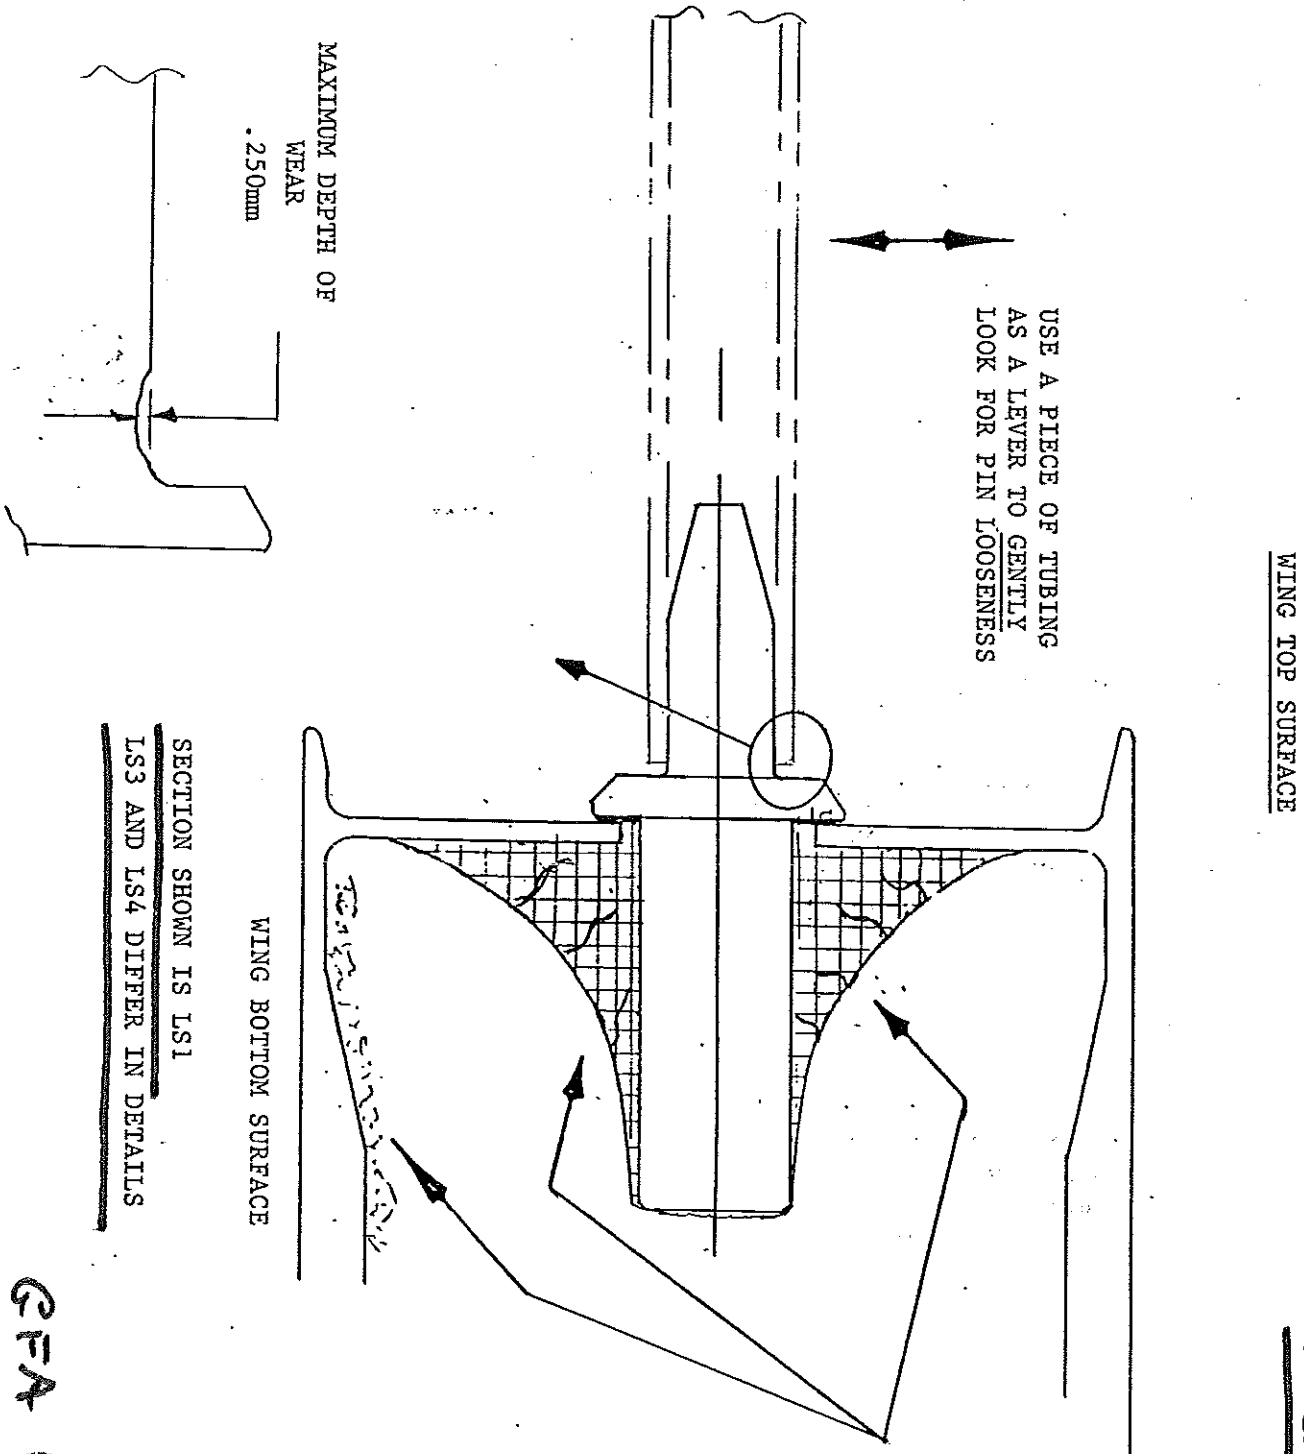
FIG. 1.

1.6 LS1, LS3, LS4, Loose Wing Root Rib Pins. Gliding Federation of Australia sketch (herewith) requires inspection. Repair scheme as recommended is acceptable to BGA.

USE A PIECE OF TUBING AS A LEVER TO GENTLY LOOK FOR PIN LOOSENESS

MAXIMUM DEPTH OF WEAR
.250mm

INSPECT FOR CRACKS IN THE FILLING MATERIAL AND SIGNS OF WHITE DUST PRODUCED BY "FRETTING".

One case of an Australian LS1 found to have cracking and loosening of the attaching material between the wing root ribs and the 4 wing to fuselage pins.

The original 4 pins are low grade steel and show early signs of wear at the point of contact with the fuselage bearings. This AD can be followed as a method of pin replacement when pin wear is considered excessive.

Factors causing the pin/rib attachment breakdown are not clear, but wing looseness due to pin wear combined with rough airfield surfaces, unsprung wing walking wheels, etc are all contributory.

- (a) Use an inspection mirror, through existing wing root rib holes to check the back of the pin mounting area (see Figure 1). Check the pin for movement (watch the back of the pin with the mirror at the same time).

If movement/cracking is found the glider must be taken out of service and the wing root pins removed and remounted in accordance with GFA Mod 88/2. The fuselage bearings are to be also inspected for any signs of damage or looseness.

- (a) Maximum pin groove depth - .250mm
- (b) Maximum out of round of fuselage bearing - .150mm

Oval fuselage bearings may be either replaced or machined back to round, in which case the new pins must be manufactured oversize (Ref Mod 88/2).

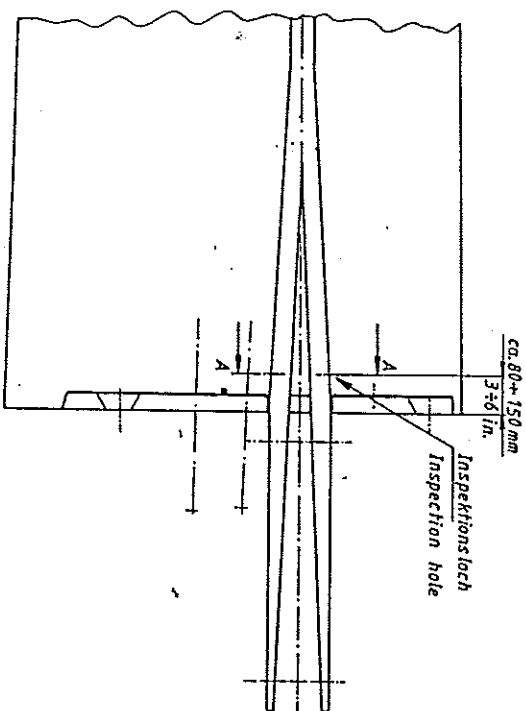
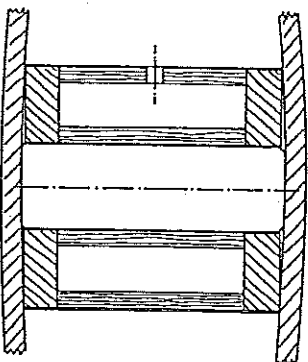
* Location and dimensions of the inspection holes

2.1 As shown in Fig. 3, the wing spar inside must be inspected, using an endoscope (or a suitable mirror with suitable lighting mechanism, e.g. pocket-lamp bulbs soldered on with two stiff, approx. 1 m long wires) for discoloration and for wood-destroying mould fungi: the endoscope has to be inserted through the inspection holes which you have to drill (move the source of light along the spar inside). With ASW 15 gliders up to the serial no. 15183 you have to first drill an opening into the front root rib in accordance with Fig. 1 (this opening already exists on all gliders with serial no.s above 15183).

In order to drill the inspection holes into the airbrakes box, the lower airbrakes have to be disassembled first. The drill cores of the boxes which you have to do with a keyhole saw of ø 28 mm (see Fig. 4), must be sent in for examination to one of the institutes listed under "Notes, point 2."; they must be marked so that they can be assigned again afterwards to the corresponding bore.

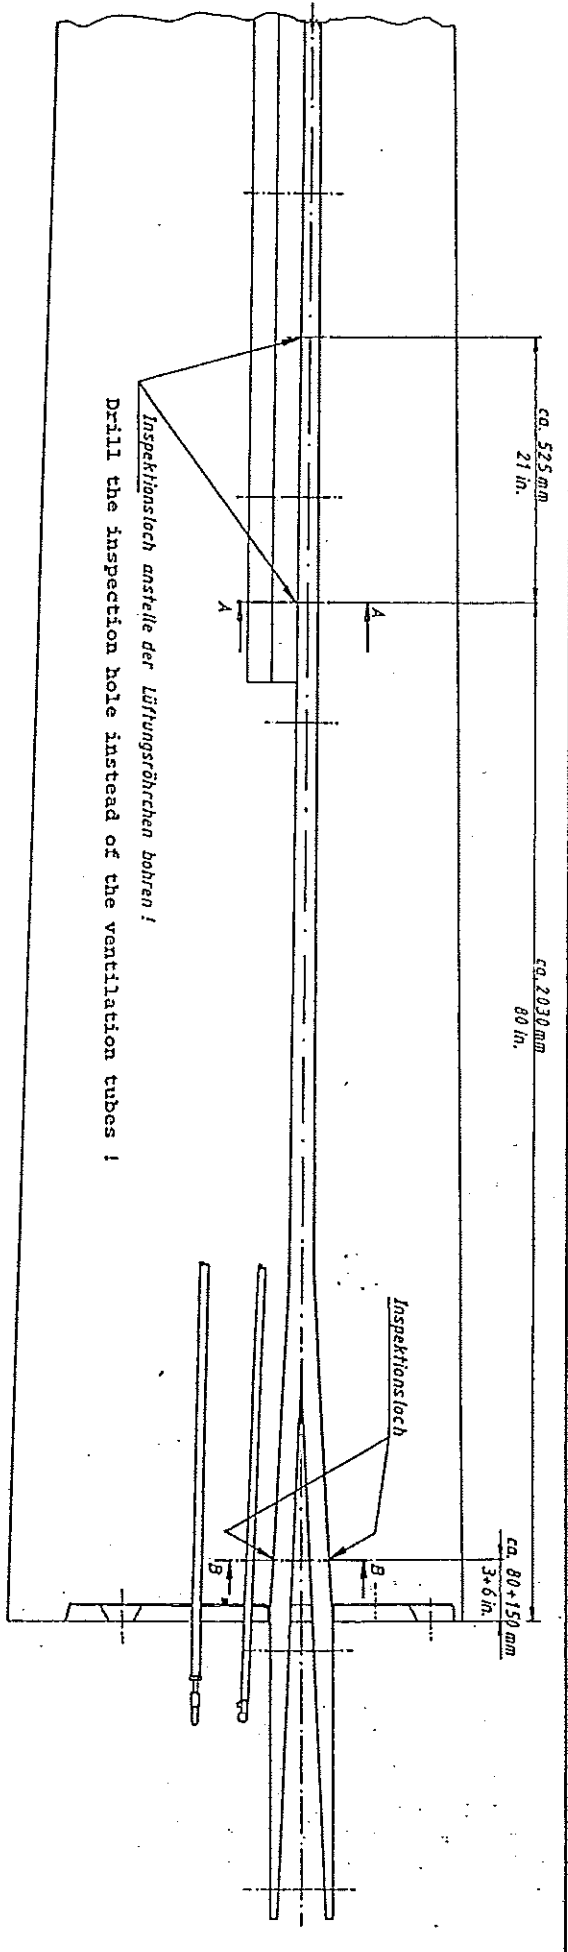
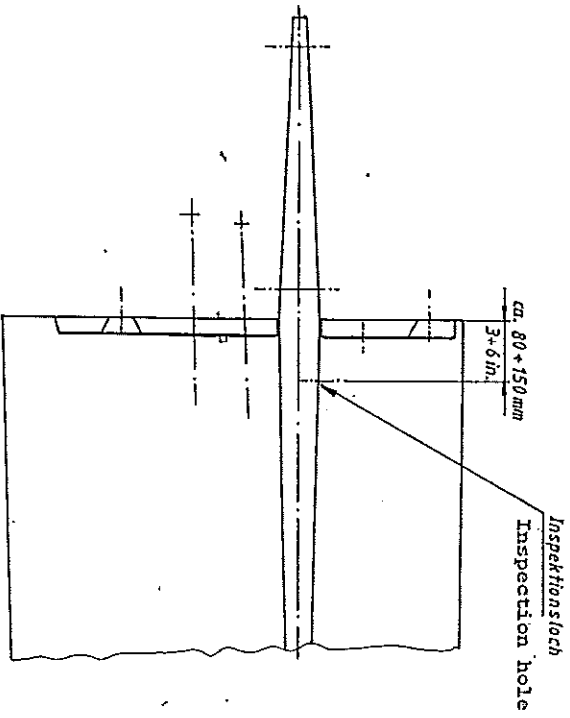
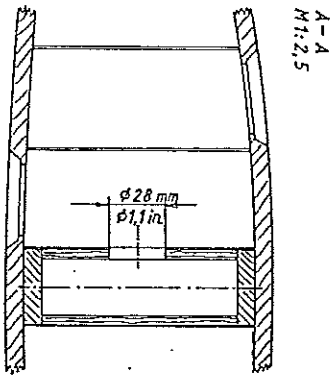
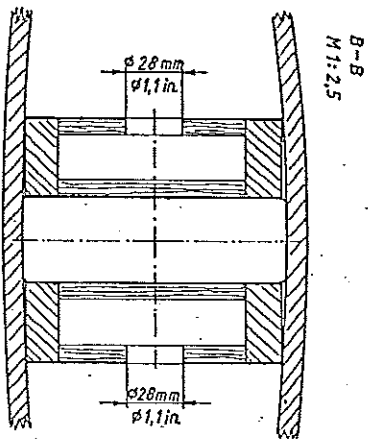
* Location and dimensions of the inspection holes

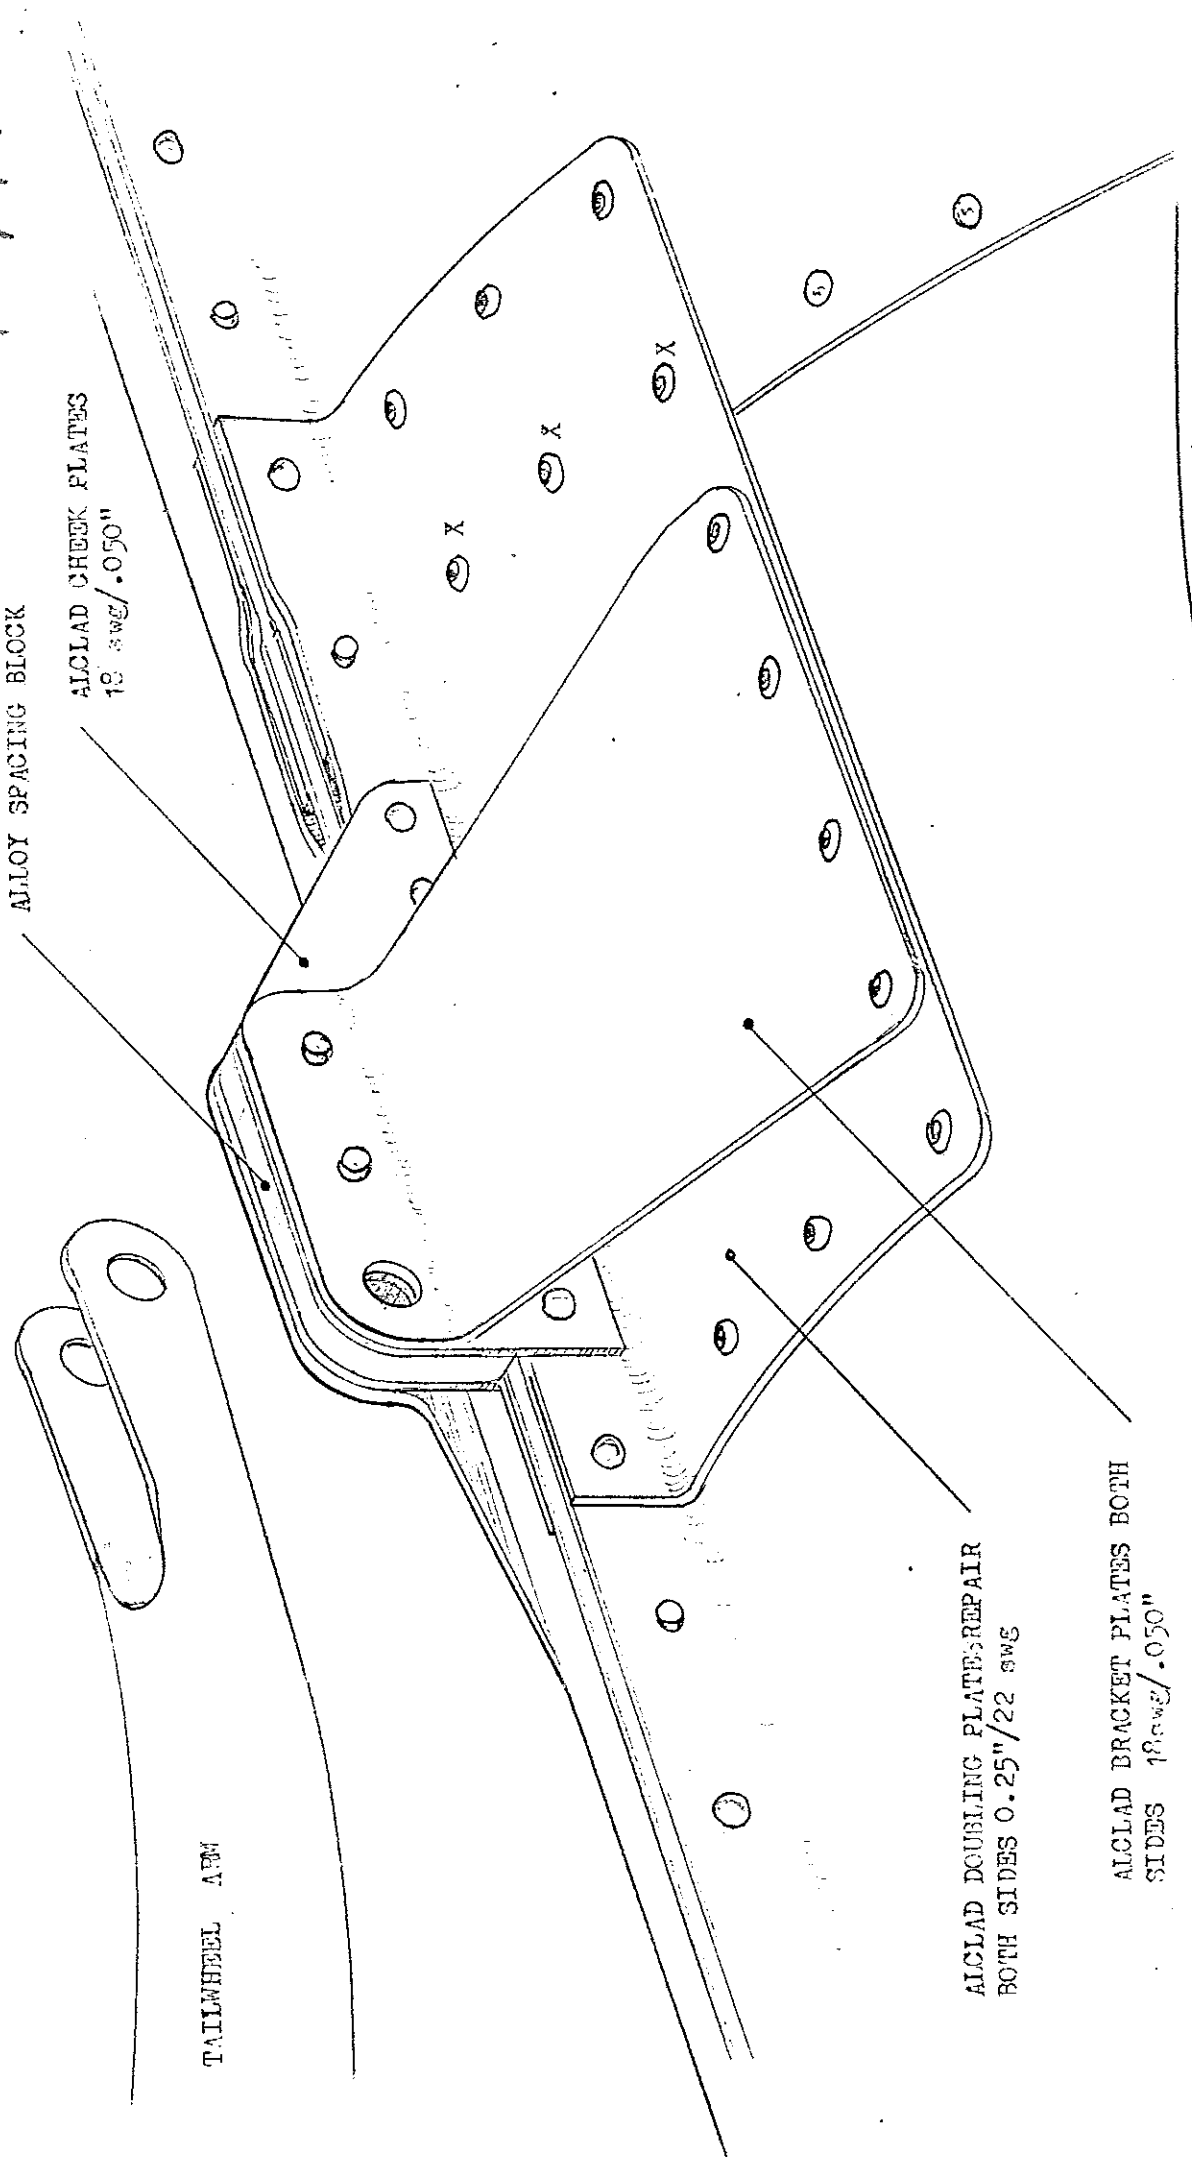
DIAGRAM 'C'

1.8 Blanik. Forward Tailskid Attachment - Repair scheme. The attached sketch from Tony Moss (Borders G.C) is approved by B.G.A.

N.B. RIVET PATTERN IN THE DOUBLING PLATES WILL BE ADJUSTED TO CRACKS AND EXISTING RIVET PATTERN. RIVETS MARKED 'X' TO BE AVDEL OR EQUIVALENT. (186)

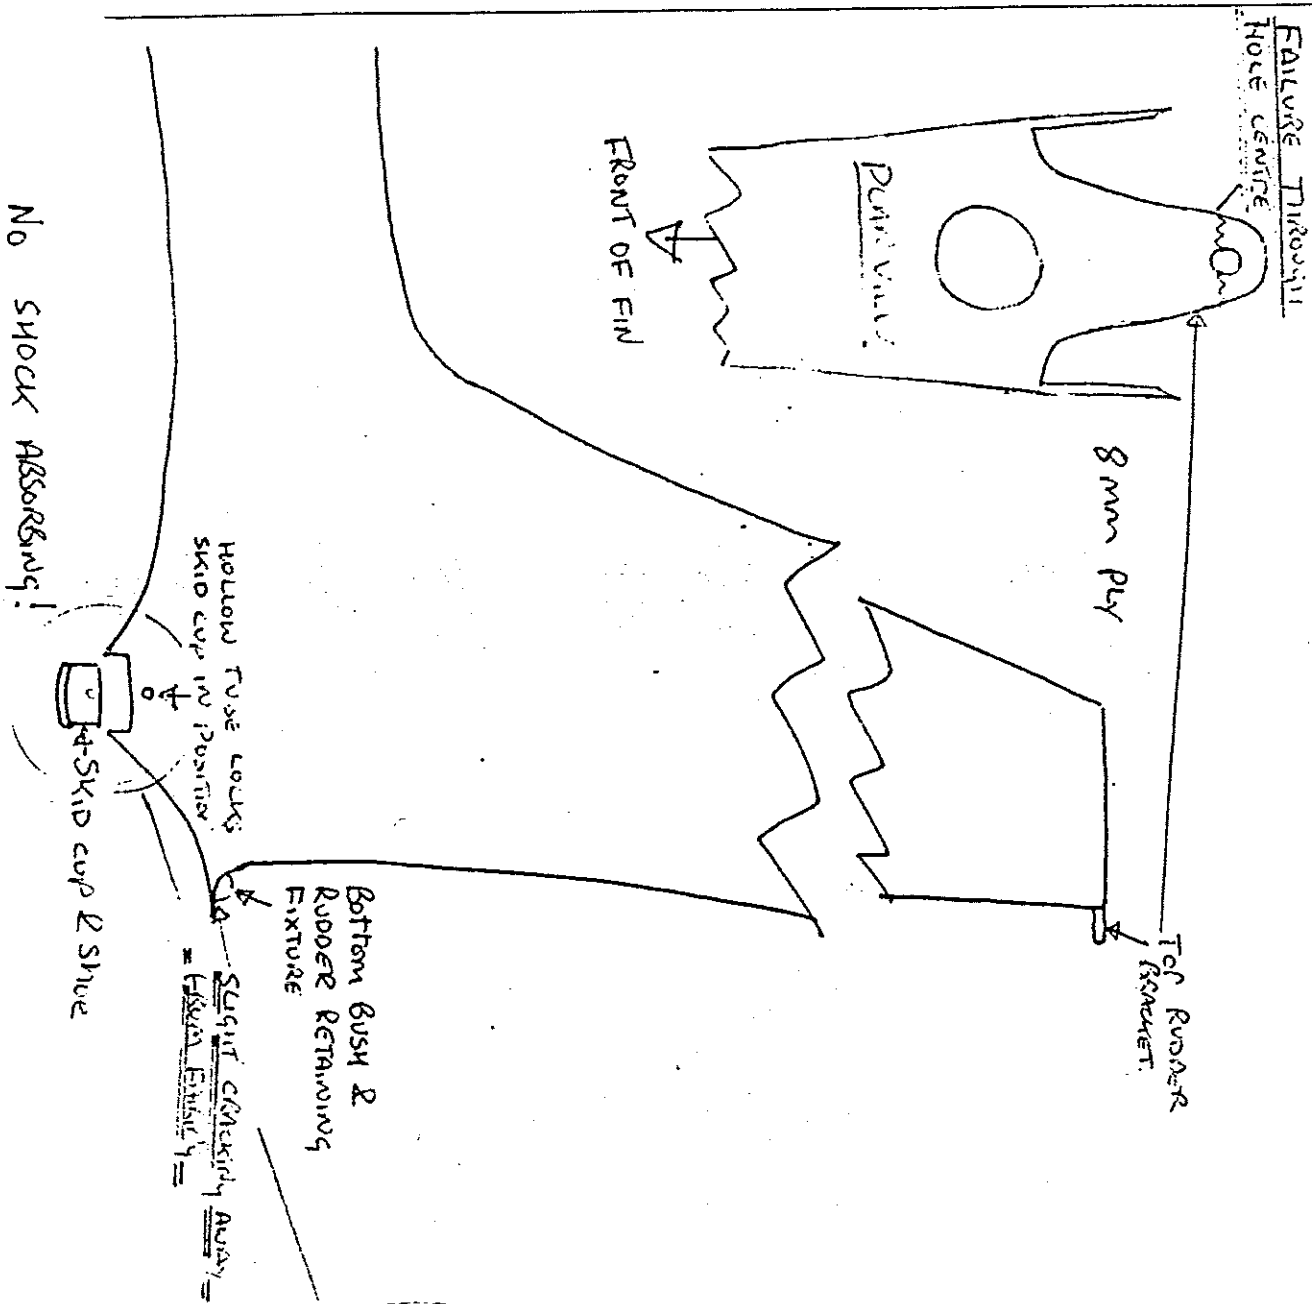
1.2 Putchatz - Top Rudder Hinge Failure, probably due to tail skid impact damage. The attached sketch recommends areas for inspection, and the introduction of a T.21 skid rubber to the tail skid. (Reported by P. Marks).

MINOR A.D. to minimize sh
 being furnished to hinge brackets
 Fin! increase in weight 14oz.
