B.G.A. TECHNICAL COMMITTEE.

TECHNICAL NEWSHEET.

TNS/7/8/88.

- PART 1 AIRWORTHINESS "AGGRO". (Please add to the 1988 Red Pages).
- 1.1 Grob G103 Twin Astirs/Accros. - Main wing spigot failure during fatigue test. The attached note was circulated to all owners. A Grob Working Party is currently changing these in the UK. Contact John Adams 0889/270577.

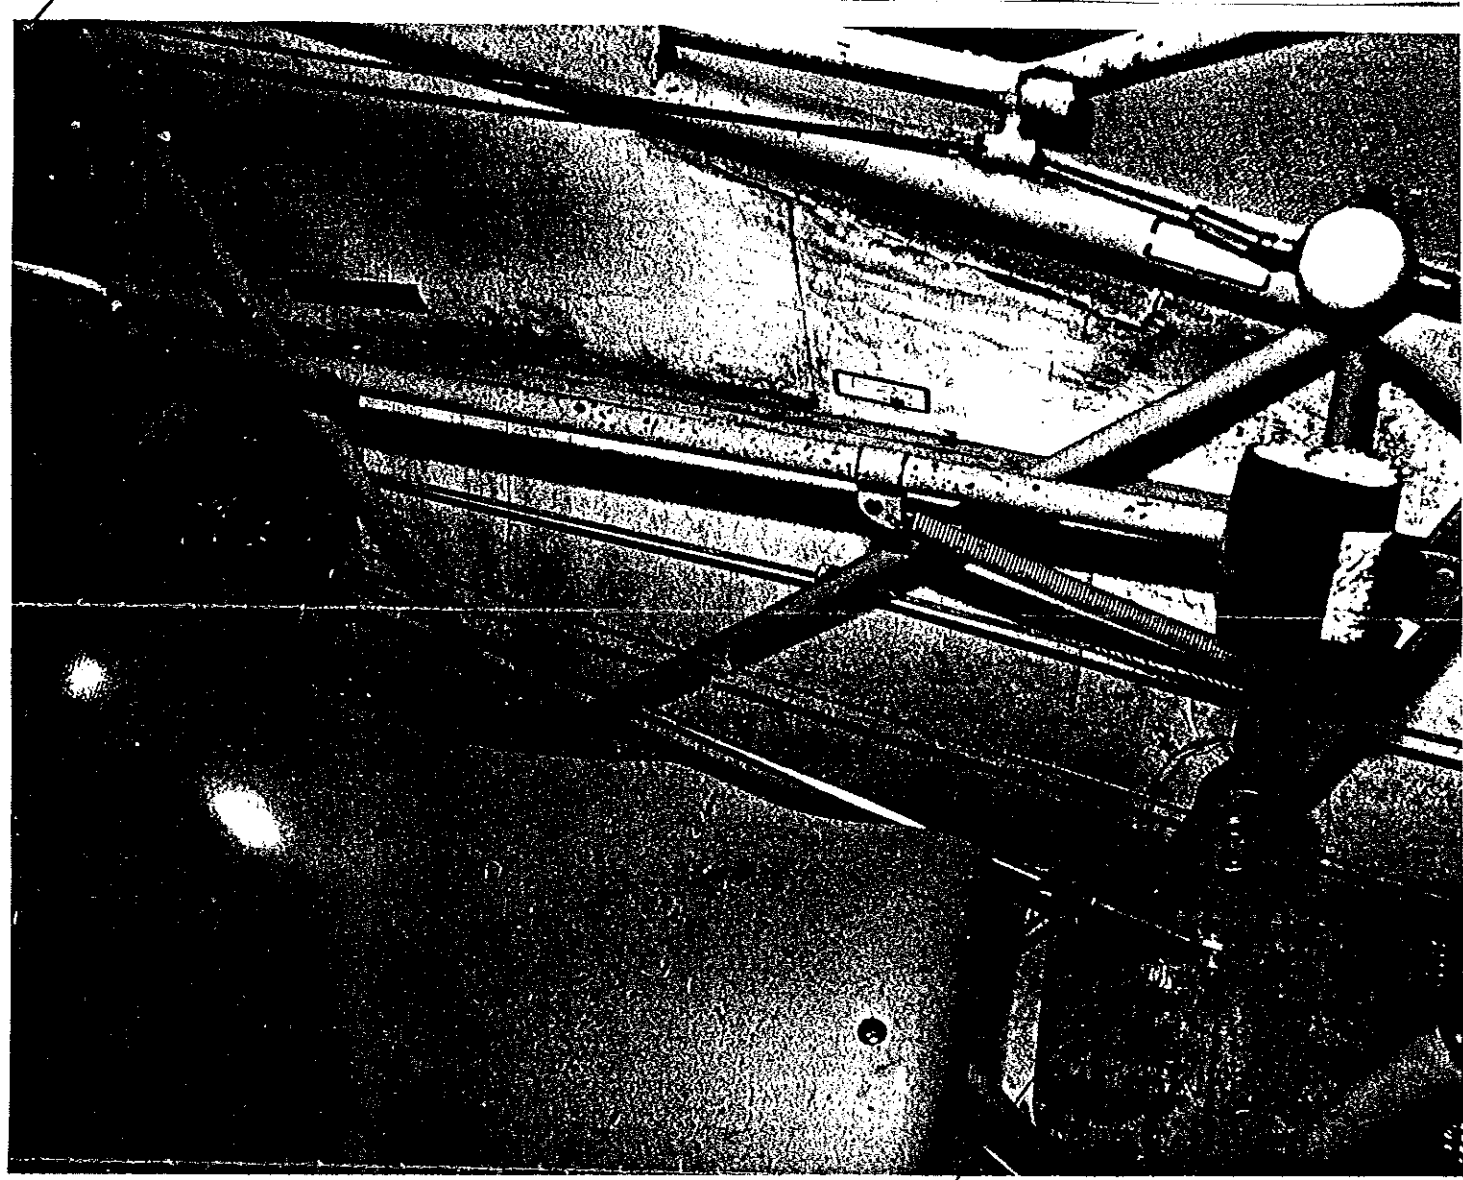
DISABLED PERSONS MANUAL RUDDER,
WELDED BRACKET FAILURE.

- 1.6 Disabled Persons Manual Rudder Conversions. (KA 7/ K13 etc). Fatigue failure of the pivot bolt mounting for the manual control lever has been reported. The detailed design of the component requires re-enforcement sketch attached. (Reported by Trent Valley G.C).

AIRBRAKE (RUDDER) FULCRUM BOLT BRACKET BROKE AWAY, BRINGING THE STEEL TUBE WALL THE SIZE OF THE WELD WITH IT.

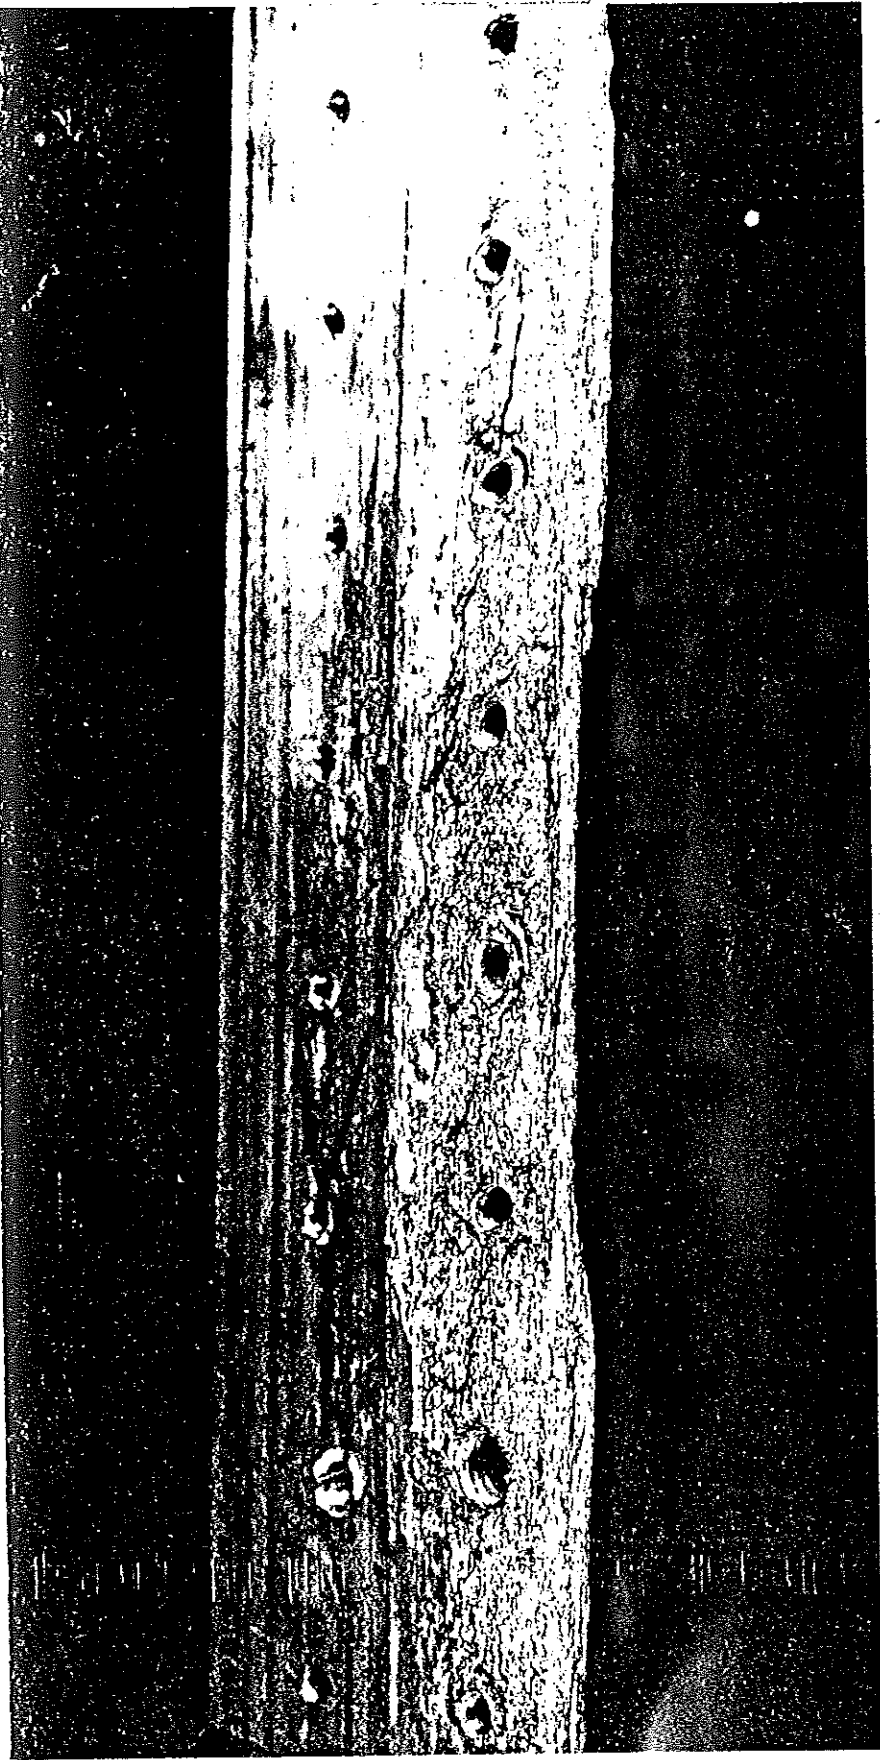
BLANK UPPER SPAR CROSSION.

On inspection of Port wing upper surface buckling of skin between rivets on mainspar joint observed. Rivets also showed strain signs with loose heads. Further inspection, internally, indicated some evidence of corrosion at spar boom extruded angle. On stripping down removing section of boom angle, severe exfoliation of Dural angle was exposed. Corrosion was limited to the angle only (reference Photographs already provided). Other Dural parts in contact with corroded parts showed little or no corrosion. Only the long taper packing showed damage (cracks) caused by the swelling affect of the angle. Laboratory tests of offending piece (Lucas Aerospace) showed no indication of contamination from external sources. It was considered that the angle was breaking down internally by normal process. Stress corrosion was considered but not supported by any indications from other sections.

British Aerospace Warton Materials Laboratory: Confirm that the exfoliation is the product of moisture ingress setting up electrolytic action, with consequent breakdown of extrusion material.

Further signs of corrosion in remainder of Port Wing are evident. The extent of the corrosion makes this Wing unservicable. The Starboard Wing appears to be sound. Wing.

BECAUSE OF THE DRY ASSEMBLY METHOD IT IS MOST PROBABLE THAT WATER ACCUMULATES IN THE GAP BETWEEN THE 2 SKINS AND SEEPS UNDER THE 2 SEPARATE PACKING STRIPS. THE EXTRUDED ANGLE THEN BECOMES ANODIC AND BEGINS TO BRENE DOWN UNDER THE CORROSIVE CONDITIONS. ITEMS IN CONTACT WITH ANGLE SHOW NO SIGNS OF CORROSION.

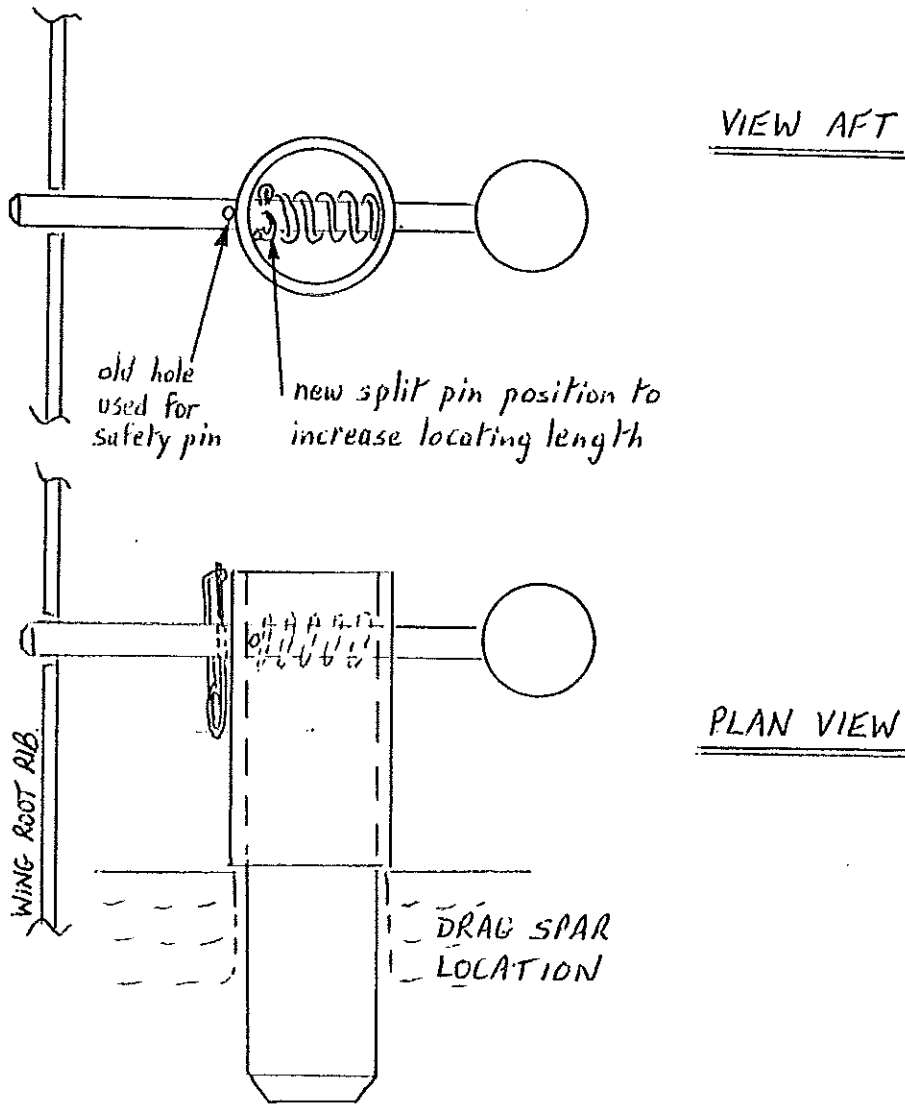
PILATUS B4 - DRAG SPAR PIN

- 1.11 Pilatus B.4. Drag Spar Pin. Improper Engagement. The attached sketch is self explanatory.
- 1.12 Pilatus B.4. Locked Brake Buckles U/C Fork. The attached sketch refers to fractured hub bolts joining the Tost brake unit. (Reported by Blackpool & Fylde G.C)

IMPROPER ENGAGEMENT.

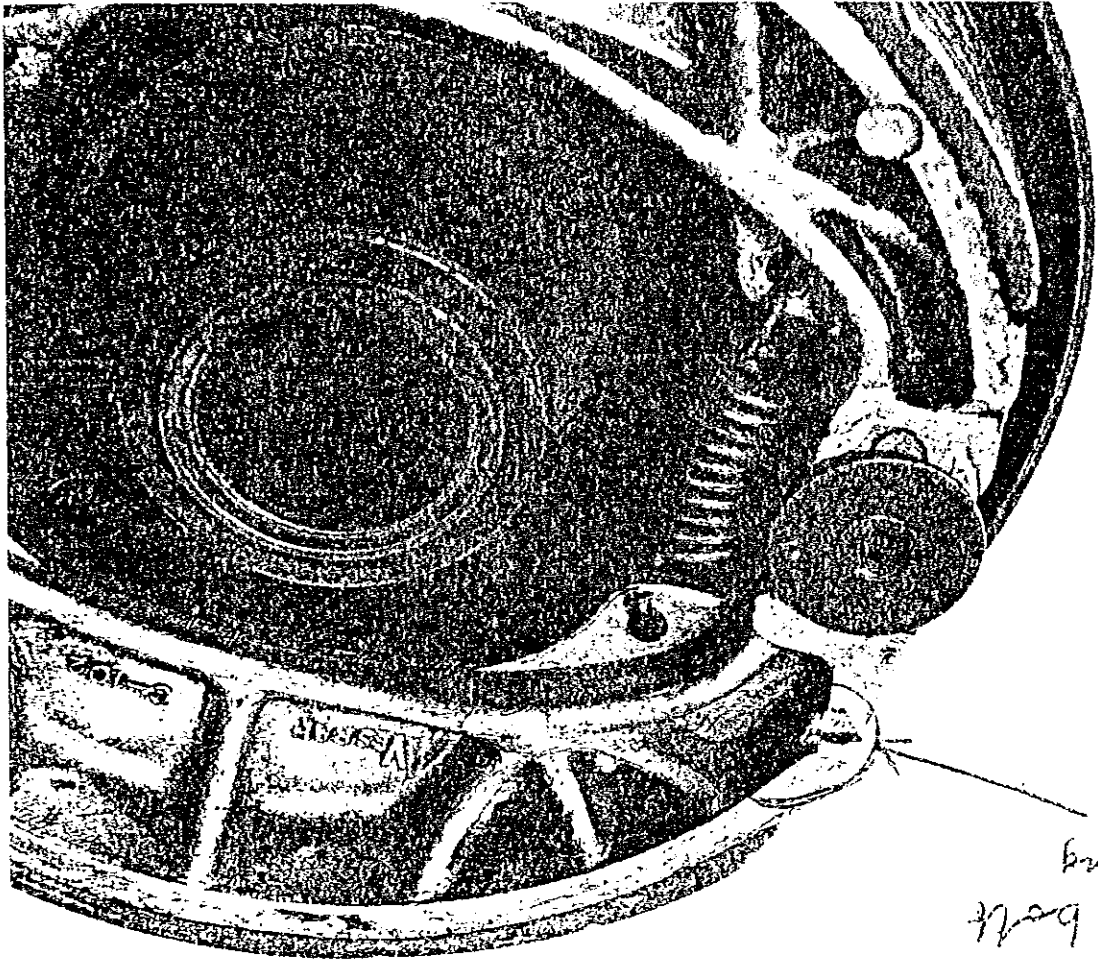
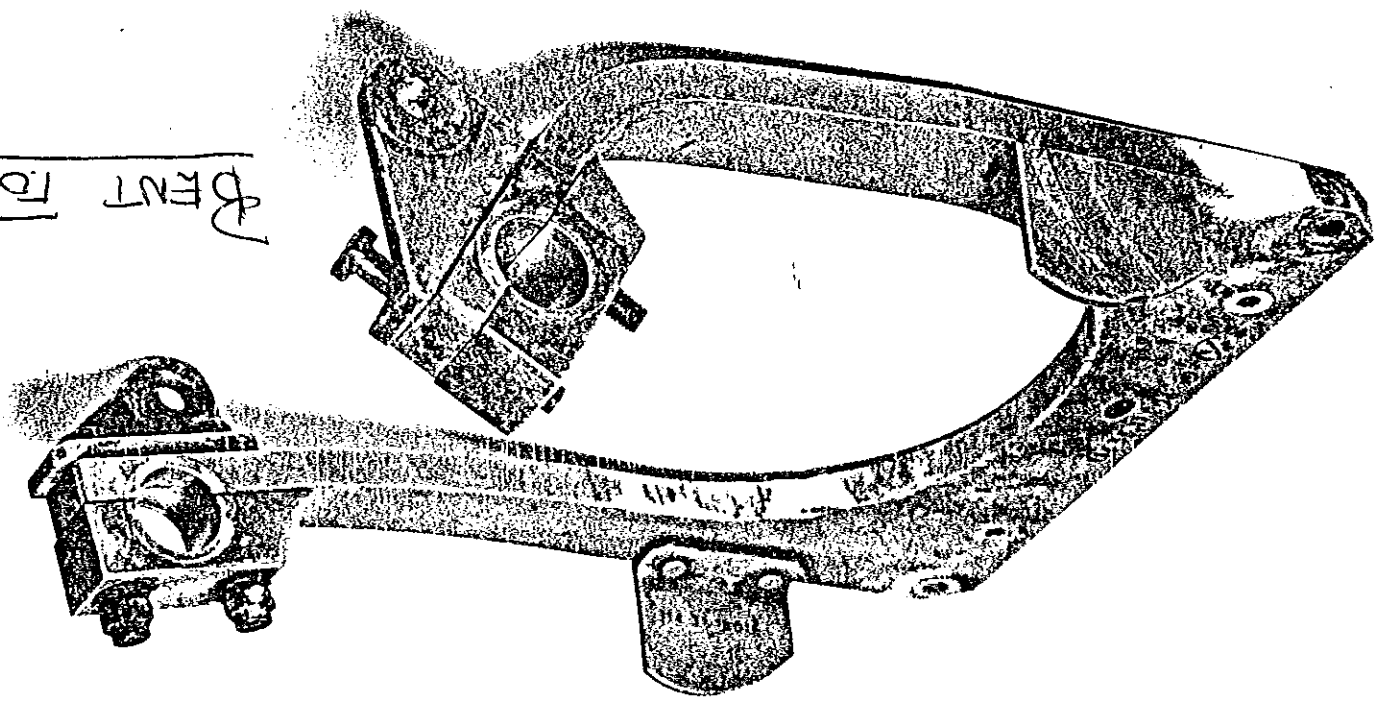
Pilatus B-4. LOCKED BRAKE.

Witness of bolt
head pointing
back.

SPLIT WHEEL BOLT FAILURE - Locks wheel.

BENT FORK

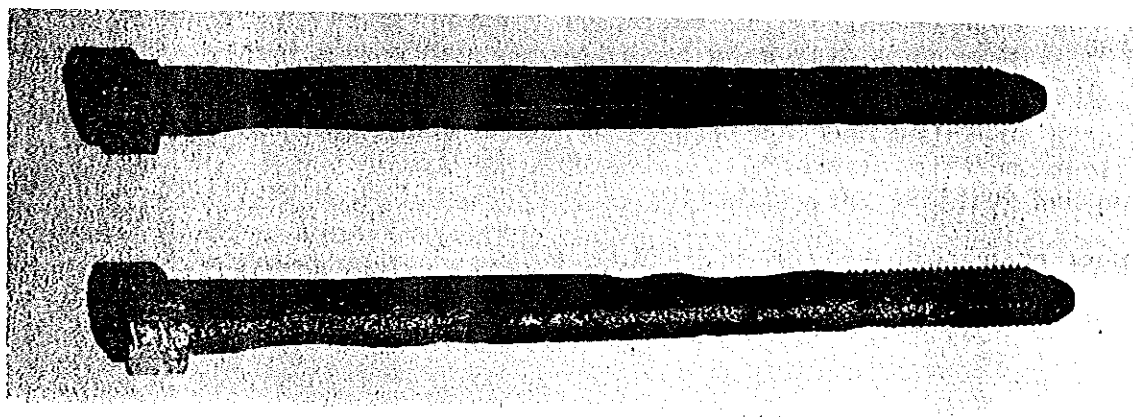
E1. REAR SPAR ATTACHMENT BOLTS BADLY CORRODED

During the C of A renewal inspection, the rear spar to fuselage attachment bolts were removed for inspection. The threaded ends of the bolts required numerous applications of penetrating oil to release them and the bolts were removed with difficulty. The corroded bolts were not cadmium plated and as the photo shows corrosion had reduced them in diameter. The replacement bolts were cadmium plated and assembled with 'Duralac'.

The LAMS inspection schedule requires that Structural Attachment joint assemblies be inspected every 150 hours and each Annual check. The reporter suggests that these bolts be removed and inspected every three years.

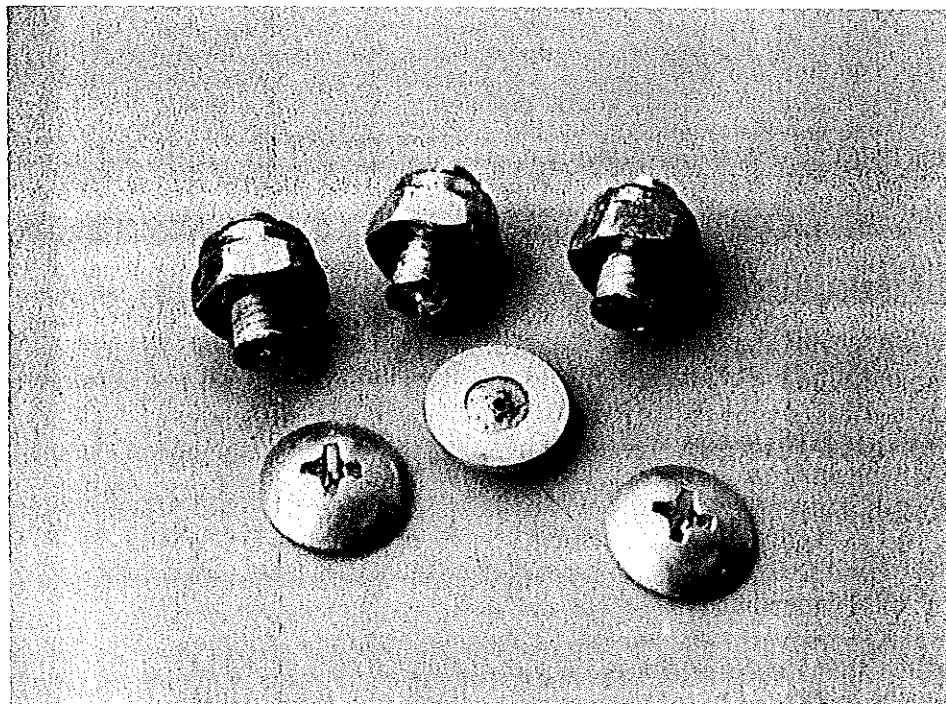
Item 10 Head Detached on Truss Headed Screws

Still more of these faulty screws are appearing. The ones shown below are used to secure the aileron hinges to the wing on a Cessna 150. Extreme caution must be exercised when using these screws and should any fail then the batch should be returned to the supplier.
