B.G.A. TECHNICAL COMMITTEE

TECHNICAL NEWSHEET

TNS 9/10/88

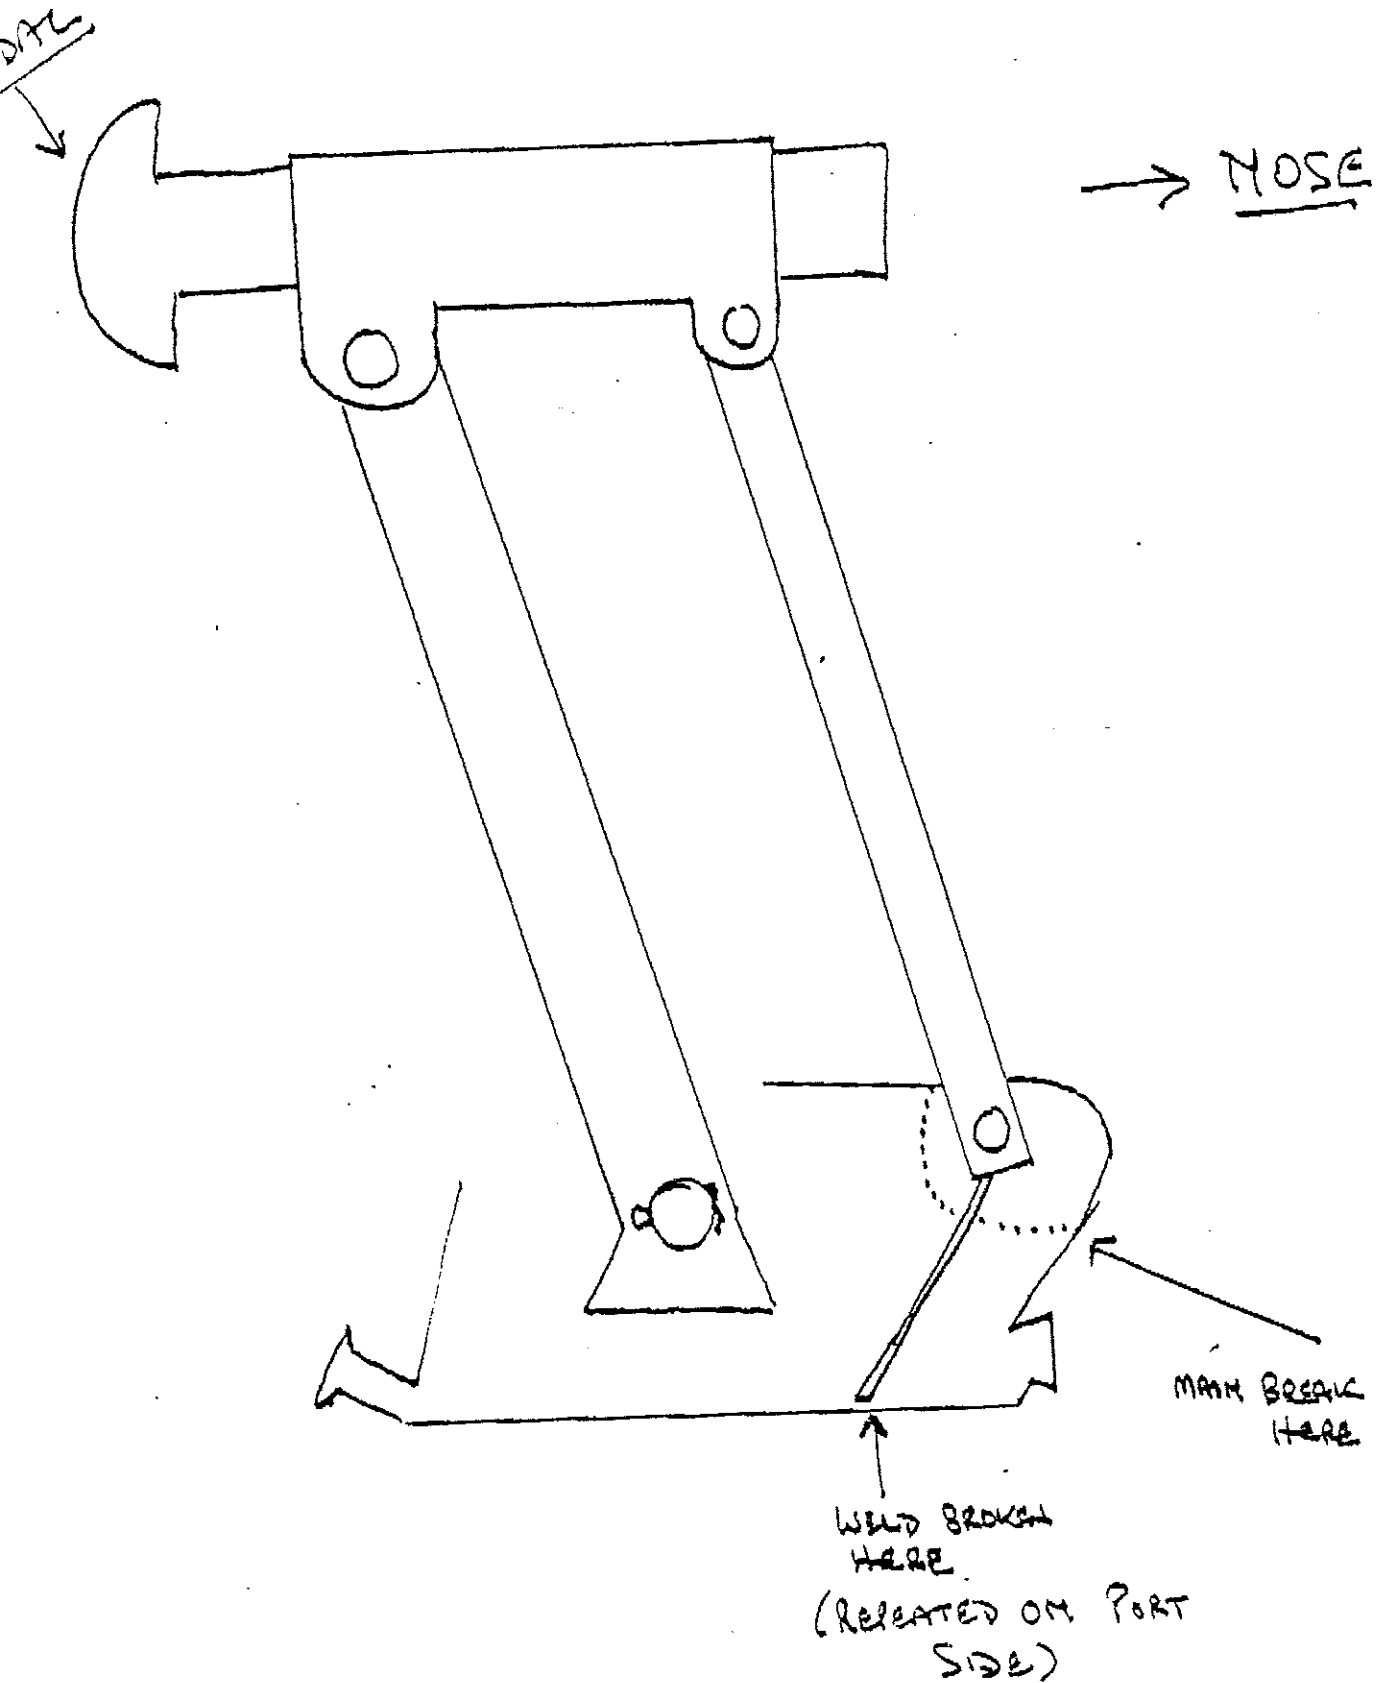
Bocian Rudder Pedals.

Failure of steel web carrying front rudder pedal angle actuating rods on Bocian 1E and subsequent failure of bracing straps and timber frame.

At C of A it was noticed that the steel web (see accompanying drawing) carrying the two rods which are coupled to the rudder pedals and adjust the pedal angle as the pedals are depressed had broken, allowing the rods to "float". The bracing straps, which also hold this assembly, had fretted at the point where they were welded to the fitting. One of the welds had failed and the other was holding by only about a third of its width.

Had this second strap failed the two rods, still connected at their base, would have been free to move backwards, or forwards, from their upper pivot points.

After removal of the pedal assembly it was apparent that the wooden frame which carried it had also fractured, possibly as a result of the stresses caused by the abnormal movements occurring.

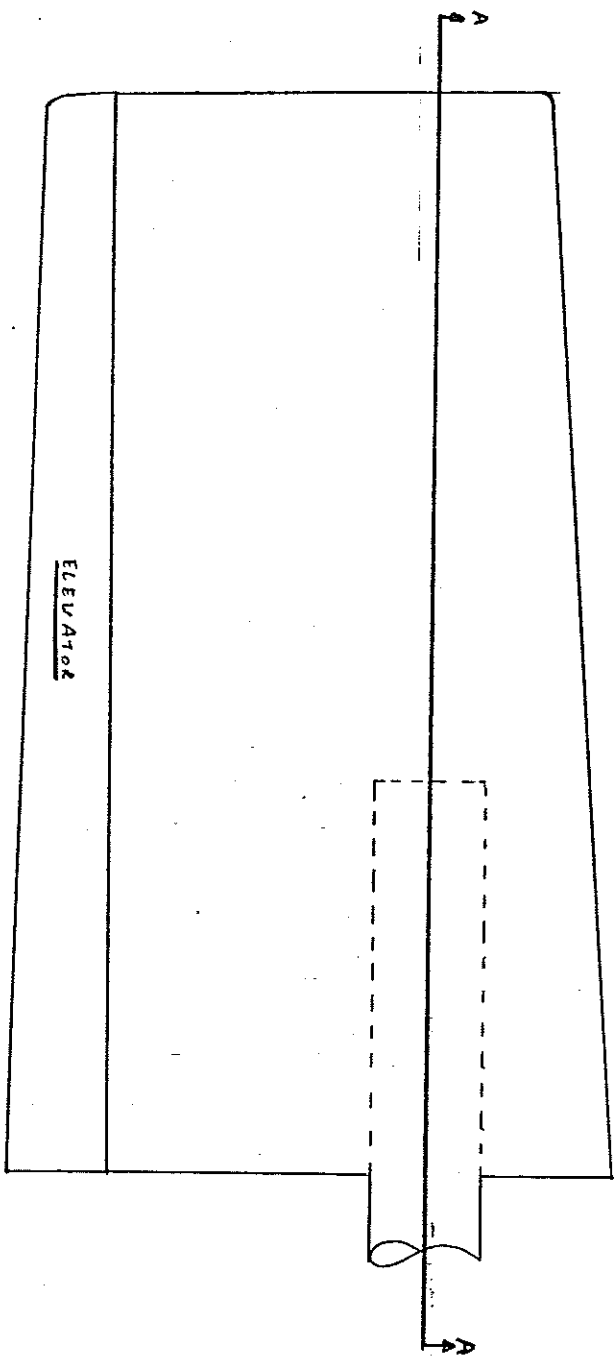
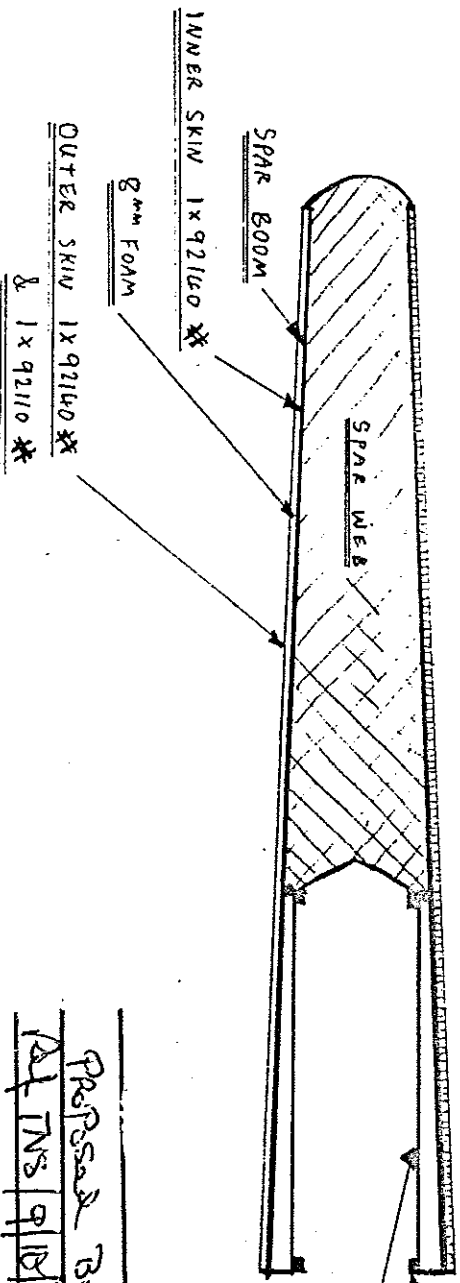
DIAGRAMATIC SKETCH OF SF 34 TAIL PLANE

GLASS TUBE 2x921140 * GLUED TO INNER SKIN TOP & BOTTOM, BADLY BROKEN AT BOTH SIDES.

PROPOSED TO REPAIR 921140 & ADD 6x92125.

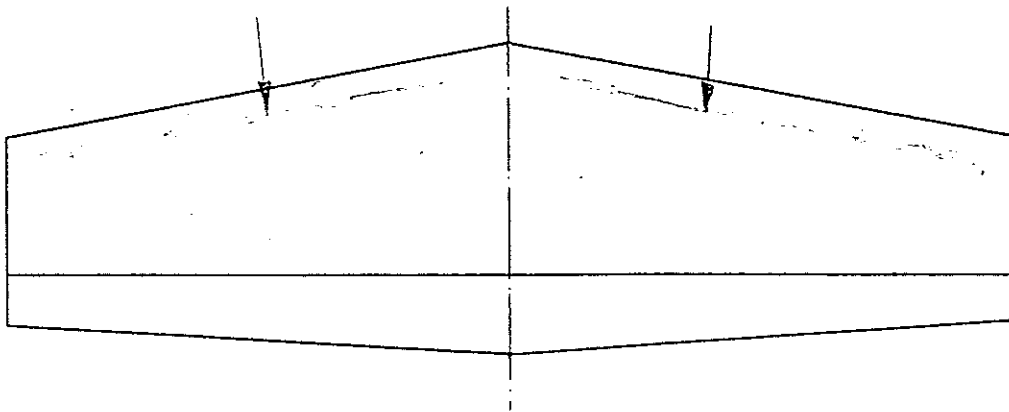
Deux cas de décollement de l'intrados du plan fixe horizontal côté droit ont été signalés. Ils peuvent avoir été provoqués par une manoeuvre malhabile.

- A) 1) Sur l'intrados du plan fixe horizontal, en particulier aux endroits définis par le croquis ci-dessous, vérifier l'absence de décollement tissus (voir manuel d'entretien page 5.11. bis).

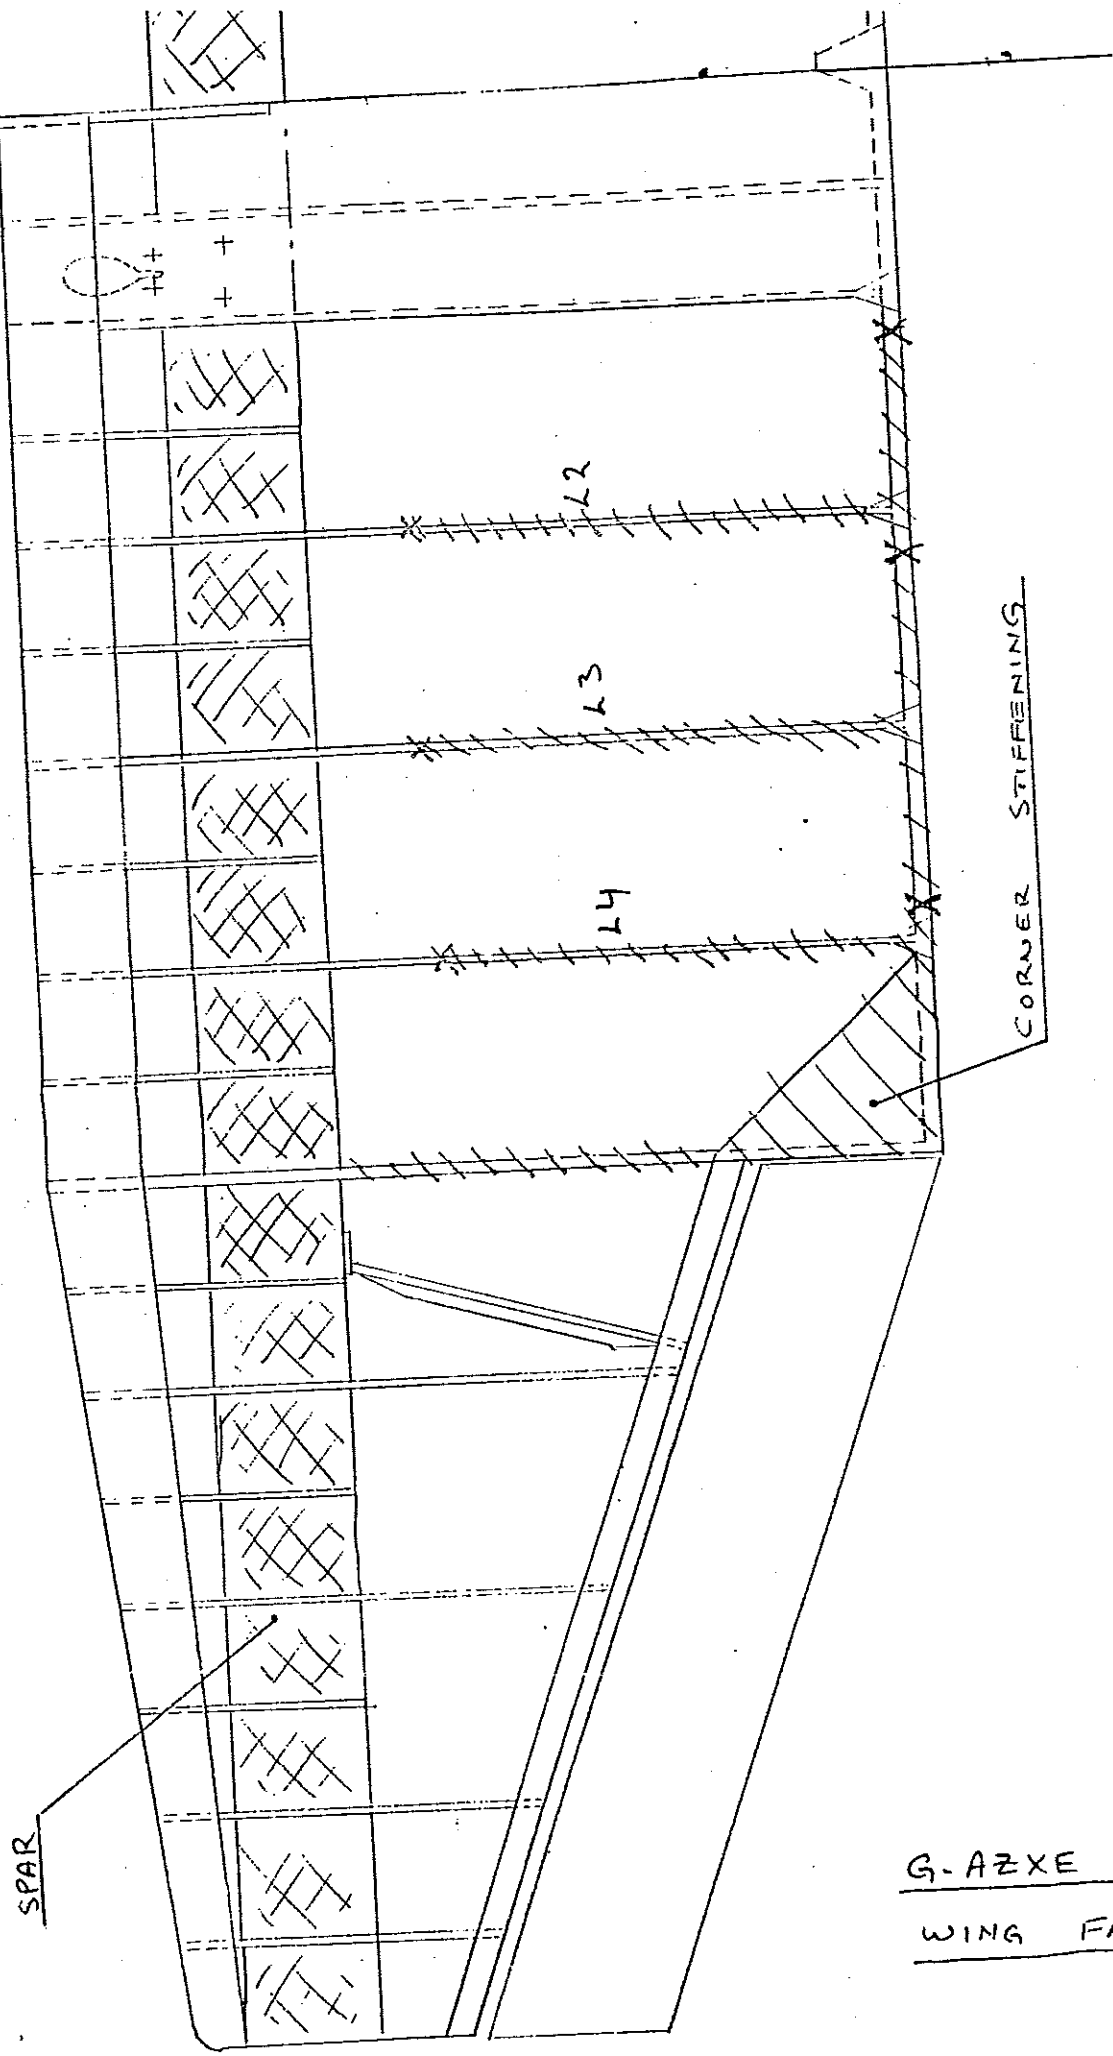
G-AZXE LEFT
WING FAILURE

A reconstruction of the left and right wings showed the right wing to have been intact prior to impact, whilst the left wing showed evidence of failures having occurred in the centre wing rib structures, aft of the spar, and their associated trailing edge section (see figure 1). The spar itself had been intact at impact. The upper surface fabric covering this left wing had become detached in flight from the structure around all of the trailing edge. In addition, an area of lower surface fabric had also become detached at the trailing edge around the centre of this inner wing. Only some of the fabric and trailing edge section from this region of the wing was recovered from the wreckage trail.

- Two fractures in rib L4 were associated with "sloping grain". This would have reduced the bending strength by 20%, although it was considered unlikely that this would have been sufficient to initiate the major failure. However, it was considered that it may well have been a contributory factor in the failure.

- There was some evidence of previous crack growth in rib L3, next to the trailing edge. There was also evidence of "rubbing together" of the fracture surfaces of one failure, in both ribs. There was considerable and consistent evidence that the rib members had been subjected to high compressive stresses and that these, because of their distribution, had not occurred at the time of the major break-up of the wing. It would appear, therefore, that the wing had been subjected to high compressive stressing before the final break-up. Two possible sources of such stressing were considered:-

/// = WING STRUCTURE FAILED IN FLIGHT.

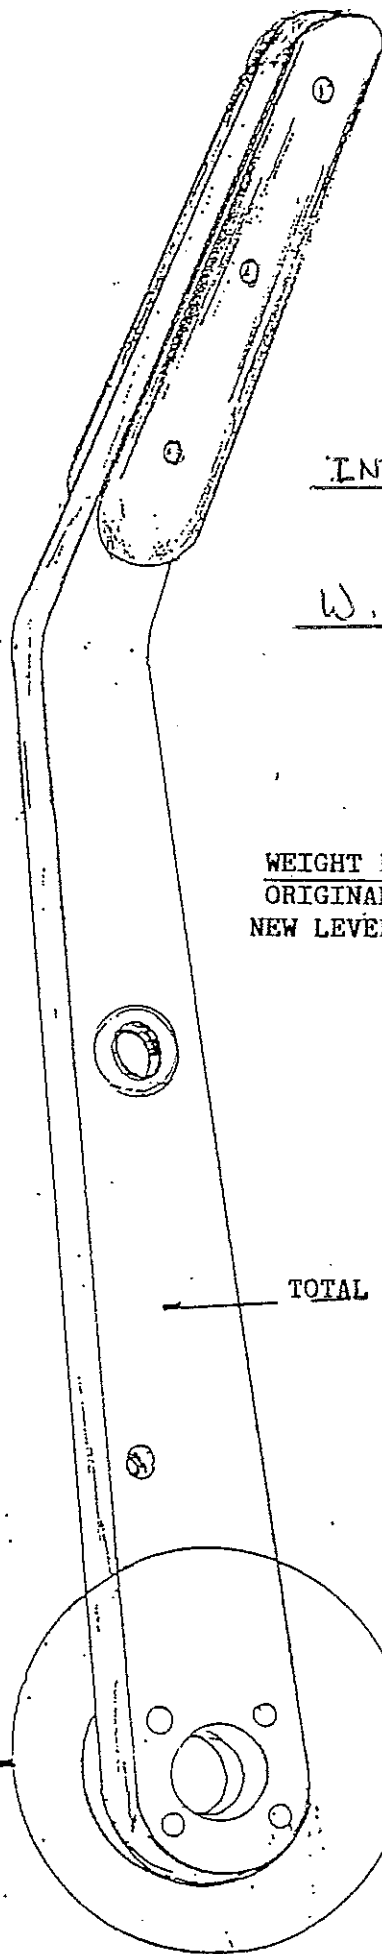
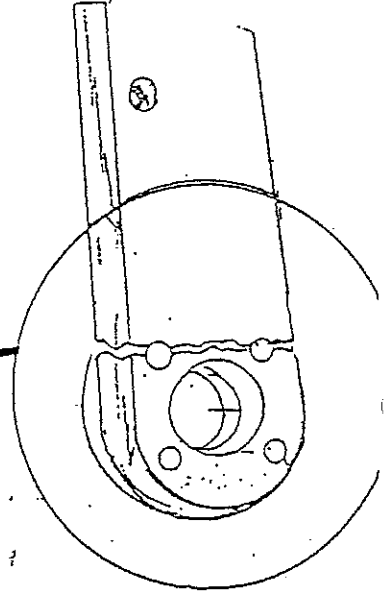
IN FLIGHT FAILURE.

FRACTURE
