B.G.A. TECHNICAL COMMITTEE.

TECHNICAL NEWSHEET.

TNS 11/12/88

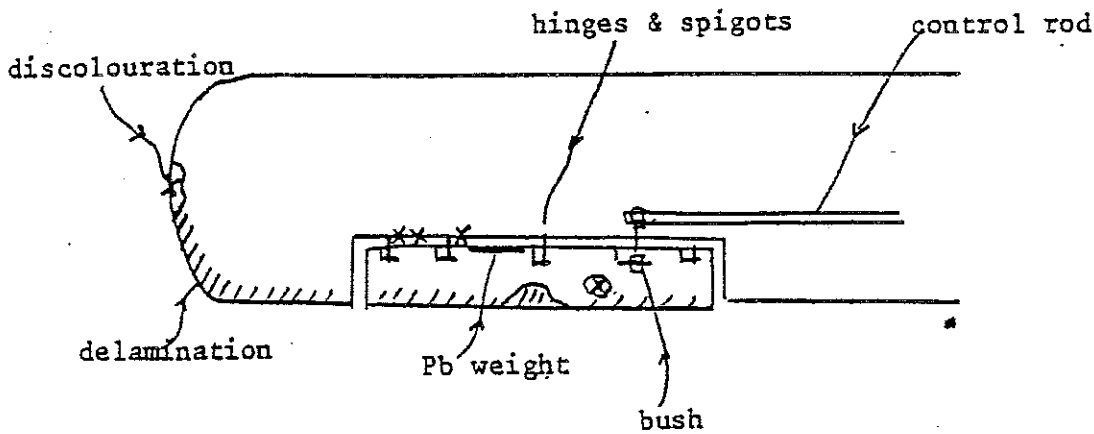
Port Wing assembly

Port Wing

Wing tip end and T/E delaminated. Discoloration and slight crazing of paint at wing tip. At the T/E spar of the wing where the aileron is located several small holes (several mm diam) with burn marks in the glass fibre were found. On the aileron itself there was severe delamination of the T/E and holes in several positions with burn marks. Over the upper surface around one of the holes the fibre glass was badly damaged; a region near the trailing edge was also badly damaged. The lead weight inserted in the aileron showed several pitting marks. The bush joining the control rod to a spigot in the aileron showed severe arc erosion and the rear end of the spigot embedded in the fibre glass was blackened. At the position of the hinges there was considerable discoloration of paint work.

It would appear that the LS4 sustained a wing tip to wing tip lightning strike. The holes in the aileron and T/E spar of the wing for the port assembly suggest that arcs were formed inside the wing and aileron; the explosive forces resulting from these arcs were sufficient to

cause delamination of the wing and aileron tip respectively. Inboard of the control rod bush, it would appear that the current was transferred via the control rods. No damage or evidence of pitting was observed at the fuselage ends of control rods however. The control rods have electrical continuity to the control column and foot pedals and to the elevator assembly. This could cause the pilot to receive a shock and for an arc exit channel to occur from the elevator. Again it would appear that an arc formed inside the elevator and caused extensive delamination. It is known that even for moderate lightning strikes of 20kA, overpressures of several atmospheres occur near the arc. Without opening up the left wing it is impossible to say why an arc could penetrate inside it; one possibility would be if the inner surface was wet or moist.

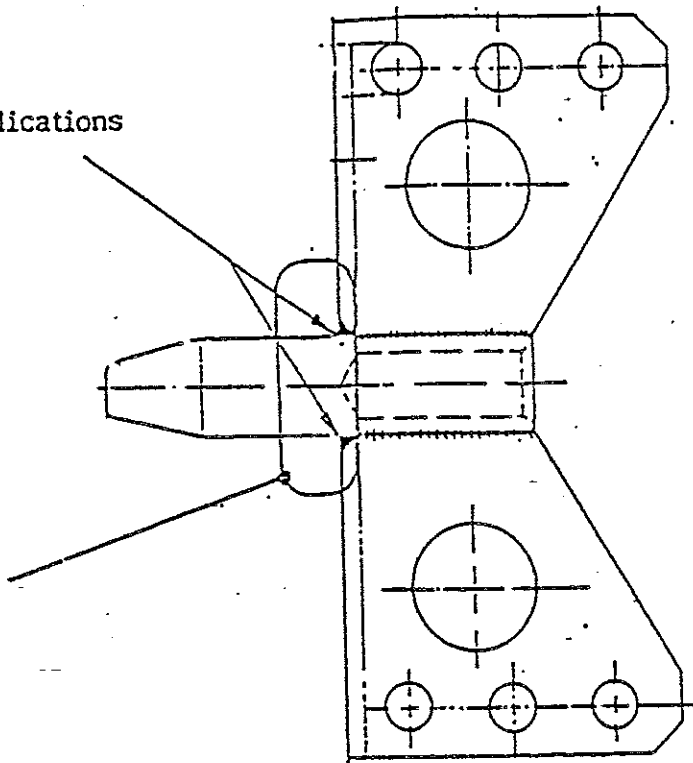
G109 SPIGOT FITTING

CAA ADDITIONAL AIRWORTHINESS DIRECTIVE 006-10-88
GROB G109 AND G109B SERIES MOTOR GLIDERS
SPAR STUB END FITTINGS - CRACKS AT OR NEAR THE TOE OF
THE WELD ON THE TOP AND BOTTOM SURFACE OF THE SPIGOT

Check for crack indications

- (i) Remove the wings in accordance with the Flight Manual instructions.
- (ii) Remove the glass reinforced plastic (grp) or the protective lacquer covering the spar stub extremity, avoiding any damage to the metal parts, sufficient to expose the top and bottom weld ends and the weld transition into the spigot body - see figure A.

- (iii) Inspect the end of the weld and the spigot itself at the toe of the weld for cracks, using a x10 magnifying glass (four places) - see figure A. There are two spigots per aircraft and cracks can occur on the top and on the bottom of the spigot..

- (iv) If a crack is suspected, and appears to be confined to the weld itself, i.e. does not extend circumferentially into the spigot, or where there is a lack of weld penetration, the wings may be replaced. The aircraft may be flown to a place where the existence of cracks can be confirmed or otherwise by NDT means, by an Organisation approved for that purpose by the CAA. The flight must be conducted with the pilot only on board. Abrupt manoeuvres and/or high speeds are prohibited.

If a crack is confirmed either in the weld only or in the spigot itself, rectification must be carried out to the manufacturer's approved repair scheme before further flight.

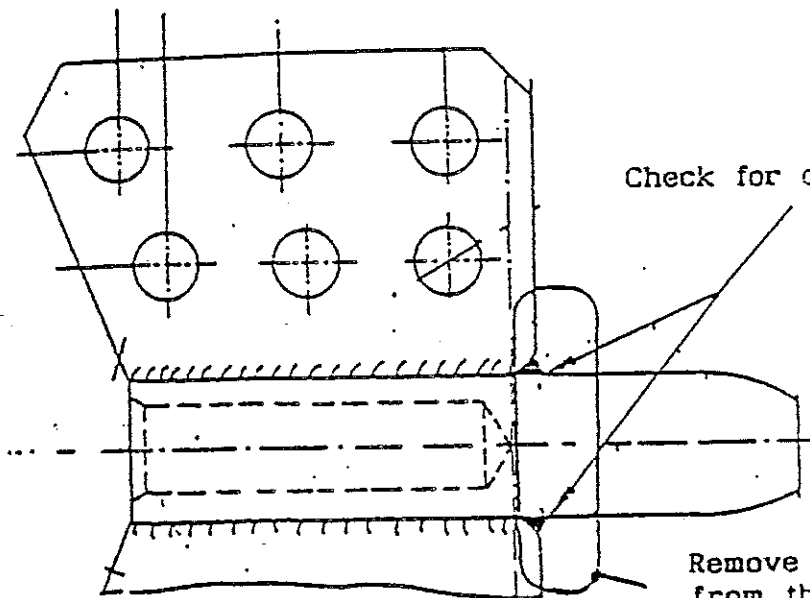
G109B SPIGOT FITTING

Check for crack indications

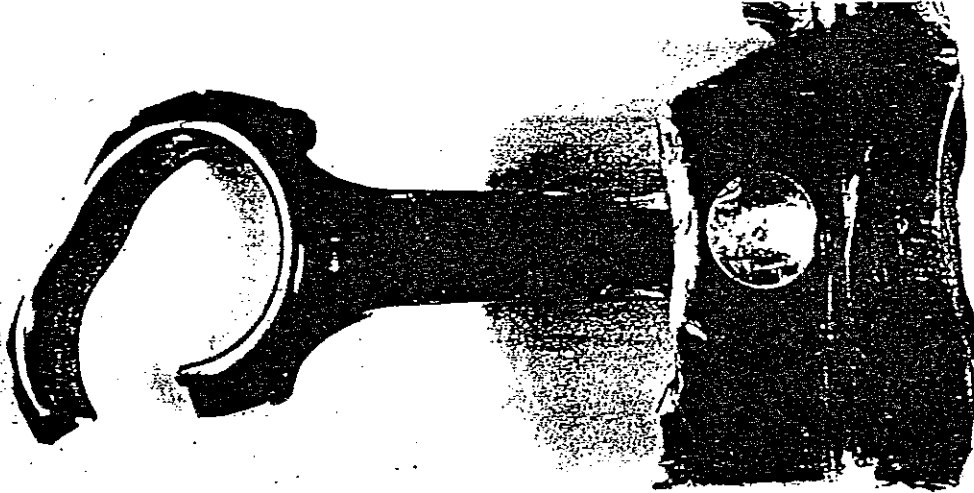
Subsequent inspection showed that the No 3 (right aft) cylinder had completely detached from the crankcase and the corresponding connecting-rod (figure 1) had been wrenched from the crankshaft, with considerable damage to the piston.

Figure 1: No 3 piston and connecting-rod, G-BMNL

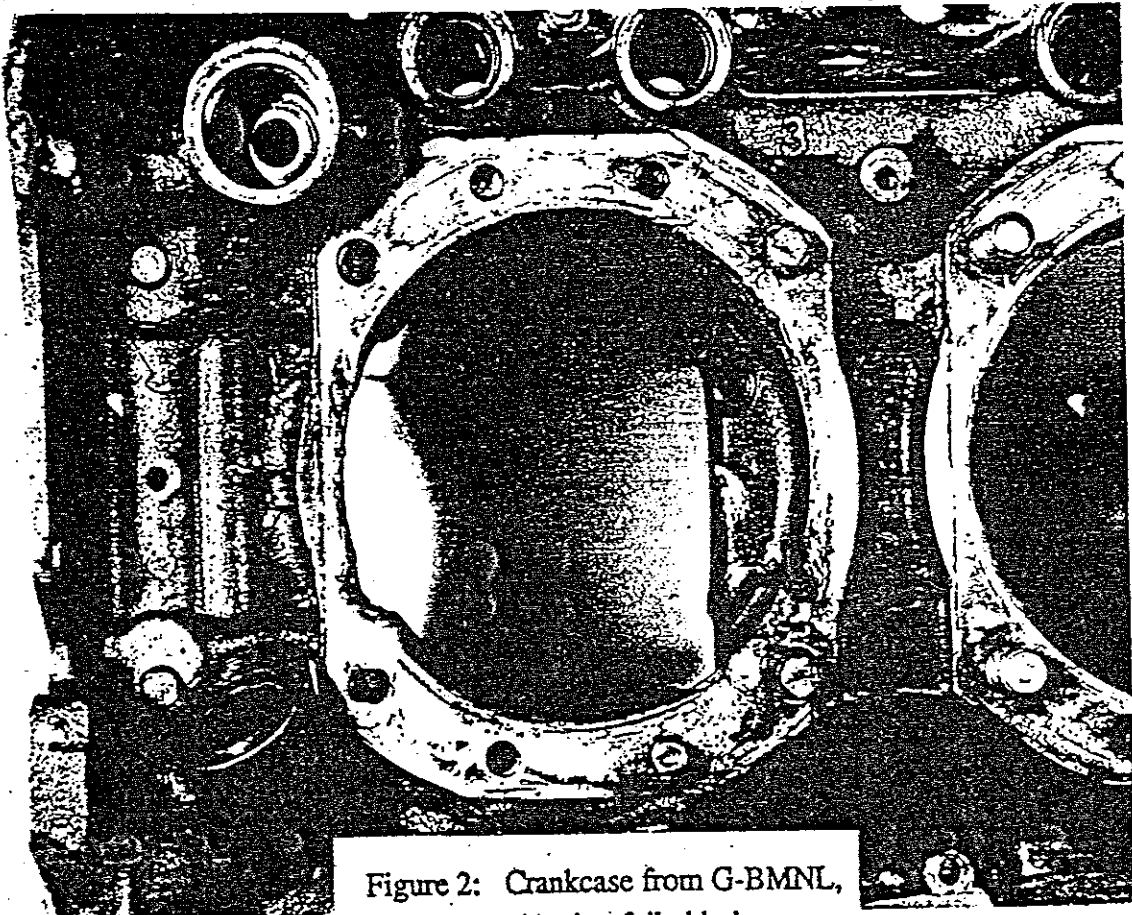
During AAIB investigation of the engine it became apparent that the connecting-rod failure had occurred after the cylinder had become detached. Of the 8 bolts (figure 2) which are used to secure the cylinder

to the crankcase, at least 5 showed positive evidence of fatigue failure. The apparent sequence of failure was that the bolts had become unevenly loaded, leading to progressive fatigue failure through a portion of their cross-section with final failure in overload as the cylinder detached.

Figure 2: Crankcase from G-BMNL, showing failed bolts

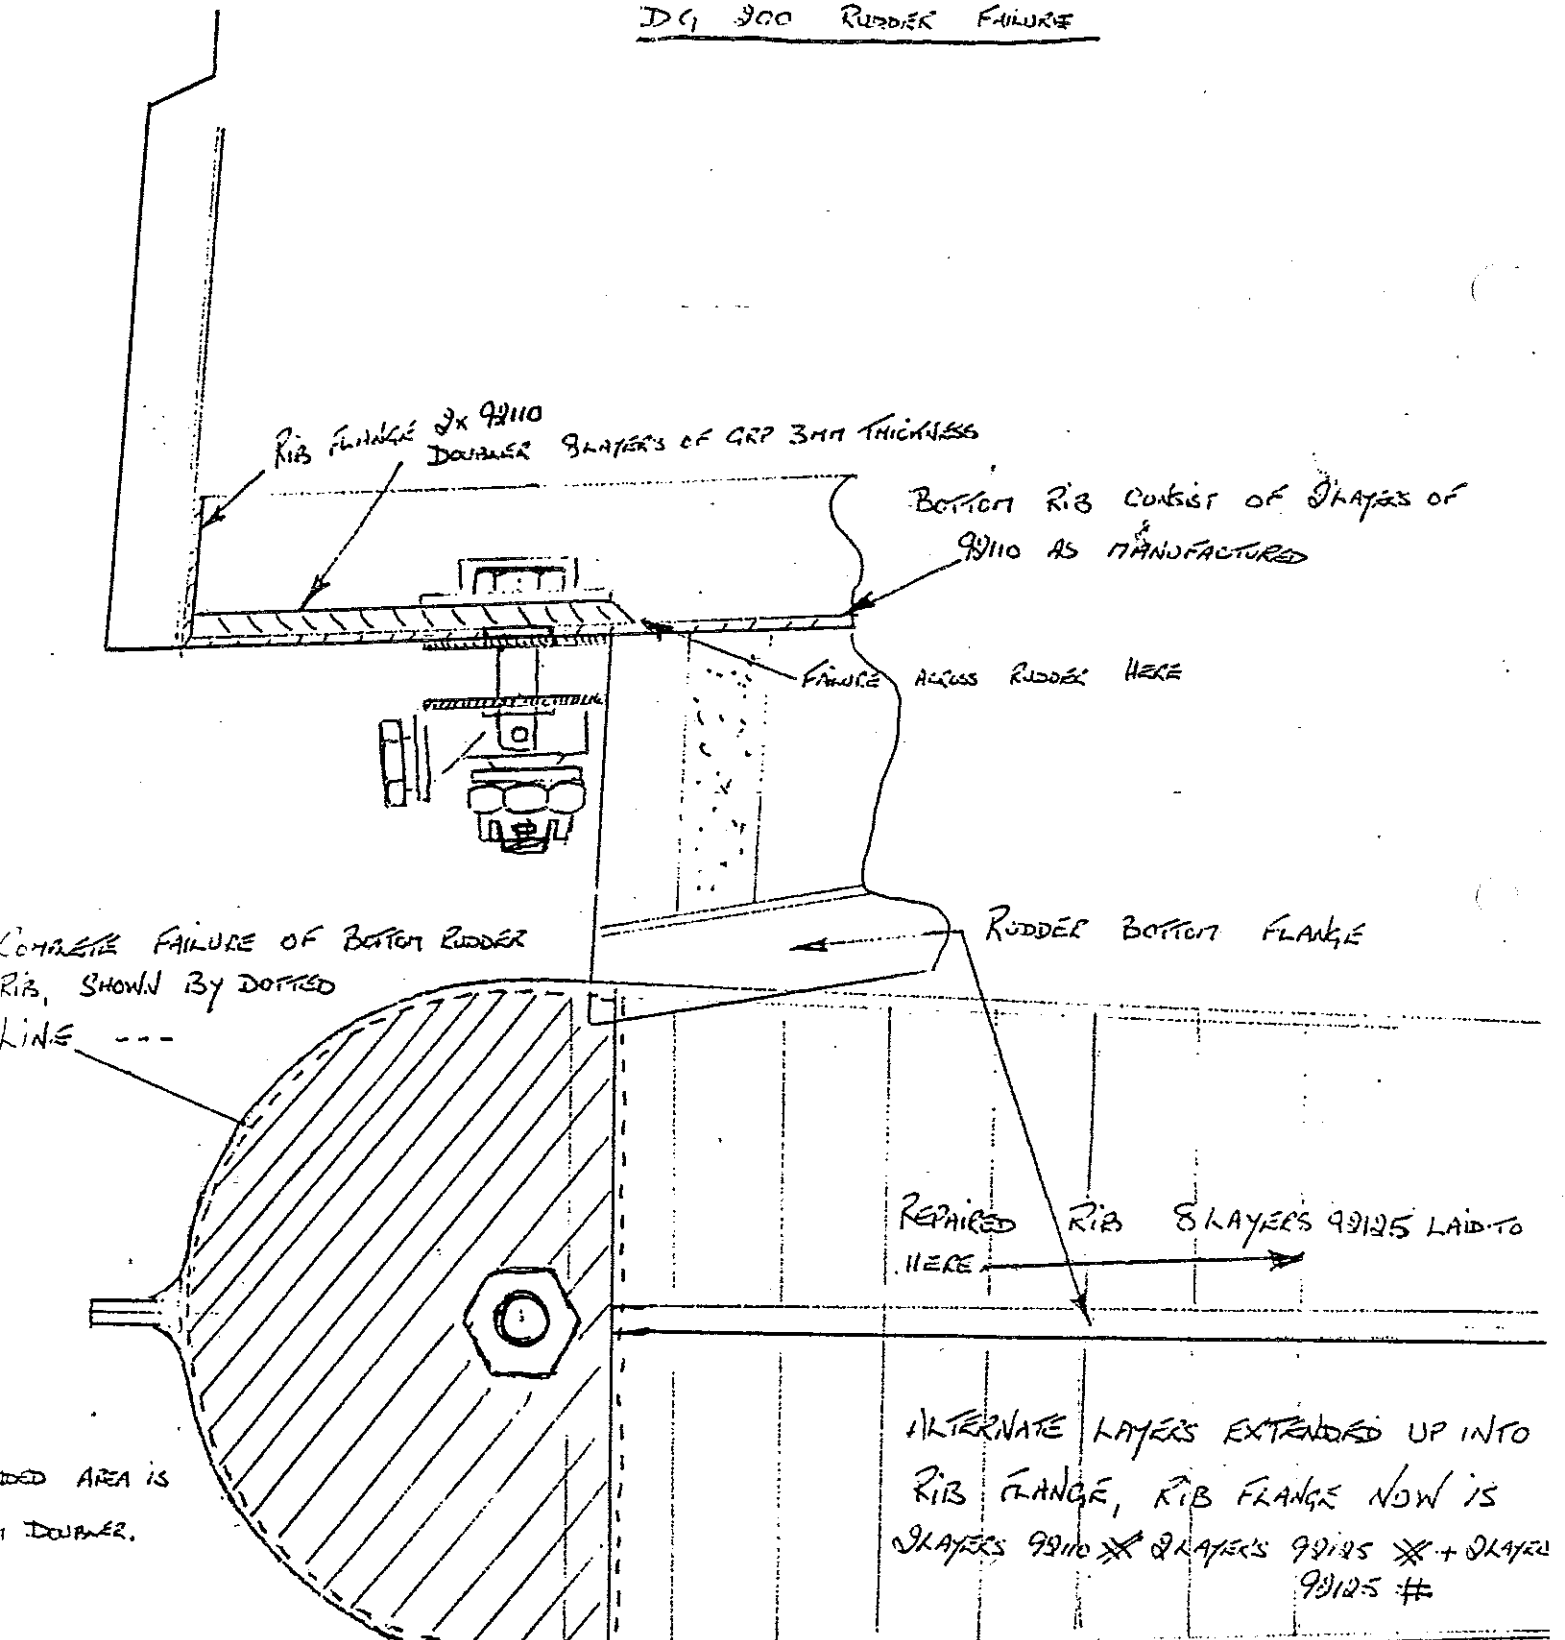
DG 200 RUDDER FAILURE

- PART 1 "AIRWORTHINESS AGGRO". The 1988 "Red Pages" will be re-issued early in 1989 as "Blue Pages".
- 1.1 DG 100, 101, 200, 202. Separation of the rudder in flight. The attached letter to operators was issued 12/10/88. The attached sketch of the failure (and its repair) is by courtesy of Southdown Aero Services.

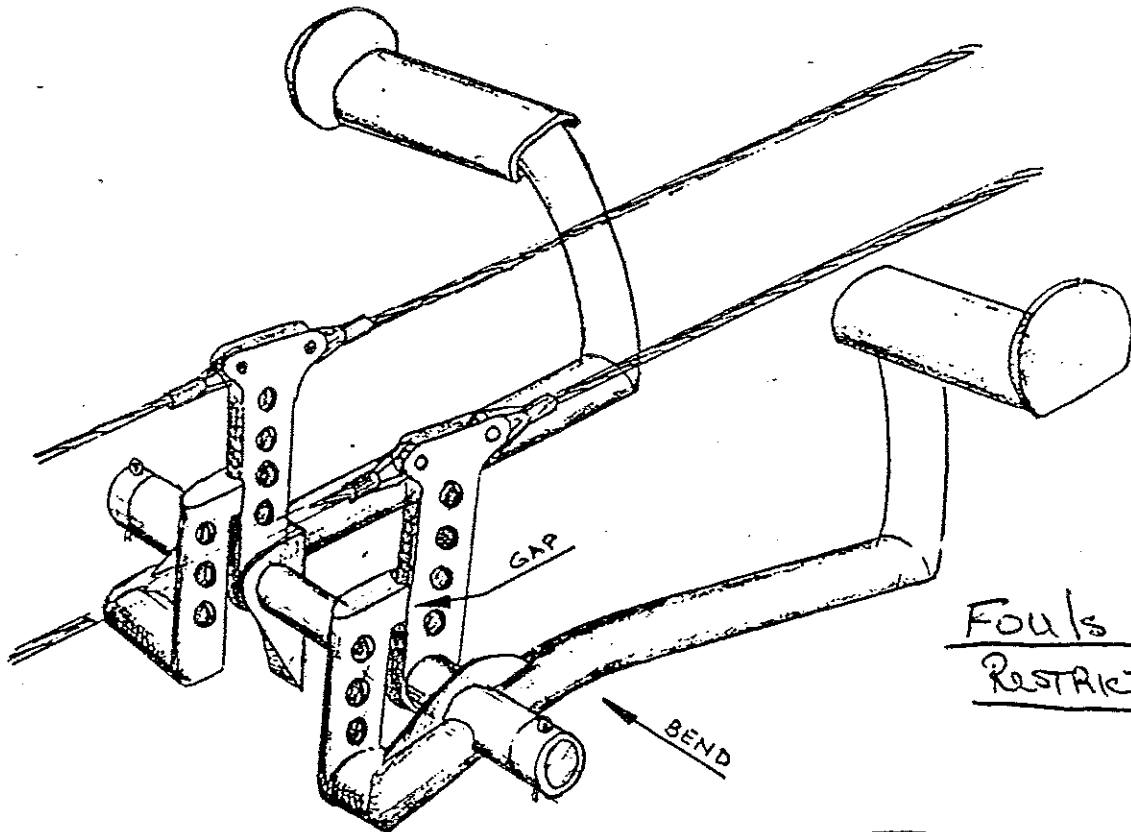
BOCIAN ID BGA 2734

- 1.5 KA7 / KA13 (KA7 conversions) cracking of the weld at the airbrake over centrelock. (Sketch by I.D. Smith is self explanatory).
- 1.6 Bocian Assymetric rudder pedal travel between front & rear cockpits. (The attached sketch by Tony Mos, Borders G.C outlines the problem).

Fouls Floorboards.
RESTRICTS TRAVEL.

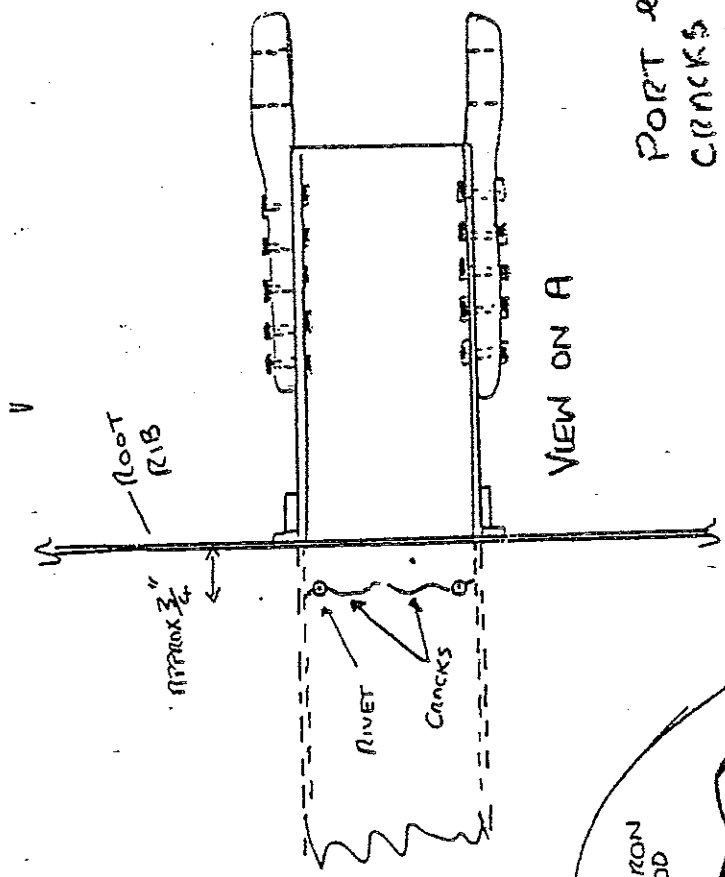
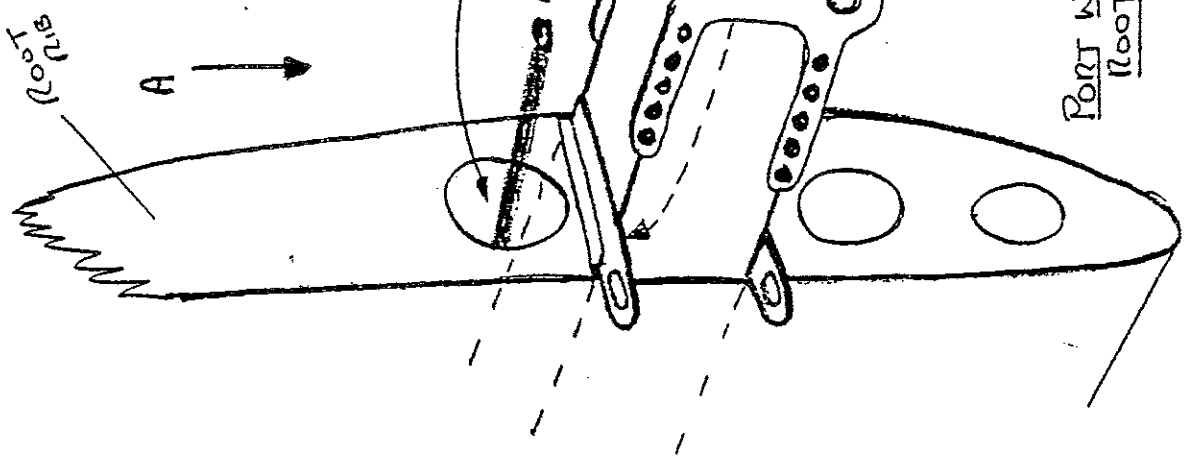
VIEW ON A

- 1.7 BG 135. Cracks in spar web at wing root. (Sketch by W.G. Cook highlights the defect).
- 1.8 Grob G.109's wing root spigots. CAA AD006-10-88 (herewith) has been mailed by CAA to all registered owners. Repetitive inspection at 300hours is required. (BGA note: There is neither an LBA Directive, or Manufacturer's T/Note. For advice contact U.K. Agents).

CRACKS VISIBLE THROUGH HERE.

PORT & STBD WING ROOTS.
 CRACKS IN SPAR AFT WEB
 APPEAR TO BE PROPAGATING
 FROM RIVET HOLES, AS SHOWN.

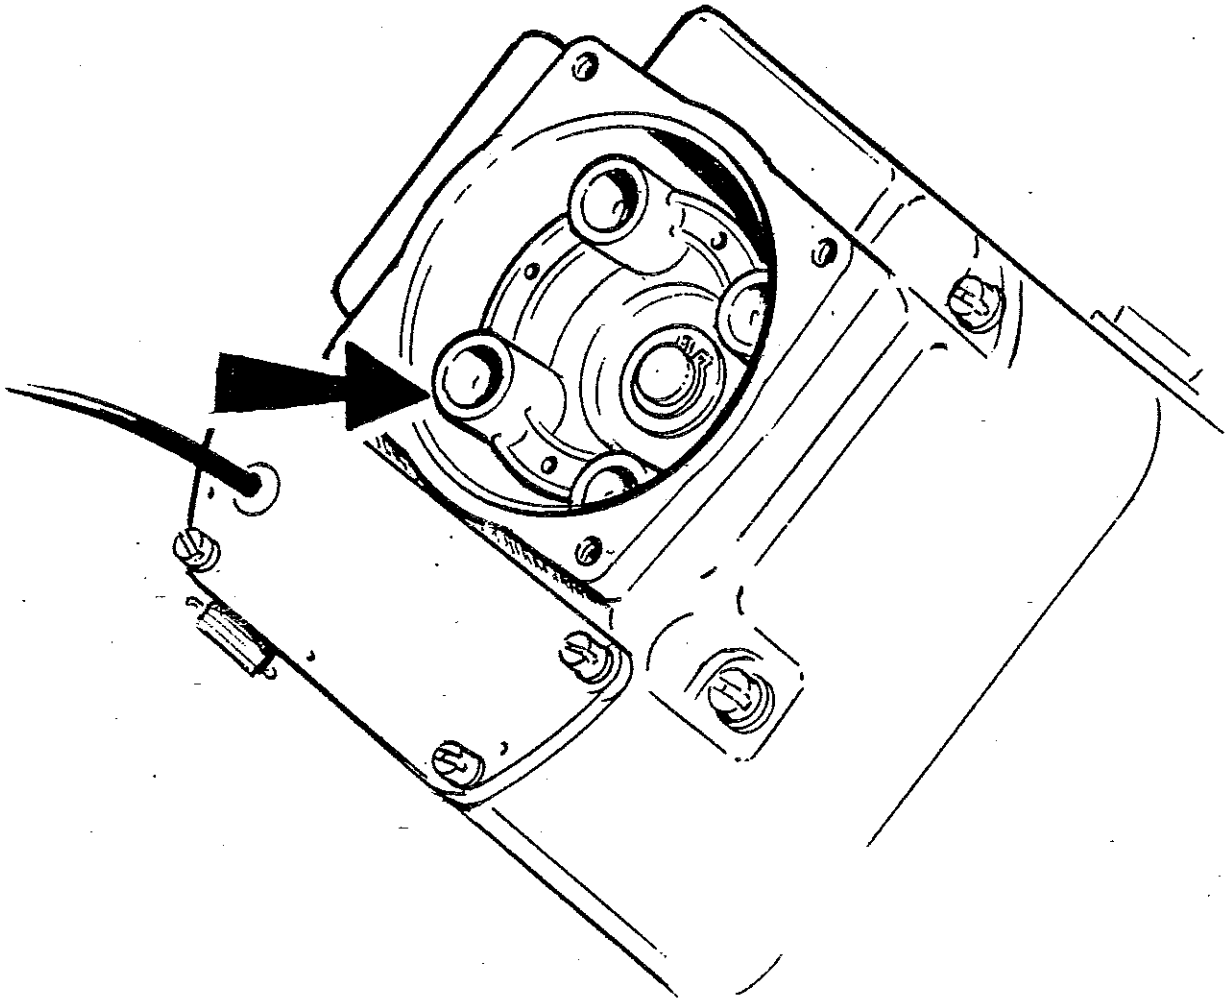
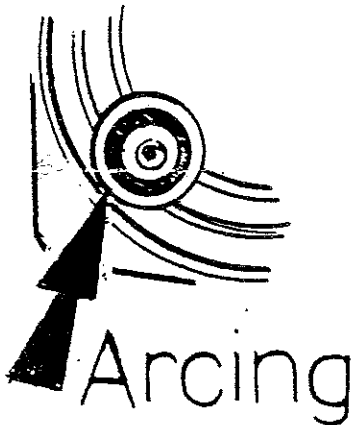
BENDIX MAGNETS.

- 1.10 Bendix magneto - break down of the distributor cap. (Sketch by Roy Garner attached).
- 1.11 Chipmunk flap cables - may foul on pipework in the port wing root area! chipmunk flap cables may become detached from actuator pulleys in wing roots (port & starboard). (Reported by RNGA, Le-On-Solent).

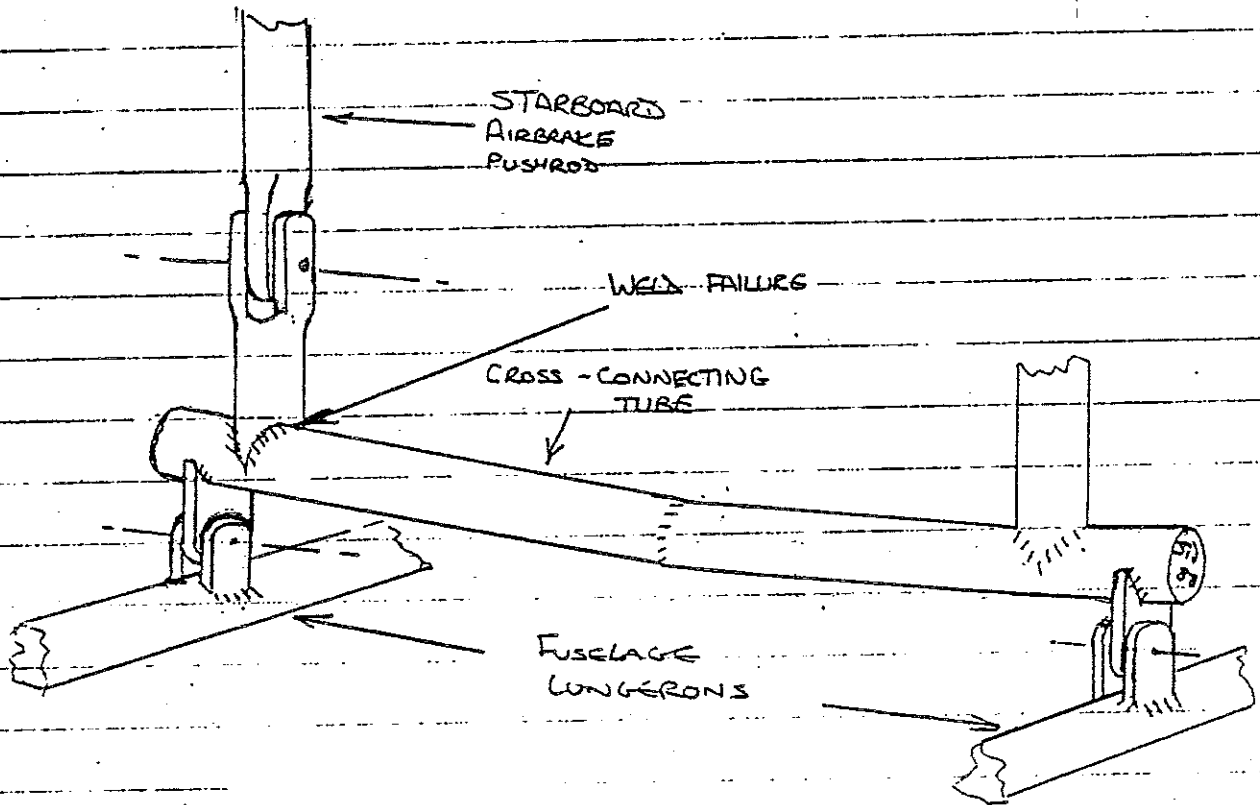
SKETCH SHOWING LOCATION OF FAILURE IN K7/K13 CONVERSION
(BGA ?) AIRBRAKE OVER CENTRE LOCK.

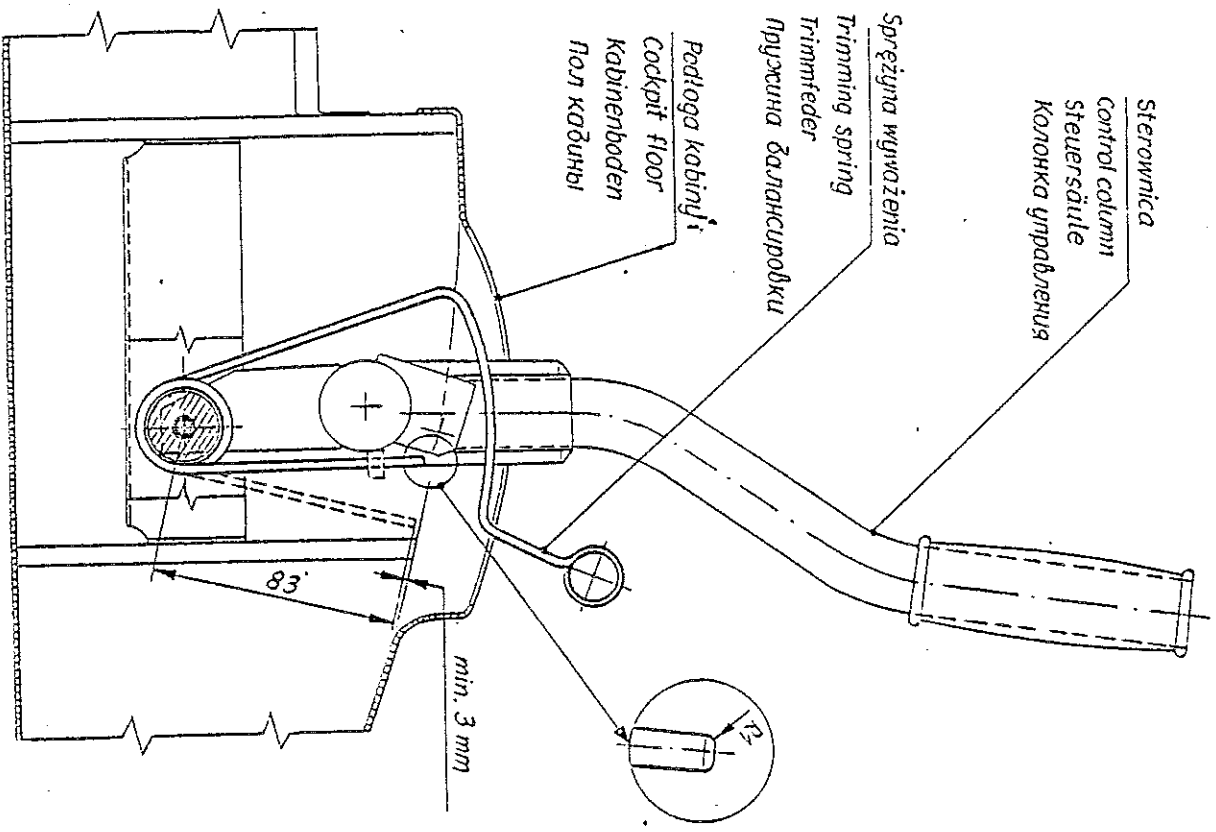
Fig. 1.

During the post-repair test flight of SZD-48 glider the following occurred : the end of trimming-spring /the arm fitted in the "eye" on control column body/ hitched the composite floor of the cockpit /"seating pan"/. In respect to the above according to directions of this Bulletin the inspection should be performed to check that the spring end to floor distance retains the minimum clearance.

4.1. Take out the cockpit floor /"seating pan"/. Look for the symptoms of the floor being worn by the spring end and for the correct protruding of the spring out of the "eye" on the control column body.
