BRITISH GLIDING ASSOCIATION

TNS 3/4/89.

PART 1 AIRWORTHINESS "AGGRO"

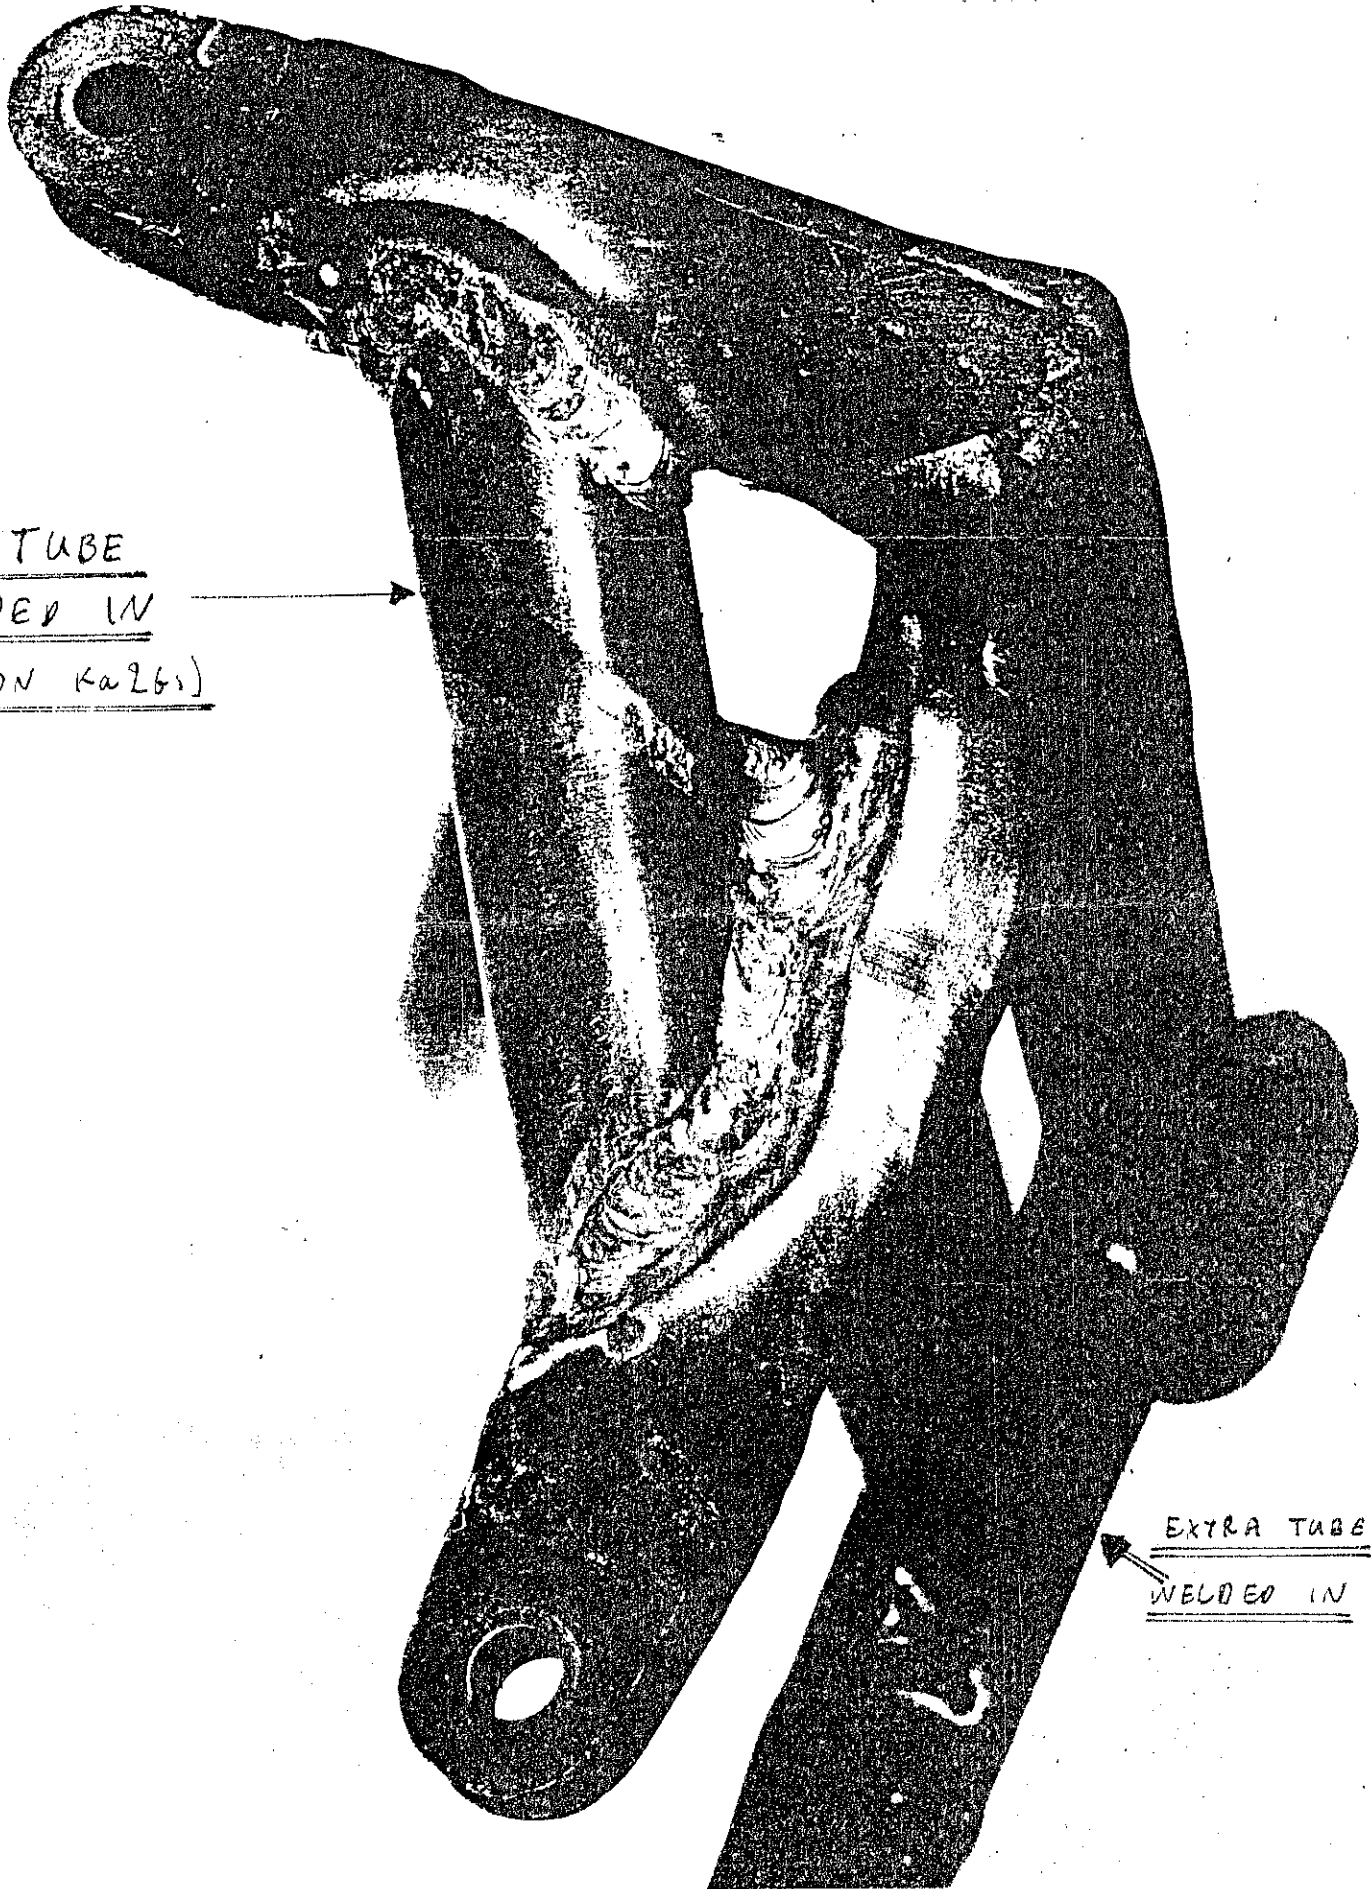
Ka7 & Ka2G AIR BRAKE CROSS LINK - MODIFIED

- 1.1 KA7 (KA 2's) Air Brake Cross Links Cracked - Re-enforcement recommended as per attached photo. (Reported by Tim MacFadyen, Cotswold G.C).
- 1.2 KA7 - Air Brake Paddles - Glue failure due to water not being drained. Drain holes required. (Reported by Tim MacFadyen).

EXTRA TUBE
WELDED IN
(NOT ON Ka2Bs)

EXTRA TUBE
WELDED IN

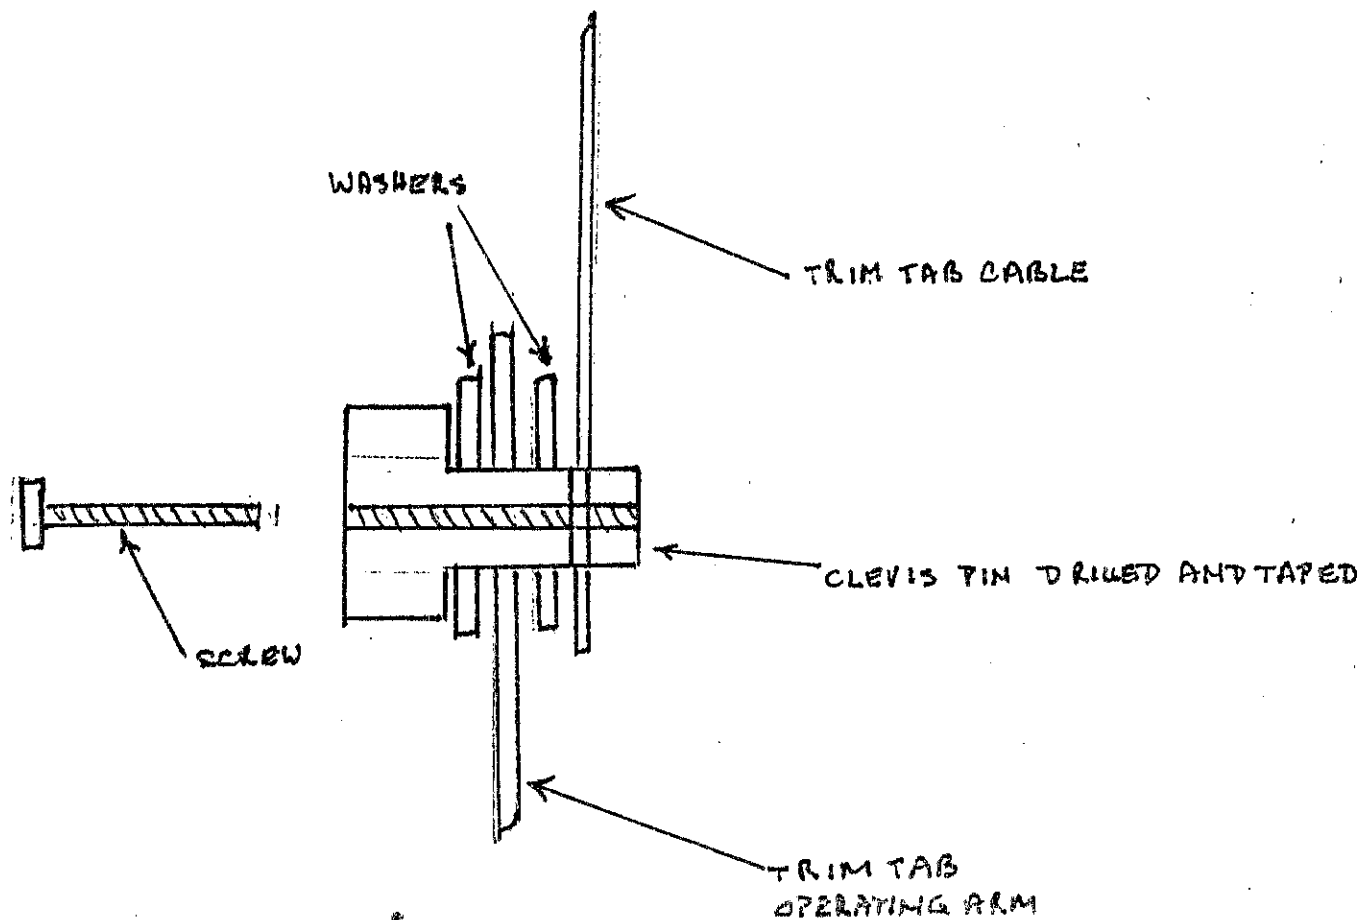
BOCIAN TRIM TAB DRIVE. TNS 3/4/89.

- 1.3 KA8B (also KA7 and K2) - Rudder pedals cracked, and bent. Inspect and re-enforce as required by TNS/1/81.
- 1.4 Bocian - Trim Tab Cable Failure At The Tab - A swivelling device must be installed to prevent cable fatigue failures, which will result in uncontrollable motions of the elevator. (Sketches by Ian Hipkin, Highland G.C).

THE CLEVIS PIN IS FREE TO ROTATE IN THE TRIM TAB OPERATING LEVER. THE TRIM TAB CABLE IS CLAMPED BY THE SCREW PASSING THROUGH THE CLEVIS PIN

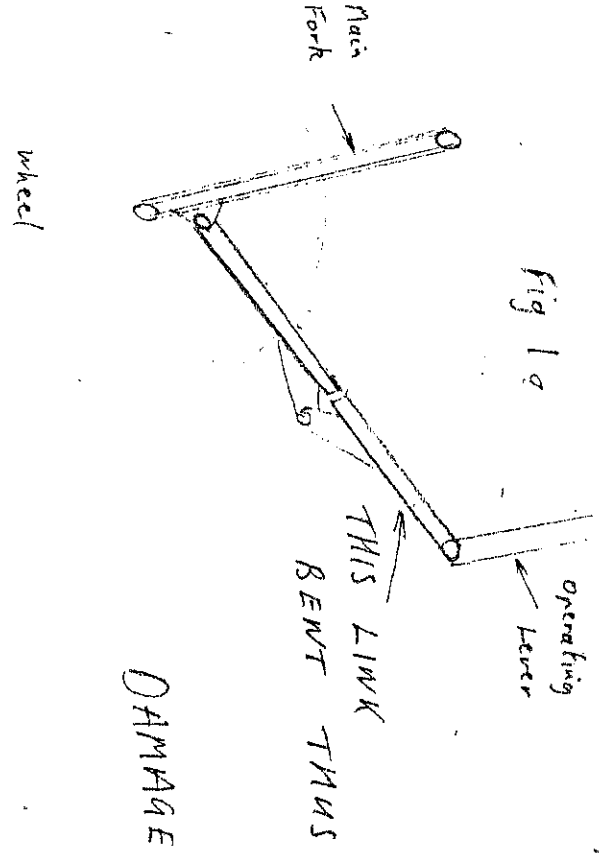
Fig 1 a

- 1.13 Failed Oil Hoses (Aeroquip) - GASIL 3/89 refers.
- 1.14 Aircraft (Piston) Refuelled With Turbine Fuel - GASIL 3/89.
- 1.15 PIK 20 Heavy Landing Damage - to undercarriage support structure, and Lower Rudder Hinge found to be cracked (sketches by M.J. Smallbridge are self explanatory).

DAMAGE TO UNDERCARRIAGE

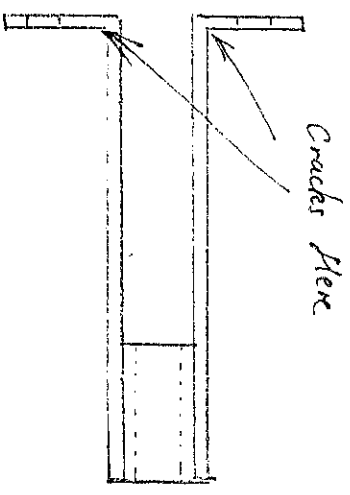
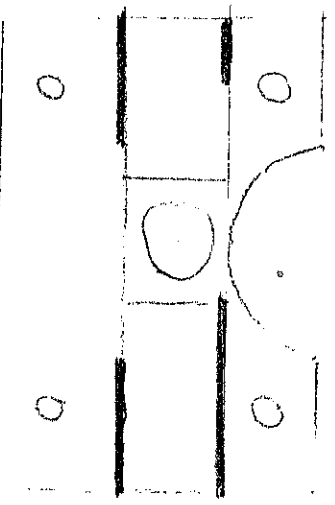
Fig 2

DAMAGE TO LOWER RUDDER HINGE

Approx extent of cracks shown.

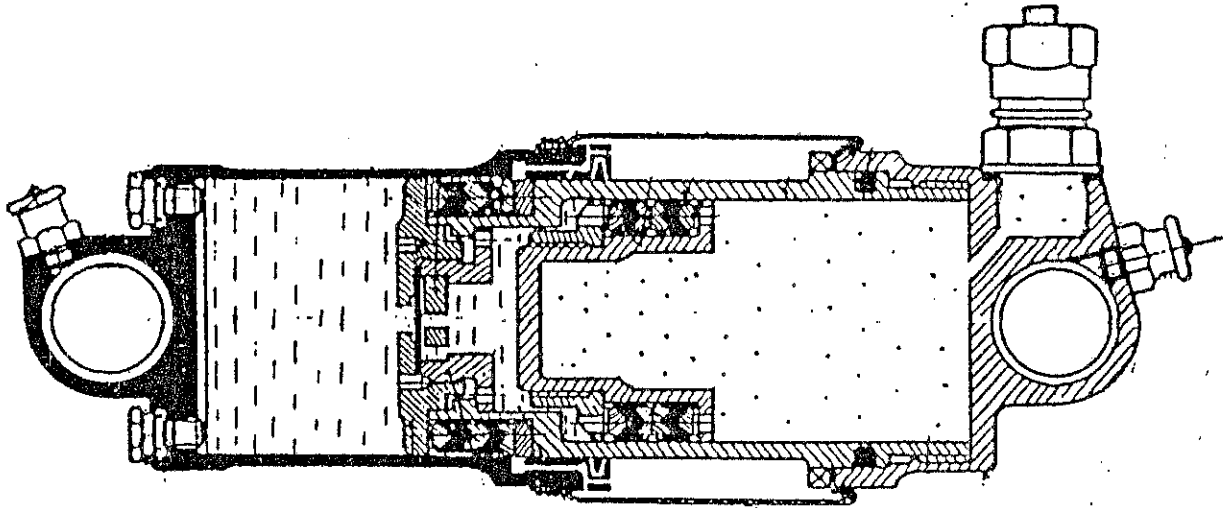
BLANIK.ITEM 18 UNDERCARRIAGE OLEO MODIFICATION. (G.F.A.Mod 88/12)

Overhaul of the Blanik oleo strut often requires the replacement of the seals shown in the following diagram.

To allow the use of standard "O" rings instead of imported metric lipped seals, a modification has been developed by a Blanik operator involving the manufacture of a new piston and cap both machined to accept standard "O" rings.

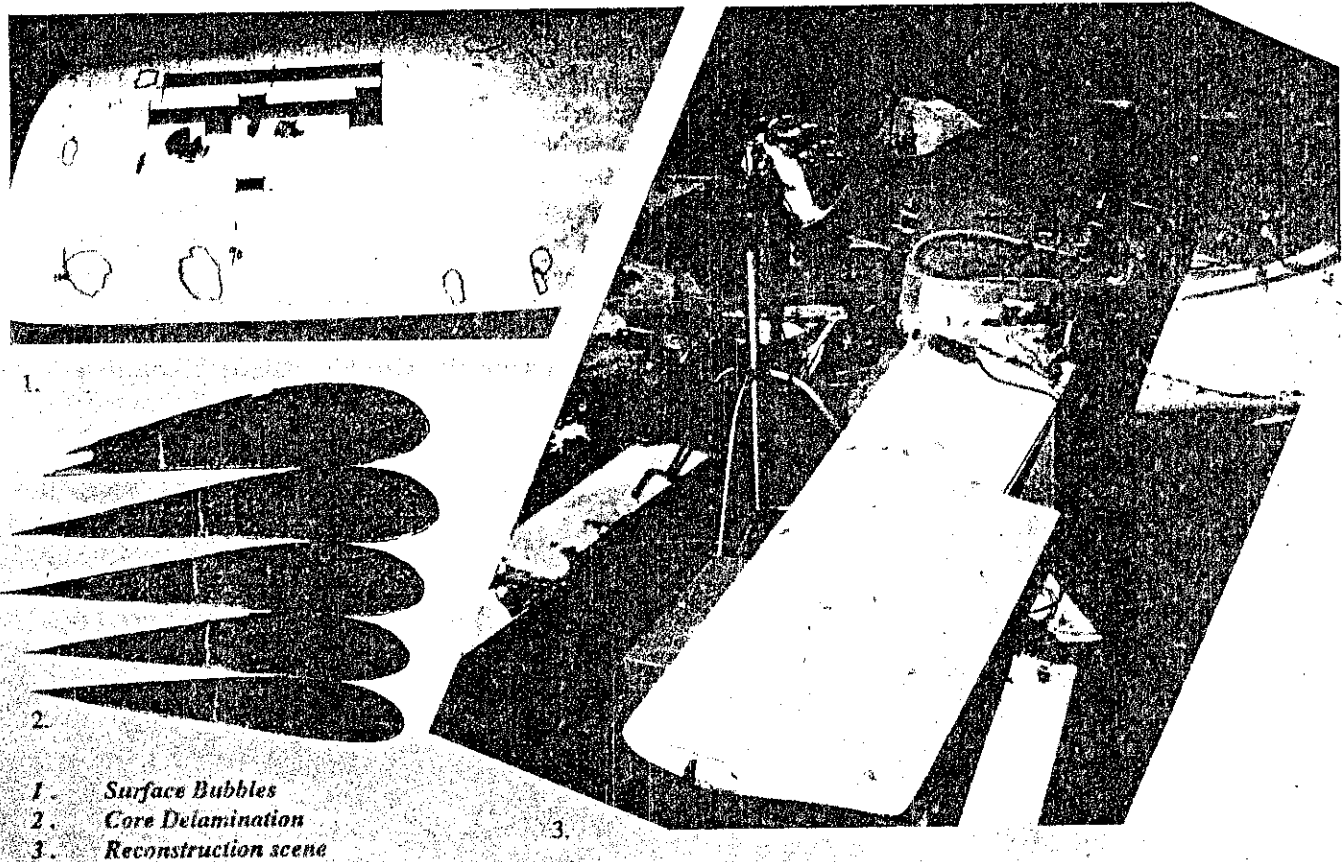
Composite wing catastrophe

1. *Surface Bubbles*
2. *Core Delamination*
3. *Reconstruction scene*

- The left wing foam core was incorrectly constructed and inadequately glued together so that visible gaps resulted.

- The owner's efforts to adjust "washout" by solar heating and twisting caused some wing-skin debonding.

The report concludes that the left wing failed in the static divergence mode with positive "G" forces bending and buckling the wing as a result of weakness introduced by improper construction and maintenance practices.

There are two lessons in this tragic story. Firstly, if an amateurbuilt aircraft is to enjoy a long and safe life it must be constructed exactly as intended by the designer. Persons or AMEs supervising such work must be familiar with the material and method of construction for a particular aircraft. Secondly, the ongoing maintenance and repair of composite structure requires as much care and attention to the detailed method of repair as did the original construction of the aircraft. Persons inspecting such work, or acting as designated inspectors, have a grave responsibility to thoroughly familiarize themselves with the aircraft designer's specifications and methods of applying material, before certifying such aircraft as serviceable and ready for flight. △

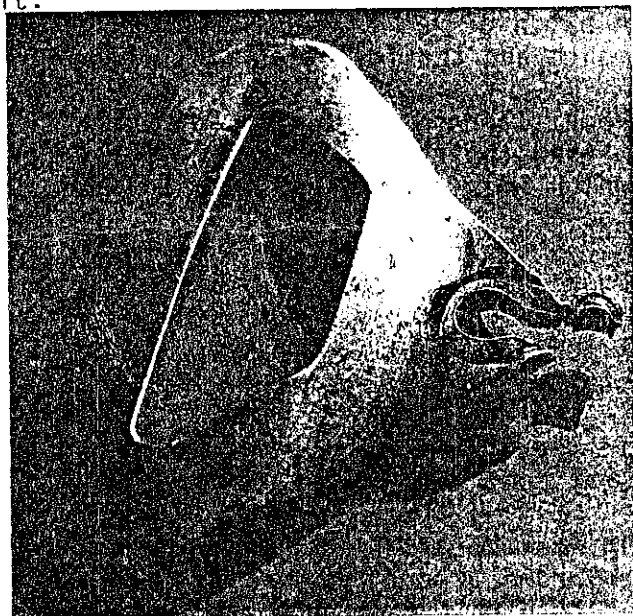
1. SEAT BELT ATTACHMENT FAILED

The seat belt fitting involved is an American Safety 6000 seatbelt, constructed from light alloy which is fitted to many other aircraft types. The right hand seatbelt attachment fitting had failed at the hole to the attach point. A considerable amount of wear had already taken place at the attachment of this fitting which cannot be inspected without dismantling. The seatbelt was generally in good condition. Whilst this matter is still being investigated by the CAA, it is strongly suggested that these fittings be inspected at the earliest opportunity and any found in a worn condition be reported to the nearest CAA Area Office. This particular aircraft had flown a total of 2777 hours.

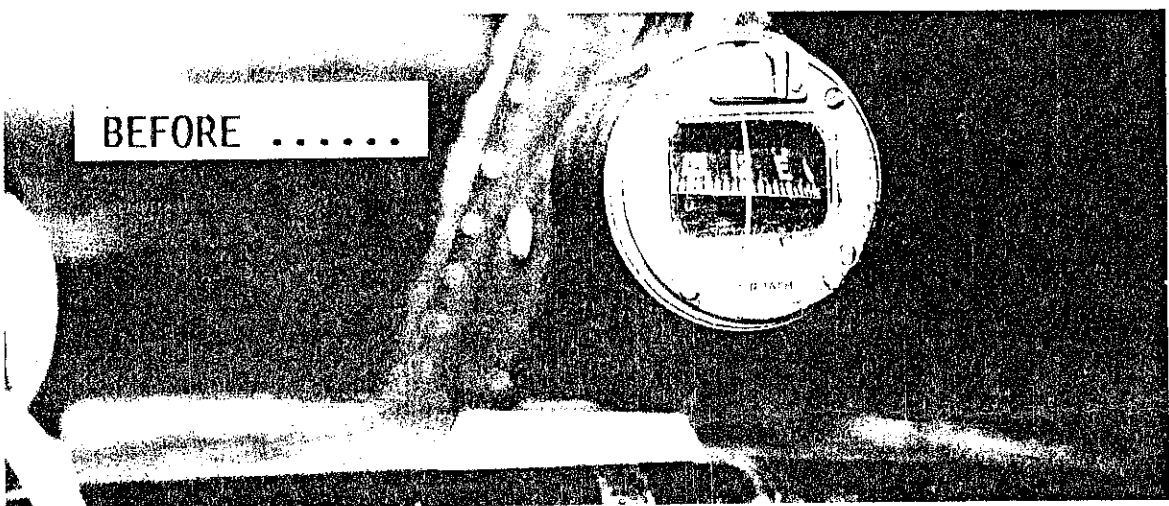
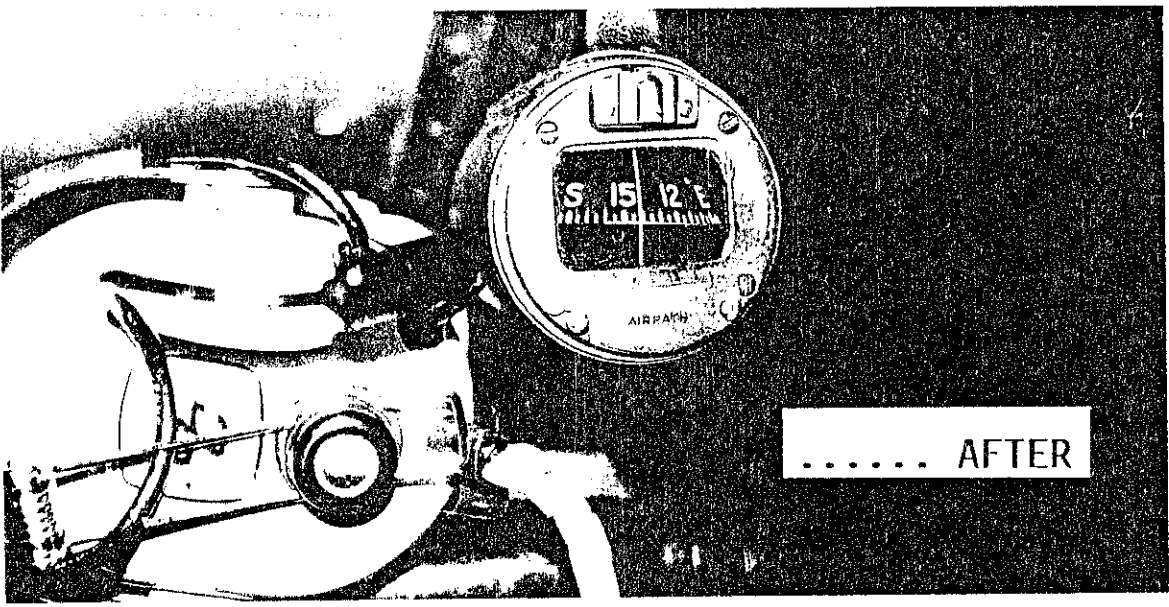
"When making position reports I always use my headset, and upon completion I laid the headset on what seemed a very convenient place since the cockpit was crowded - the top of the instrument panel! During the few minutes it took to make the report, I obviously never noticed that the compass read differently. (I steered by the liquid compass because I had not found the operation of the slaved gyro satisfactory, and, of course I had swung the liquid compass). Depending how close to the compass I had laid the headset, the compass had shown an erroneous reading of about 15° to the left.....

The photographs, taken in a Piper Cherokee 160, with all electrical systems switched off, shows the effect a modern headset had on its magnetic compass.
