BRITISH GLIDING ASSOCIATION

TECHNICAL COMMITTEE

TECHNICAL NEWSHEET 5/6/89

PART 1 AIRWORTHINESS "AGGRO"

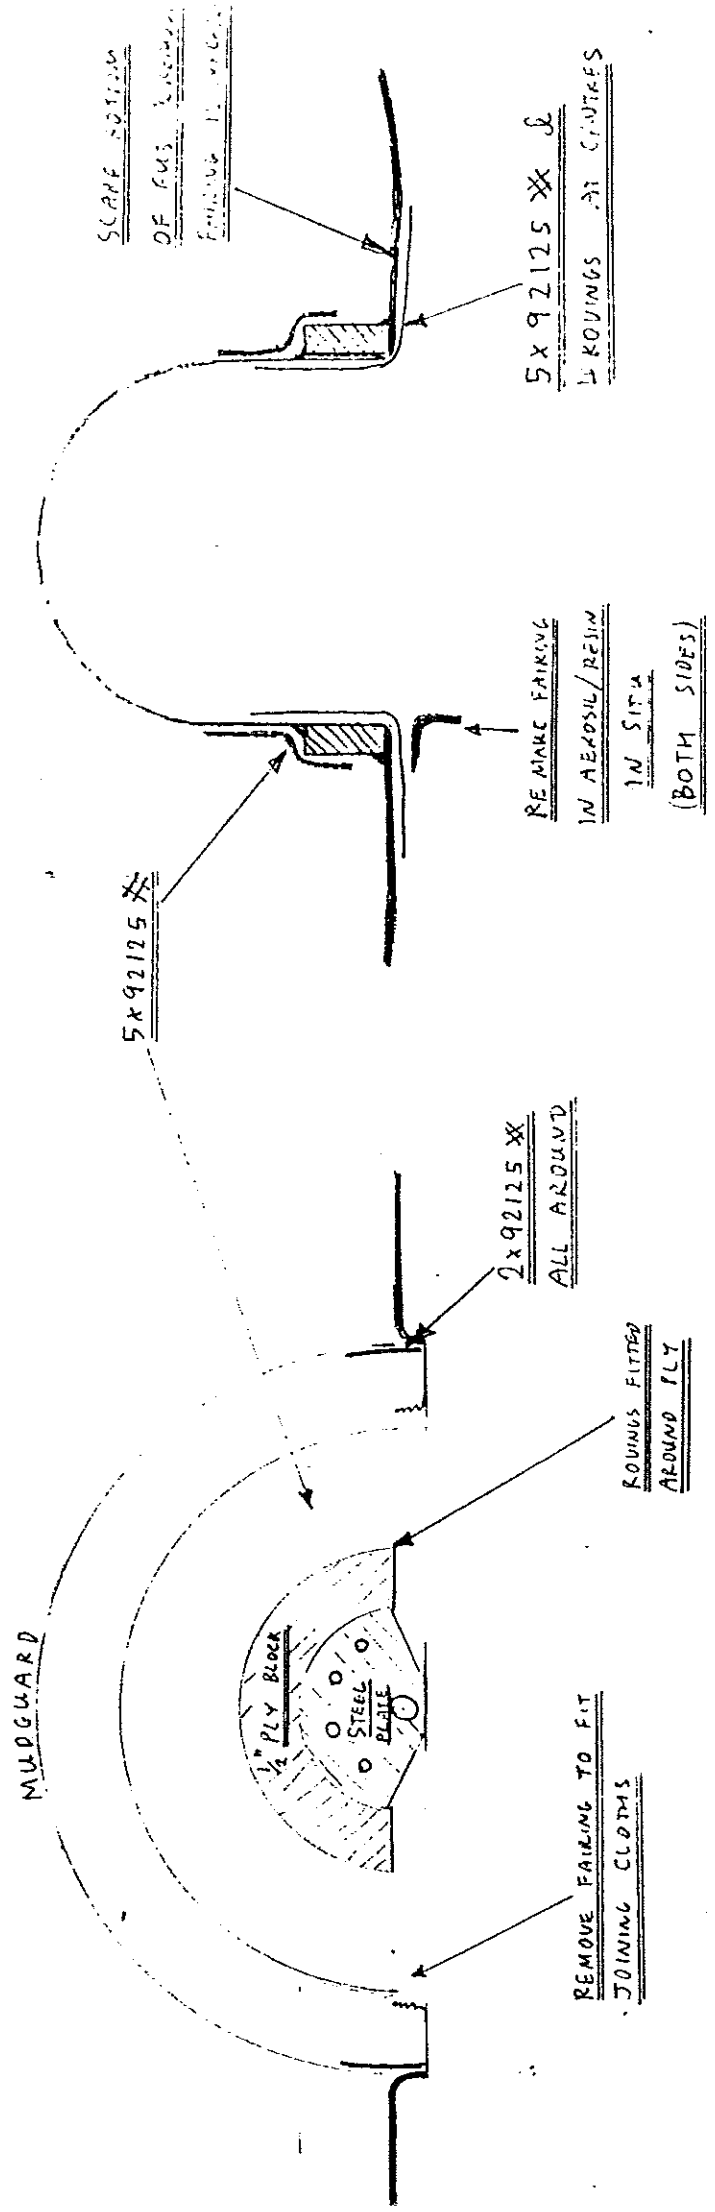
SF. 34

- 1.7 RF3 Series Motor Gliders. Mandatory Airworthiness Directives. Issue 8 of Foreign AD's is attached herewith.
- 1.8 SF34 Front Wheel Mounting - Re-enforcement The attached sketch by courtesy of Tim Macfadyen, Cotswold G.C, may be of interest to other operators?.

"X" SECTIONS THROUGH FRONT WHEEL MOUNTINGS
SHOWING REINFORCEMENTS

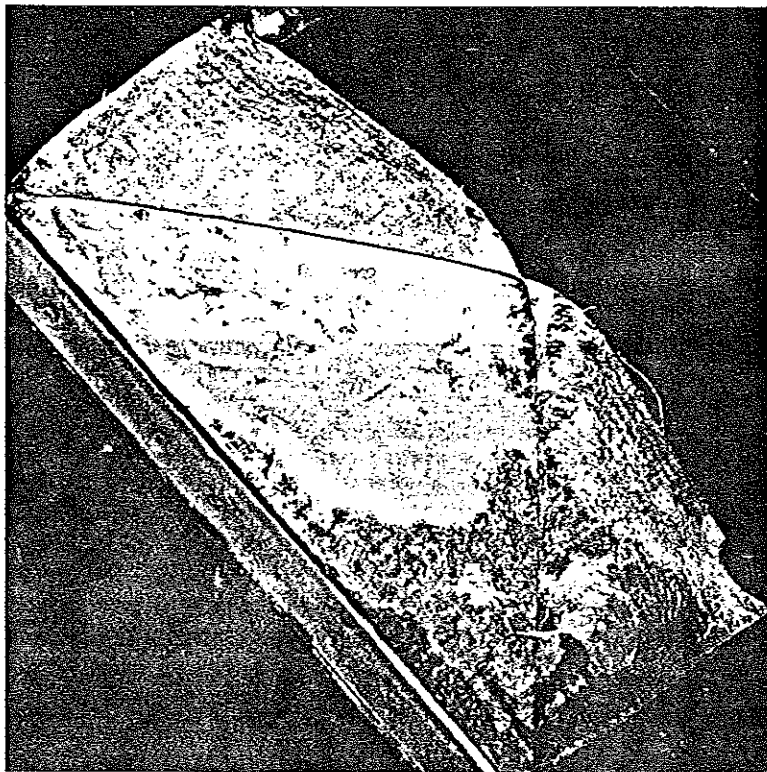
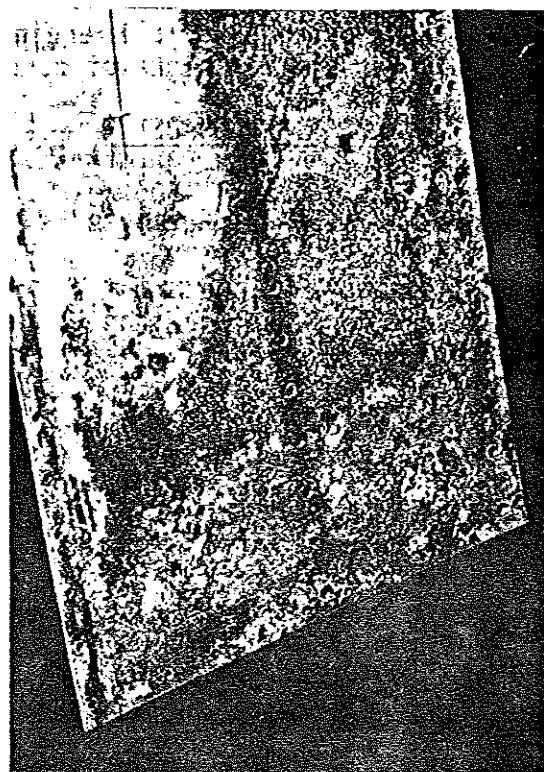
E1. WING WALKWAY PANEL CORROSION

During routine inspection, it was noticed that "bubbles" had appeared in the main plane walkway matting.

Following removal of the matting, significant corrosion was found to have occurred to the walkway panel.

If all of the "bubbles" found in a single walkway area can be depressed by hand and returned to normal skin contour, little or no skin corrosion is found when the rubber matting is removed. If one or more of the bubbles cannot be depressed, and a hard lump is found underneath, it generally indicates that oxidised aluminium powder has collected underneath and subsequent removal of the matting reveals skin corrosion in various stages. Although useful as a guide, this method of detection cannot be guaranteed.

In some cases, it was apparent that no surface preparation/priming had been applied to the skin prior to bonding of the walkway materials.

The entire panel was replaced and it was noticed that the replacement panel should have a "joggle" running the width of the panel and situated 1" away from the top and bottom of the panel. This facilitates the proper fitting around the ribs.

It is suggested that pilots and engineers inspect this area of the aircraft prior to next flight.

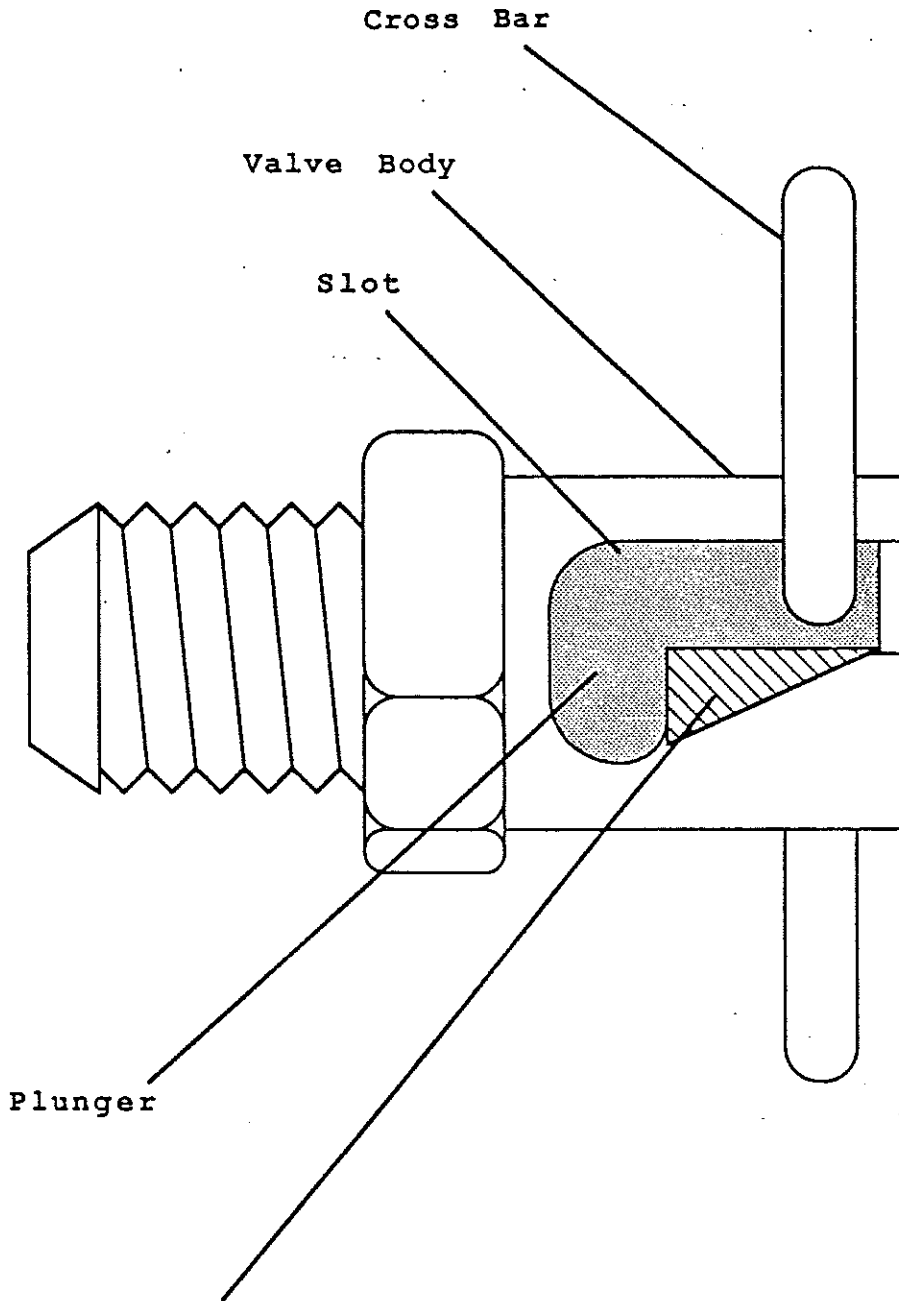
FIG 1

SCHEMATIC OF CURTISS DRAIN VALVE

Modification to prevent loss of fuel
after water checks. Drain Valve
modified to prevent it remaining 'OPEN'

Shaded area of slot for filing off in accordance with
CSE Service Bulletin 6/75 (schematic only)

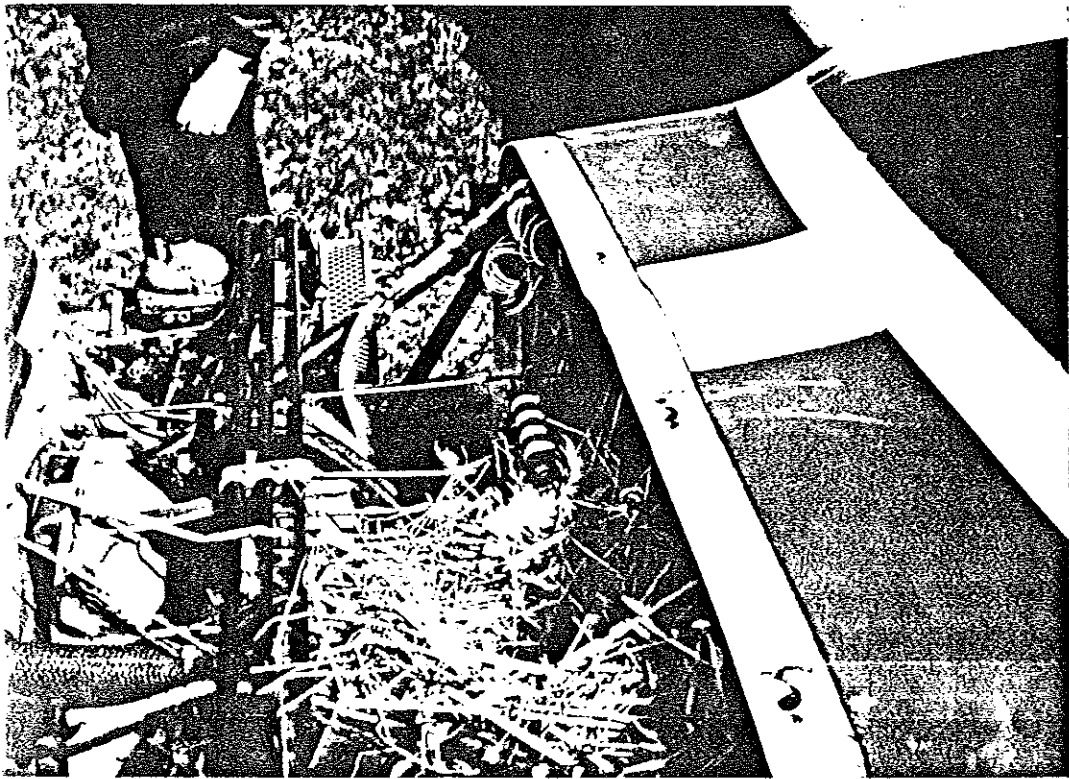
2.2 Birds in The Works The attached photo of a 7 day birds nestin marathon in a Grob 109 Powerplant at Shobdon, is worthy of attention by those who park inide or out?

BIRD'S NEST BUILT IN 7 DAYS!
