B.G.A. TECHNICAL COMMITTEE

TECHNICAL NEWSHEET

TNS 7/8/89

PART 1 AIRWORTHINESS "AGGRO"

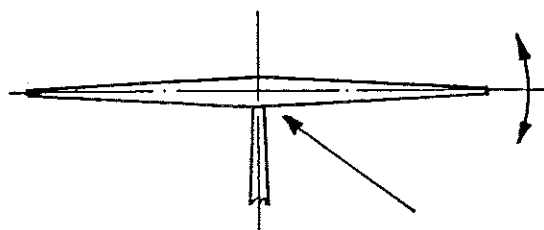
2. Check prior to each flight

± 15 daN (33 lbs.)

no permanent deformation is allowed

1b) Lift and pull down the tip of the all-
flying tailplane (aircraft rigged) with
ca. 150 N (33 lbs.) (see enclosure 2.).
If damage is detected no more flying is
allowed.

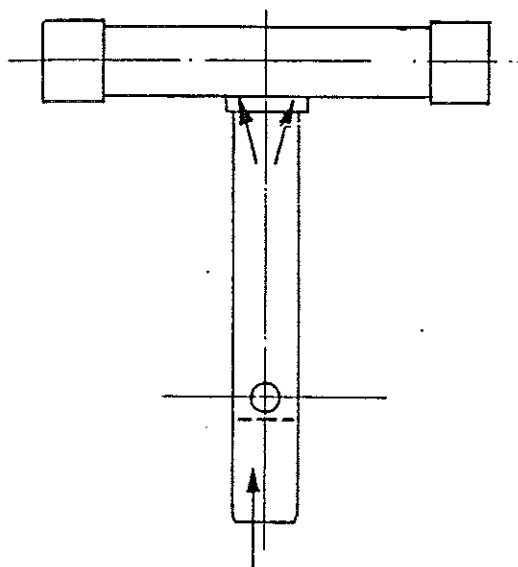
3. Inspection of the welding

REASON : On one DG-100 ELAN the main fitting L 4 of
the all-flying tailplane failed under violent
forces. Thereby it was detected,
that the welding was not done completely
over the whole wall thickness of the part.

This welding must be visible inside
the tube.

2) Inspection of the fitting L 4 for
correct welding (see enclosure 3.).
If the welding is o.k. instruction 1 may
be cancelled.
If a failure in the welding is detected
the fitting must be repaired according
to instruction 3. Until the execution of
instruction 3 further operation of the
aircraft is prohibited.

Inspect the welding in the edges
inside the tube by means of an Endos-
cope or an other suitable method.

If a plastic plug is glued into the
tube, the plug is to be removed and
to be glued into the tube after the
inspection and repair by use of metal
adhesive.
