BRITISH GLIDING ASSOCIATION

TECHNICAL COMMITTEE

TECHNICAL NEWSHEET 11/12/89

PART 1 AIRWORTHINESS "AGGRO"

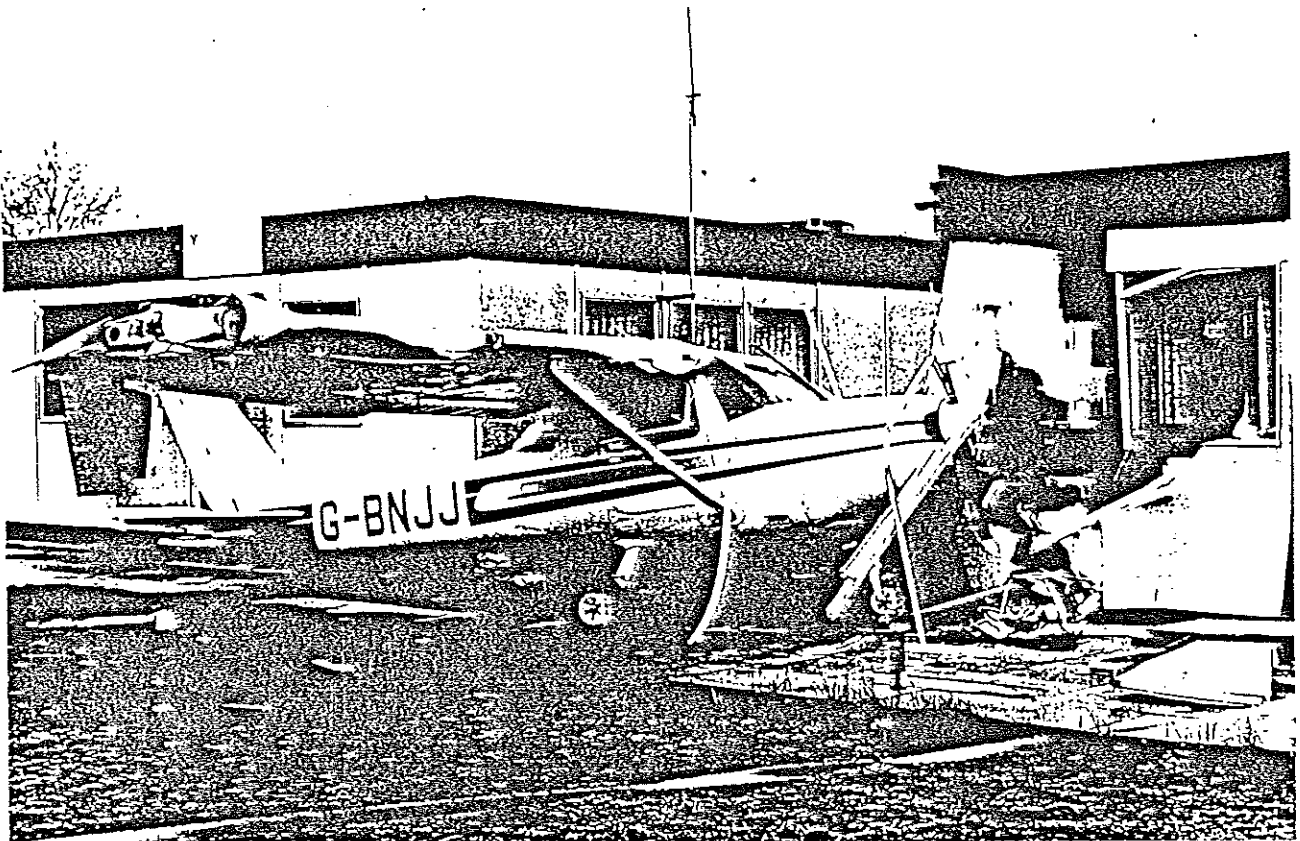
Aircraft : Cessna 152
Date : 8 May 1988

An aircraft cleaner, who had been given a limited amount of training on a Piper Tomahawk, was subsequently allowed to taxi a Cessna 152 in which he had no practical experience. He lost control of the aeroplane and, in a panic attempt to slow down the engine, he inadvertently selected full power. The aeroplane was finally halted when it crashed into a building on the airport.

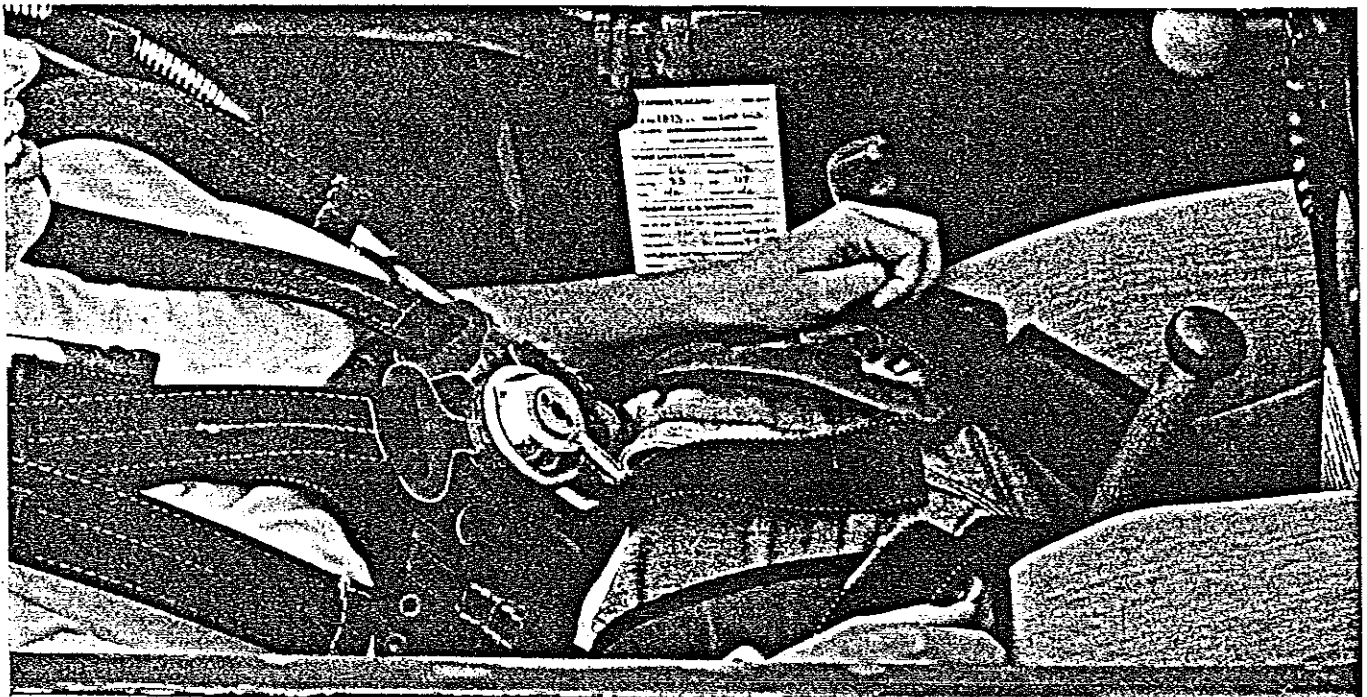
Pieces of the cockpit canopy and frame were identified in the wreckage and the distribution of the transparency pieces indicated that this had partially fractured in the air. The canopy locking mechanism showed that at impact, the canopy was still locked although when the pilot was removed it was noted that the lugs at the ends of the shoulder straps and one lap belt were not engaged with the buckle on the other lap belt. The pilot's lead ballast weight, weighing 43 lbs, was identified and was still attached to the lap retention cables, which had only failed in the final impact.

Subsequent to the accident, trials were conducted in a similar aircraft using a female subject of the same height and weight as the deceased. The ballast weight from the accident aircraft was fitted to the trial aircraft and it was demonstrated that it would not have interfered with the flying controls. The four point safety harness was adjusted to the same size as that in the accident aircraft and the subject was strapped in using cushions from the accident aircraft and a parachute of the same type as that used by the deceased. It was found that the harness was a loose fit with the buckle sitting high up on the torso and that with pilot movement the cushions moved allowing further slackening of the harness. When simulating the forces that would be present with the aircraft vertical, it was found that the subject's body could slide through the harness forcing the control column forward (see photograph). The gap between the lower edge of the rudder pedals and the cockpit floor was sufficiently large to allow the subject's feet to pass beyond the pedals to an area where there was no support for the feet with the aircraft vertical. Had the deceased got into this position in the air there would be little chance of her regaining control of the aircraft. The flight path of the aircraft during its final dive was consistent with the pilot being in this position. It was determined that it was possible to jettison the cockpit canopy from this position. There was no evidence of any attempt having been made to jettison the canopy.
