B.G.A. TECHNICAL COMMITTEE

TNS 1/2/90

PART 1 AIRWORTHINESS "AGGRO".

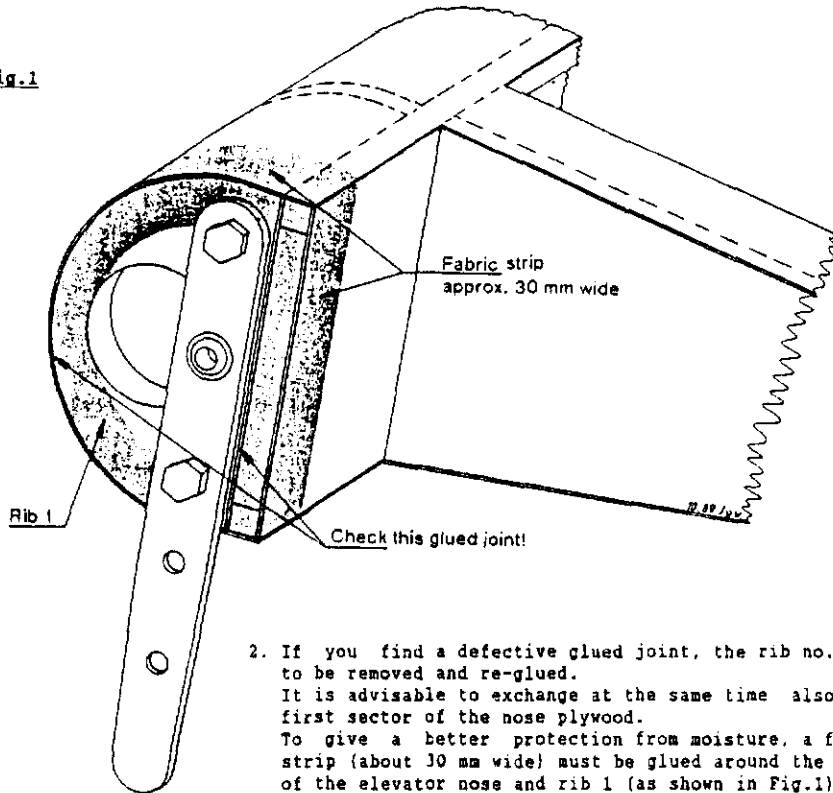
Fig.1

A glider of the model K7 failed to gain normal flight attitude immediately after tow rope release on winch launch. With the stick full back only the left elevator could be actuated in the correct direction; the right elevator deflected downwards. The reason for this was a loose glue bond at the elevator rib 1 at which the elevator fitting is attached. Similar incidents lead already before to the issue of the LTA 72-7 dated Feb.9,1972.

1. Remove elevator.  
Check that the glued joint between rib 1 and the leading edge plywood and the elevator spar respectively is in good condition (see Fig.1). Before doing so check whether the LTA 72-7 of Feb.9, 1972 was already previously accomplished (this is not applicable to K9, K11 and ASK 18); if yes then the fabric strip first carefully has to be detached in order to be able to check the glued joint.

2. If you find a defective glued joint, the rib no.1 has to be removed and re-glued. It is advisable to exchange at the same time also the first sector of the nose plywood. To give a better protection from moisture, a fabric strip (about 30 mm wide) must be glued around the edge of the elevator nose and rib 1 (as shown in Fig.1).
3. The above action under points 1. and 2. must be repeated every three years during the annual re-inspection. This copy of the Technical Note must be inserted in the Flight and Operations Manual of the respective glider as an annex and a corresponding entry must be made into the "Amendments to the Manual".

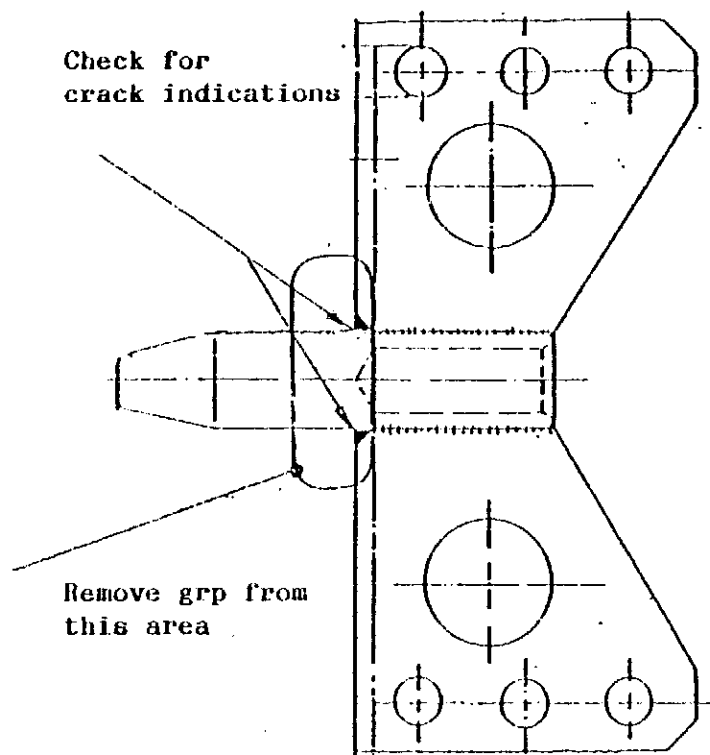
G109 SPIGOT FITTING

006-10-88		<u>Spar stub end fittings</u> - Cracks at or near the toe of the weld on the top and bottom surface of the spigot.	Applicable to all G109 and G109B Series motor gliders. Compliance is required not later than 50 flying hours from the receipt of this Directive.
-----------	--	--	--

- (i) Remove the wings in accordance with the Flight Manual instructions.
- (ii) Remove the glass reinforced plastic (grp) or the protective lacquer covering the spar stub extremity, avoiding any damage to the metal parts, sufficient to expose the top and bottom weld ends and the weld transition into the spigot body - see figure A.

<u>CAA AD No</u>	<u>Associated Material</u>	<u>Description</u>	<u>Applicability - Compliance - Requirement</u>
006-10-88 (continued)			<p>(iii) Inspect the end of the weld and the spigot itself at the toe of the weld for cracks, using a x10 magnifying glass (four places) - see Figure A. There are two spigots per aircraft and cracks can occur on the top and on the bottom of the spigot.</p> <p>(iv) If a crack is suspected, and appears to be confined to the weld itself, ie does not extend circumferentially into the spigot, or where there is a lack of weld penetration, the wings may be replaced. The aircraft may be flown to a place where the existence of cracks can be confirmed or otherwise by NDT means, by an Organisation approved for that purpose by the CAA. The flight must be conducted with the pilot only on board. Abrupt manoeuvres and/or high speeds are prohibited. If a crack is confirmed either in the weld only or in the spigot itself, rectification must be carried out to the manufacturer's approved repair scheme before further flight. Report the results of the inspections to the manufacturer and to the SDAU of the CAA.</p>

<u>CAA AD No</u>	<u>Associated Material</u>	<u>Description</u>	<u>Applicability - Compliance - Requirement</u>
006-10-88 (continued)			(v) Where the spits are found to be not cracked either after the actions of (iii) or (iv) above, reprotect the area where the grp has been removed, either with a lacquer or a brushed coat of epoxy resin. Replace the wings to the instructions in the Flight Manual. Repeat the instructions commencing at (i) above except that only the reprotection has now to be removed, at intervals not exceeding 300 hours.
