BRITISH GLIDING ASSOCIATION

Technical Committee

TNS 5/6/90

PART 1 Airworthiness "Aggro" - Please add to the BGA 1990 Yellow Pages.

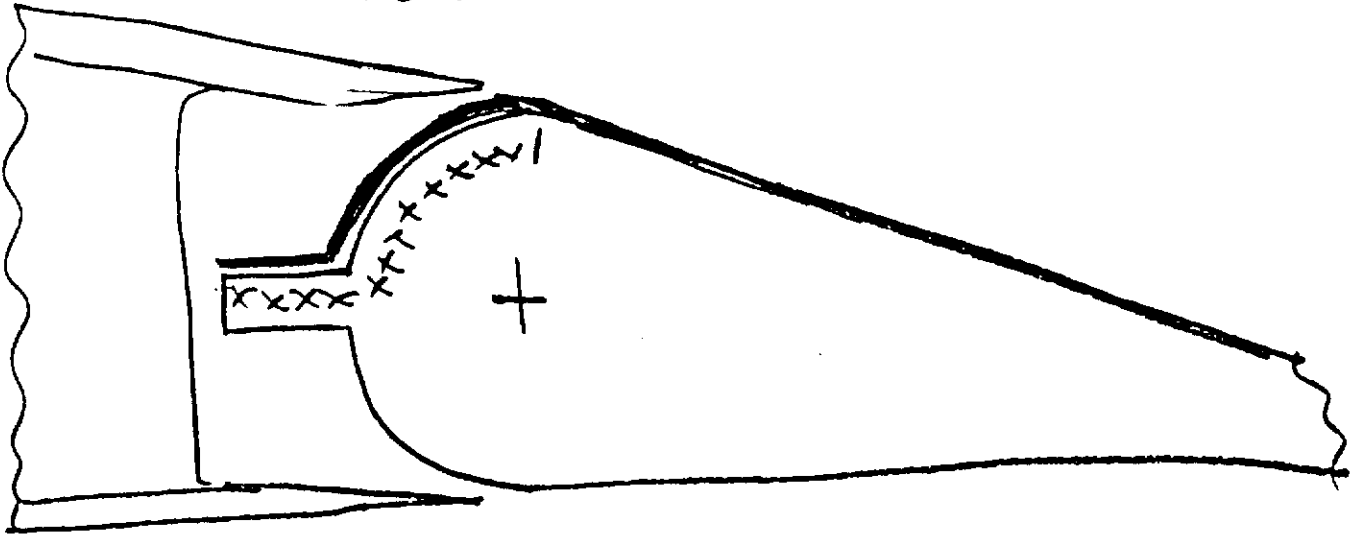
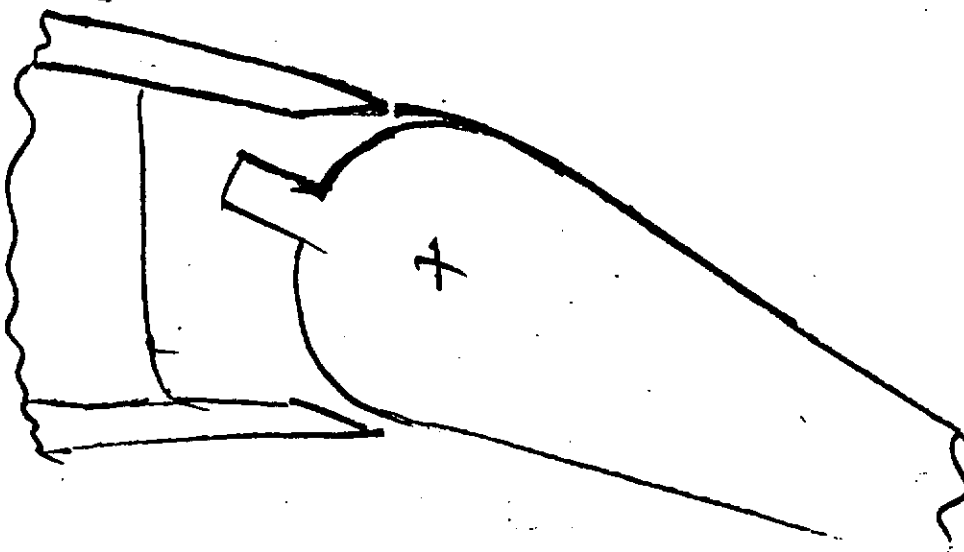
①  
KESTREL AILERON GELCOAT DETACHMENT -  
POTENTIAL CONTROL JAM.

1.2 Kestrel Aileron - possible foul from gel-coat detachment - Sketch by Chris Batty is self explanatory.

TOP SURFACE OF AILERON HAD BEEN SPRAY  
GELCOATED (VERY THICK) ON TOP OF  
MOULD APPLIED GEL COAT.

IN SHROUD RADIUS (MARKED XXXX)  
GEL COAT HAD COMPLETELY DETACHED AND  
STARTED TO BREAK UP.

AILERON JAM COULD RESULT FROM  
LOOSE GELCOAT IN SHROUD BOX  
OR BY FREE EDGE, THUS:

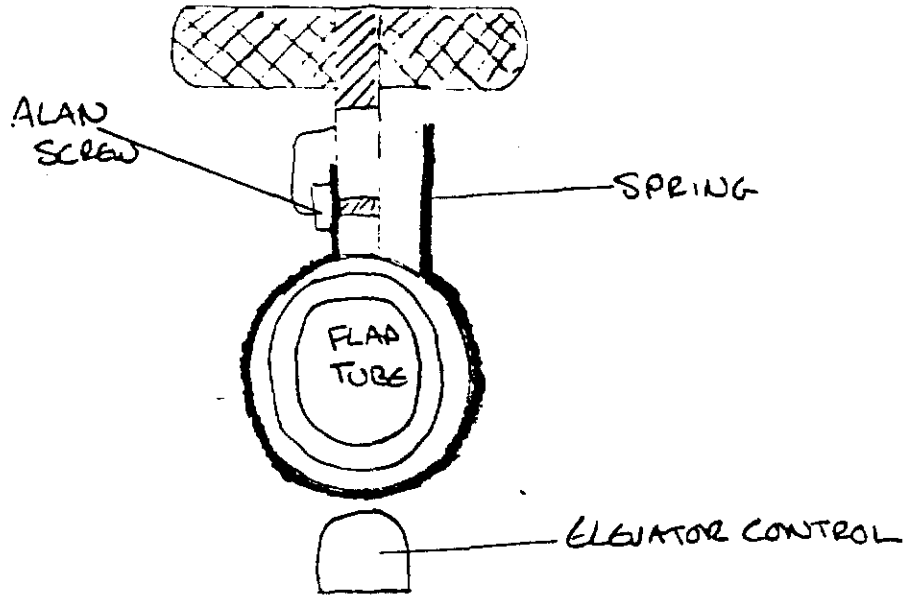
PIK. 20 D

1.3 Pik 20D. Elevator foul in cockpit. Flaplever leaf spring found to be loose and fouling the elevator control, when flaps in a negative position. (Reported by Peter Kingsford. Sketch herewith).

Resealed with Loctite

The elevator control should be checked for full movement with the flap lever in full negative position and full positive position before every flight.
