BRITISH GLIDING ASSOCIATION

BGA TECHNICAL COMMITTEE

TECHNICAL NEWSHEET TNS 7/8/90

CAA EMERGENCY AIRWORTHINESS DIRECTIVE 004-06-90  
PIPER PA-25, PA-25-235 AND PA-25-260 AIRCRAFT  
INSPECTION OF TAILPLANE ATTACHMENT FOR CRACKS

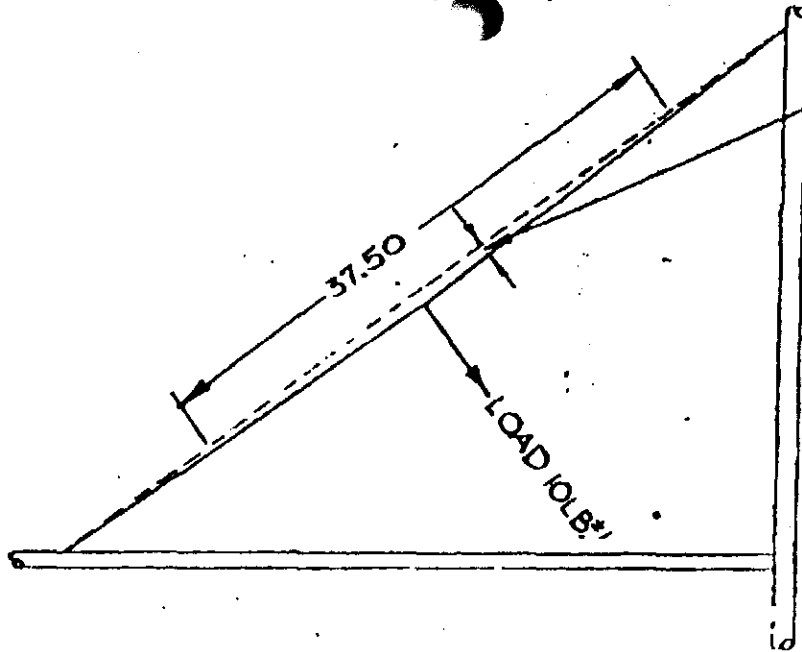
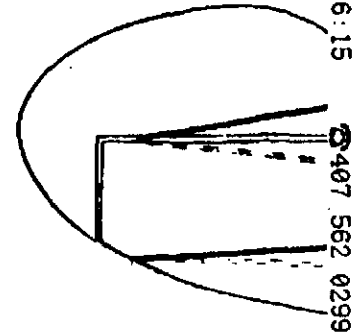
FIGURE 3  
1 1/2 IN. = 1 FT.

ADJUST TO OBTAIN  $.437 \pm .06$  DEFLECTION WITH LOAD APPLIED AS NOTED.

WITH AIRPLANE IN LEVEL POSITION & THE TAIL WIRES ADJUSTED AS NOTED ABOVE. THE REAR SPARS OF THE STABILIZER SHALL BE LEVEL; THE ELEVATOR HINGE LINE STRAIGHT. THE FIN SHOULD BE VERTICAL AT THE RUDDER  $\phi$ .

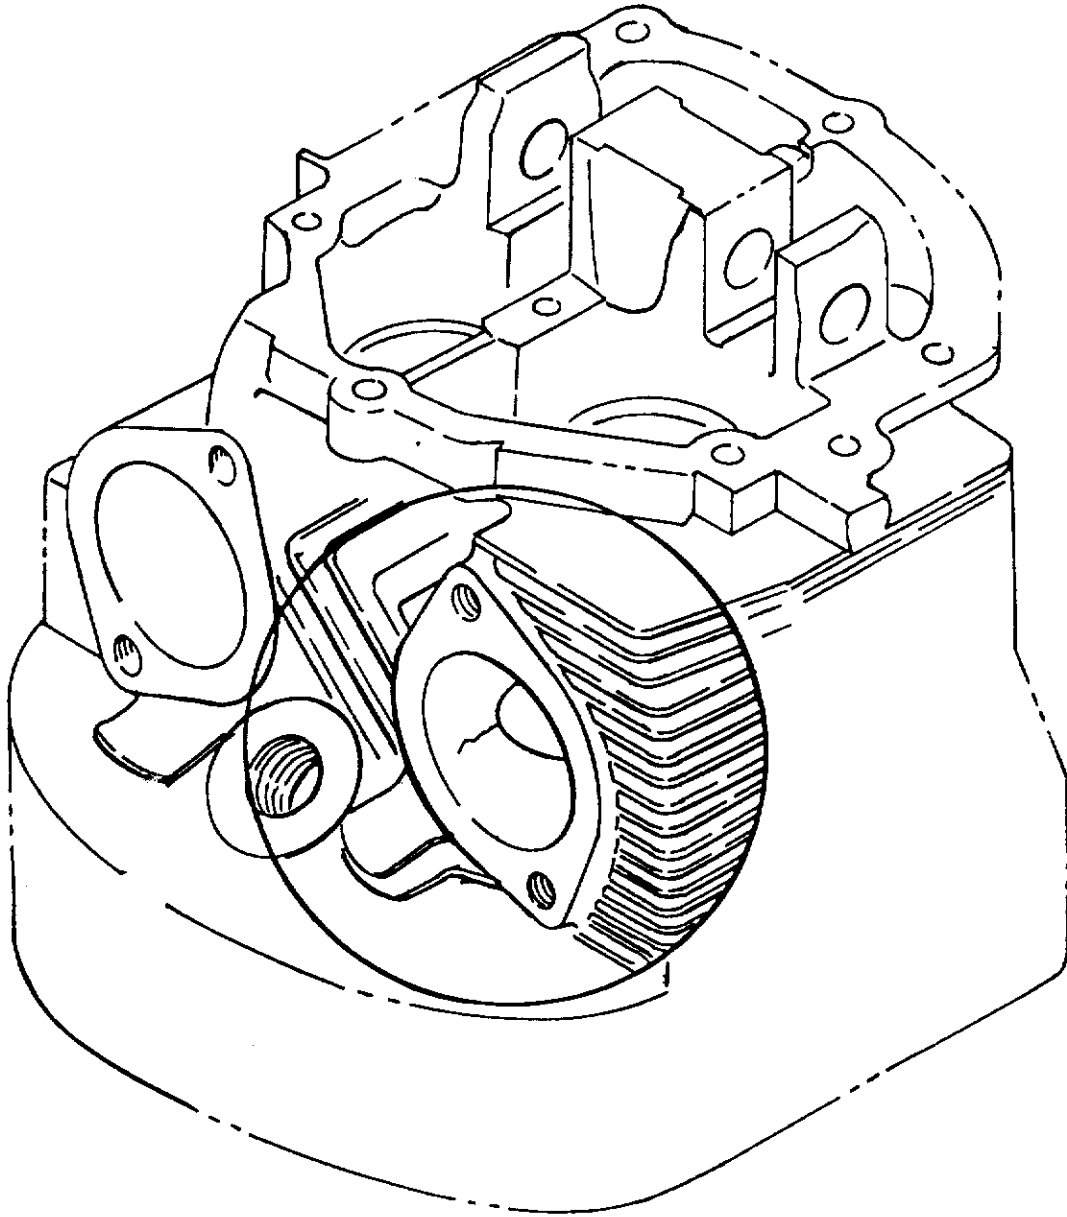
Figure 1. View of Exhaust-Port Area Prone to Cracking

Field inspections have revealed that the cylinder-head exhaust port area on some parallel-valve cylinders reconditioned in the field may be prone to cracking. The cracking is confined to the left side of the exhaust port, next to the spark plug hole (see Figure 1).

Because the cracking may be of such a fine configuration, it can be difficult to detect visually. Therefore, a dye penetrant must be used for inspection purposes. After the dye penetrant has been applied to the left side of the exhaust port, the root areas of the fins next to the spark plug hole can then be inspected for dye seepage.

Textron Lycoming advises replacement of the cylinder-head/barrel assembly, if cracking is evident.

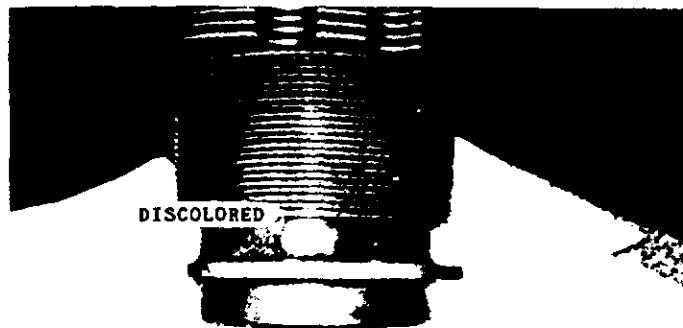
There have been several reports of engines which were utilizing the TCM steel insert piston experiencing failure. The piston/cylinder failure is sometimes preceded by cylinder discoloration and paint burning off the base of the cylinder in a triangular shape toward the cylinder head. Impending failure is sometimes accompanied by a tapping sound similar to that of a collapsed lifter, high oil temperature, and high cylinder head temperature. Upon disassembly after failure, severe piston scuffing below the third ring, (possibly indicating insufficient clearance) is often evident. Part times since new range from 1.5 hours to 40 hours.

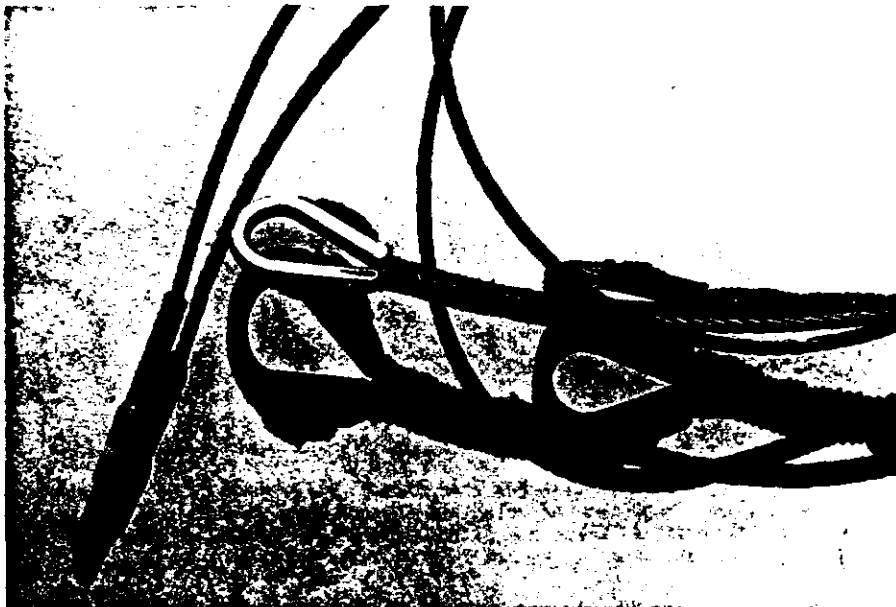
When the engineer tried to fit the flap cable he found that the thimble and the string binding made it too large to fit through the locating hole in the wing ribs. In addition, when it was attempted to tighten up the turn buckle, he found that the threads were of a different type and that the threaded section was of such poor metal that it sheared as soon as any pressure was applied.
