BRITISH GLIDING ASSOCIATION

BGA TECHNICAL COMMITTEE

TECHNICAL NEWSHEET TNS 9/10/90

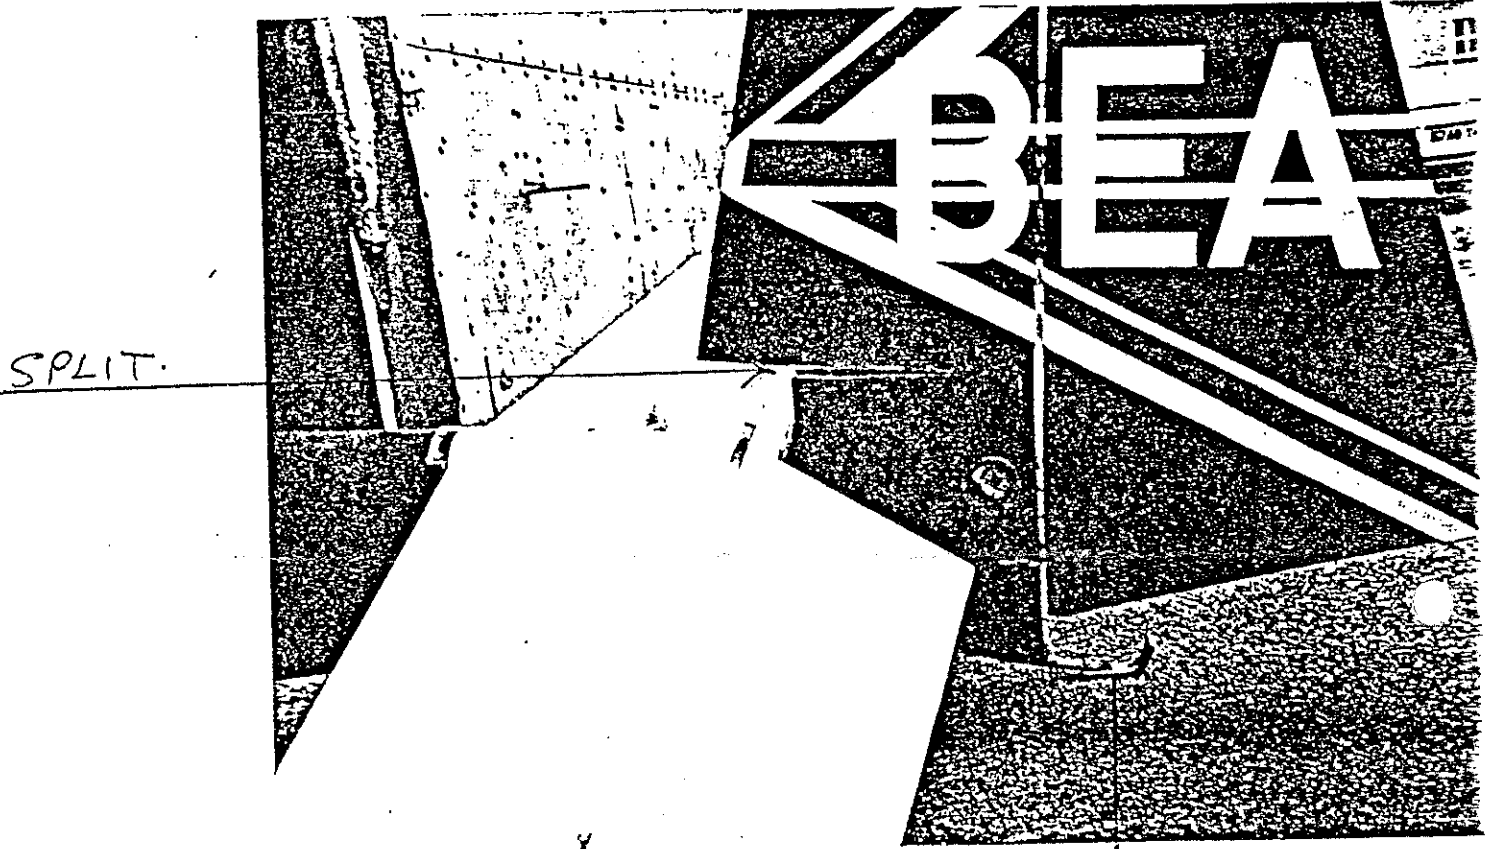
SKYLARK FIN FAILURE.

- 1.4 Skylark - horizontal split in the fin (see diagram). May have been induced by "Shock Load" after tailskid snagged on landing. (RAFGSA Bannerdown).

SPLIT.

POSSIBLE SNAGGING
OF
TAIL SKID?
