BRITISH GLIDING ASSOCIATION

BGA TECHNICAL COMMITTEE

TECHNICAL NEWSHEET TNS 11/12/90

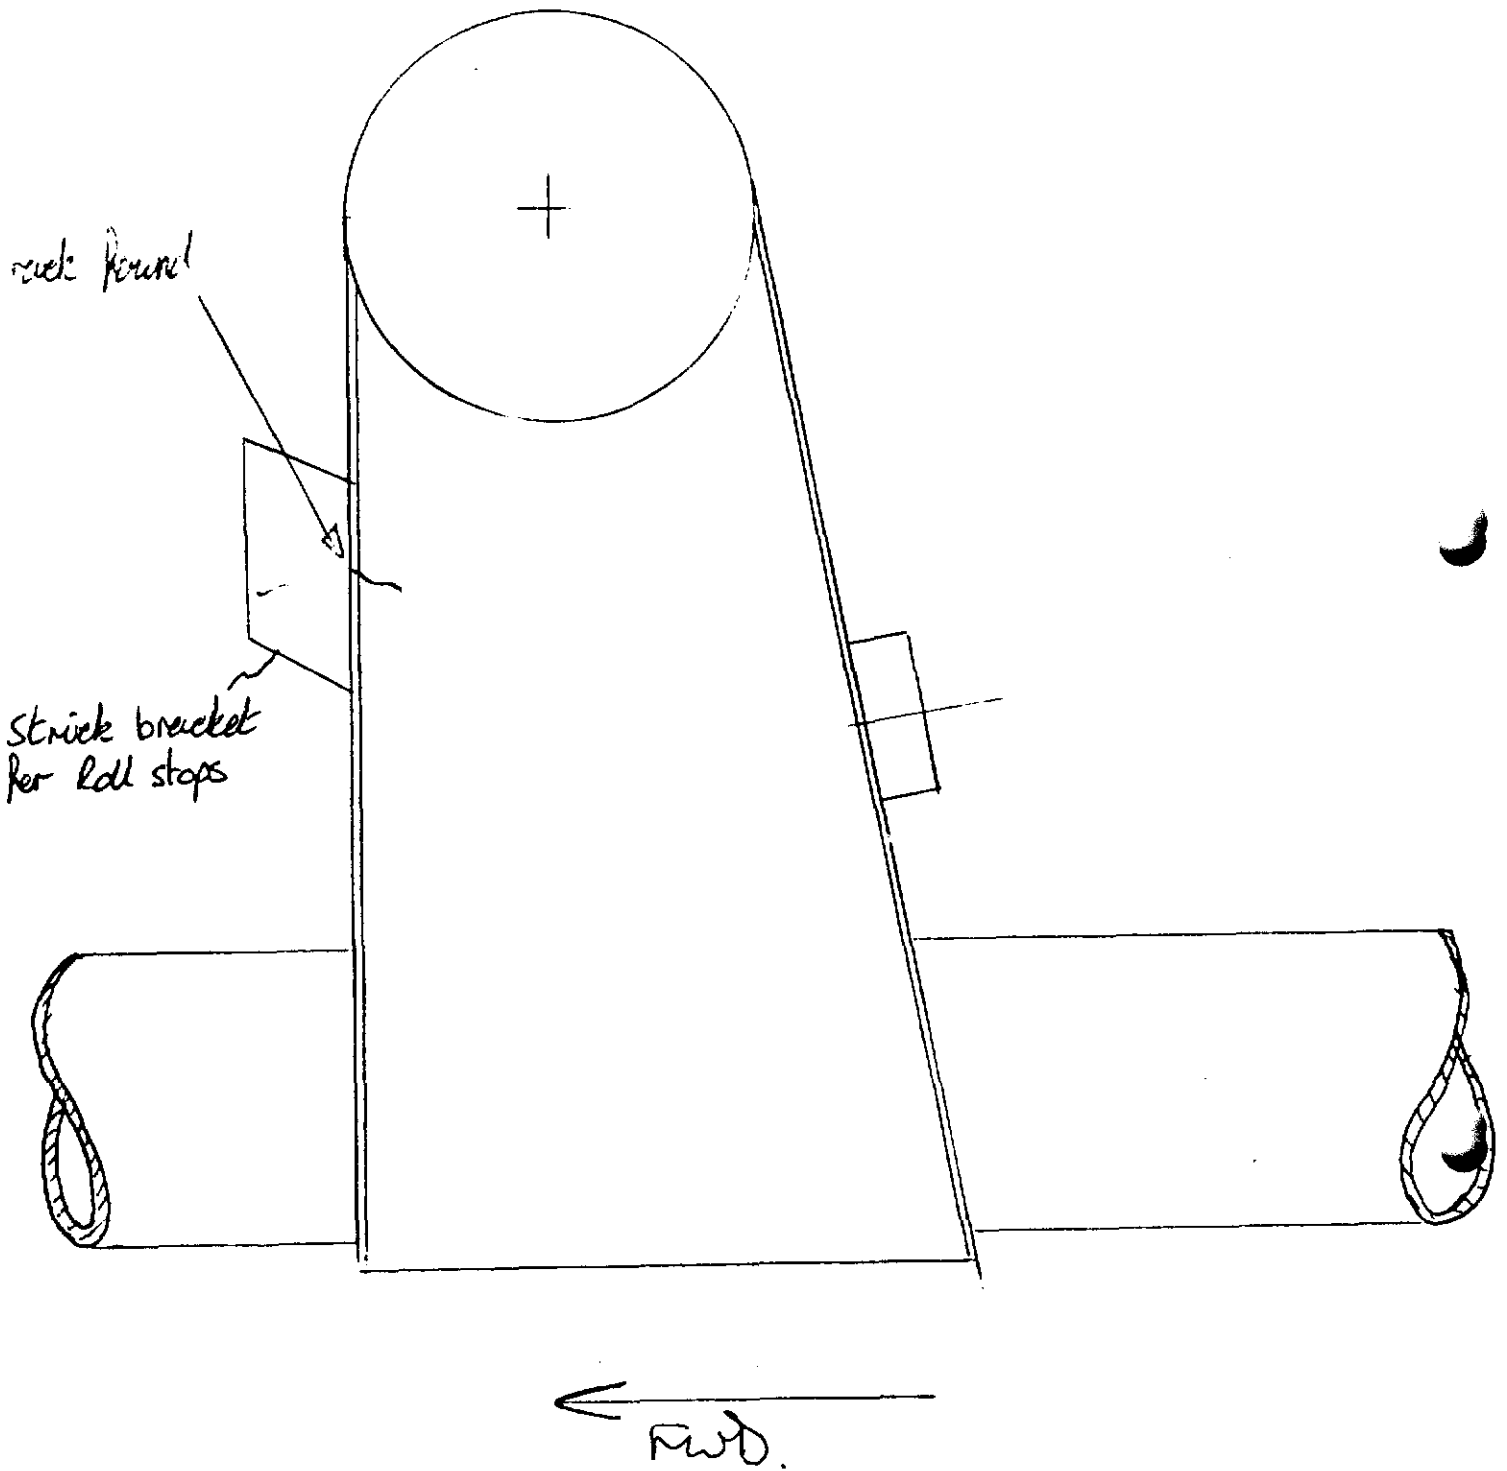
SLINGSBY TWS SWALLOW COCKPIT TORQUE TUBE/YOKE ASSEMBLY  
FOUND CRACKED AS SHOWN ABOVE. NK BGA NO 921.

TE:- To remove the torque tube for repair it is necessary to remove the four taper pin in the rear section. New taper pins Part No SP31/L16 are available from LIGHT AERO SPARES LTD, SHEBBEAR, BEAUCORTHY, DEVON EX21 5LR.  
TEL. 040-928-578 and 610.
