BRITISH GLIDING ASSOCIATION

BGA TECHNICAL COMMITTEE

TECHNICAL NEWSHEET TNS 3/4/91

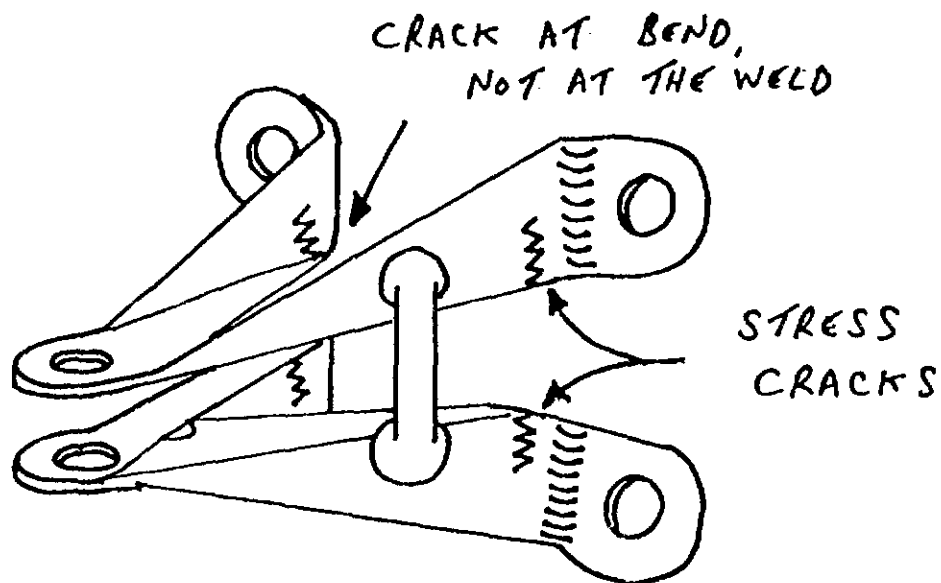
K8 LOWER RUDDER BRACKET.

- 1.1. KA8 Lower Rudder Brackets. Cracks at the weld as illustrated. (Reported by Cambridge G.C.).
- 1.2. G.9 Security Parachutes (USA). If any of these are in the UK, please refer to FAA A/D 91-02-05 herewith.
- 1.3. JANTAR STD II. Elevator Bell Crank corroded. Found only by removal of the Rudder. Water fails to drain from the top well of the Rudder. (Reported by Colin Jacques - E. Sussex).
- 1.4. Lightning Strike Protection - Bonding of essential metal components e.g. controls, cable releases etc. Continuity should be checked annually. (Reported by Martin Carolan).
- 1.5. Weak Links - Issue 3 of the BGA list is included herewith, amended as indicated. Thanks to our readers for the information.

DAMAGE caused by Rudder BLAMING
in strong winds?

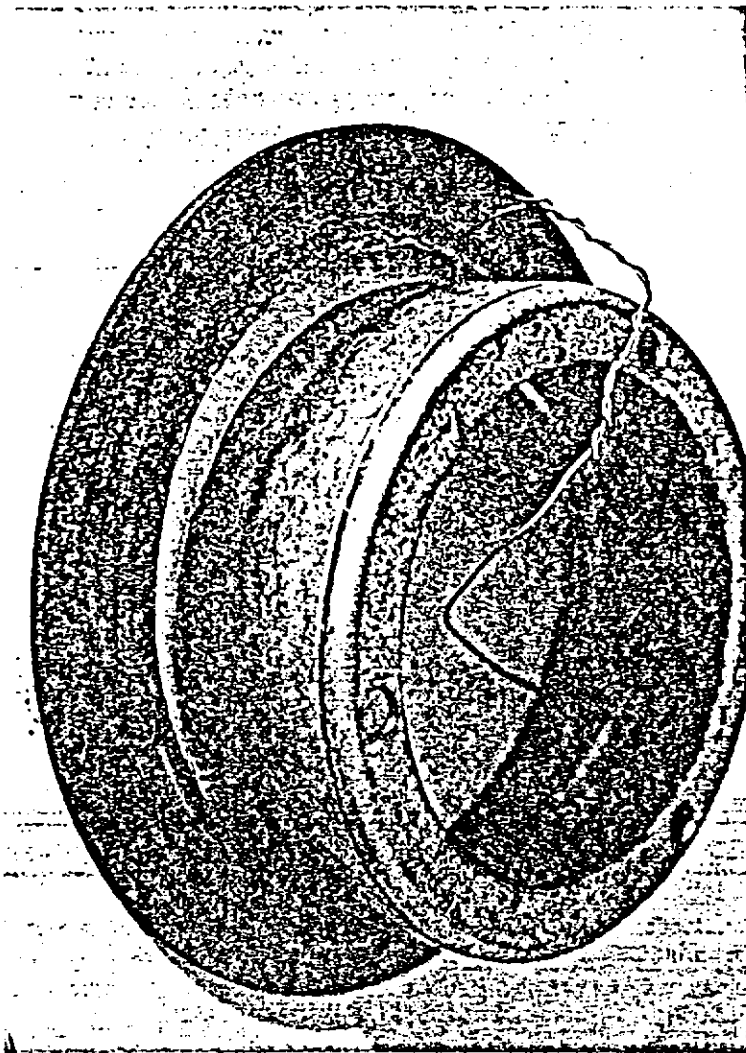
1. FRACTURED BRAKE DISC

After an uneventful flight and landing, the pilot turned off the runway to taxi back to the hangar. When the pilot applied the brake, there was no braking effect at all so he shut down the engine.

It soon became apparent that the weld between the brake disc casting and the pressed steel back plate had sheared. After removal it was noted that the area was extensively corroded.

On some assemblies the joint is brazed and not welded.

Corrosion of these discs is a well known problem although the Authority has not had many reports of the brake disc shearing. The problem does seem to be worse on low utilisation private category aeroplanes, particularly those with wheel fairings. Regular inspection and perhaps replacement with stainless steel or chromium discs is the best prevention, but change the pads at the same time.
