BRITISH GLIDING ASSOCIATION

BGA TECHNICAL COMMITTEE

TECHNICAL NEWSHEET TNS 1/2/91

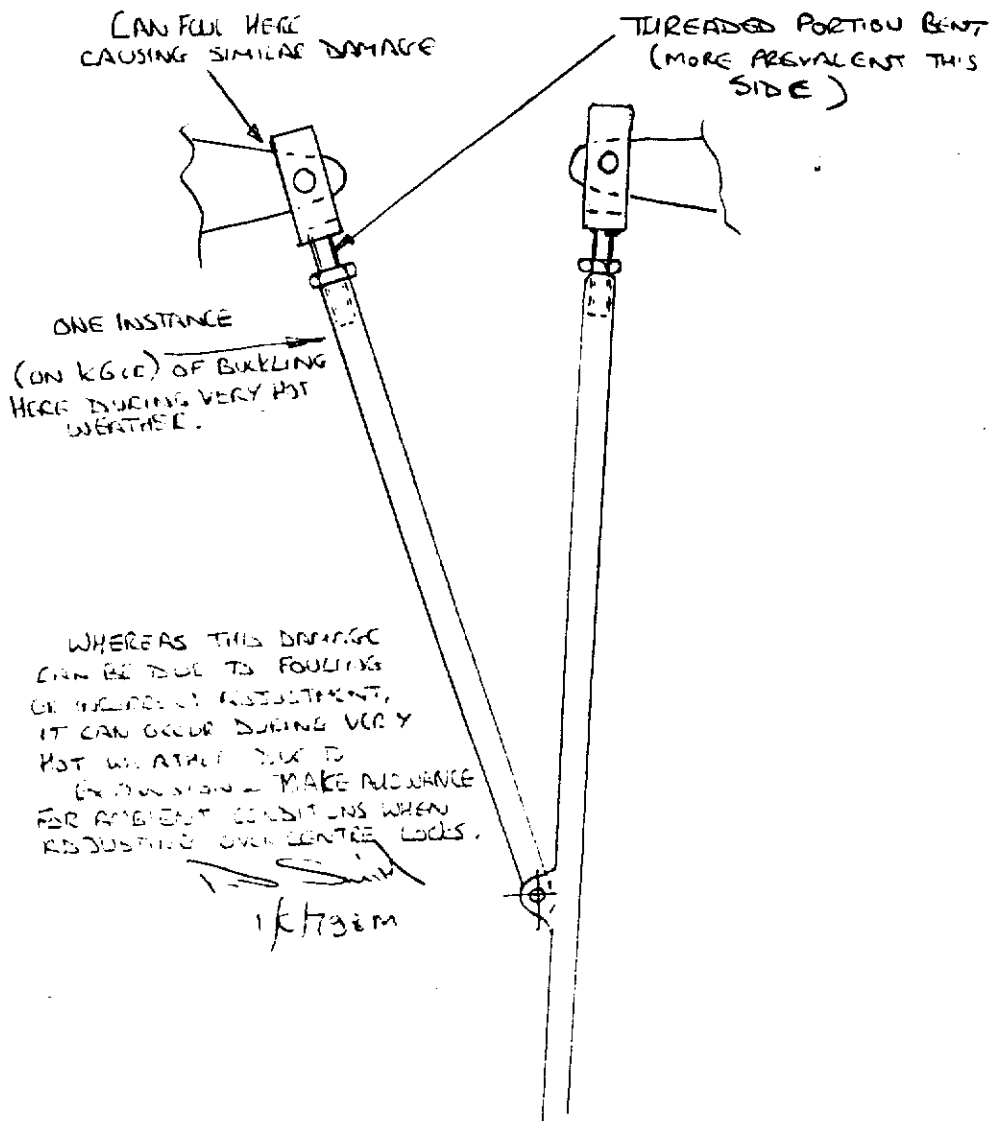
BENDING OF AIRSPACE PUSHRODS K6, K8, K7

- 1.4 KA 6, 7, 8 Airbrake Push Rods (Bending) - Sketch from I.D. Smith, is self explanatory.
- 1.5 L'Hotellier Control Connectors - R.D. AVIATION have a supply of "Sticky" transfers as illustrated herewith, to remind you how to connect your controls correctly (Call 0865-841441 for details).

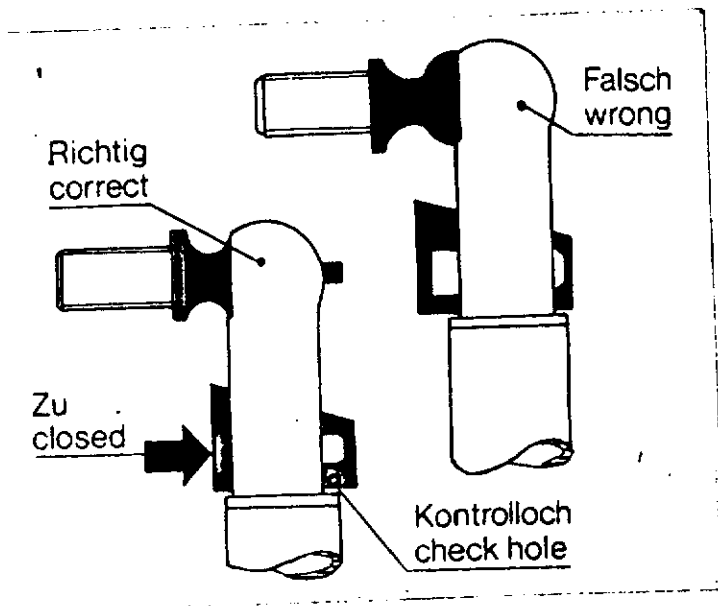
L' Adellier Connectors

Why not plaster these
"Stickers" whenever you
have a connector?

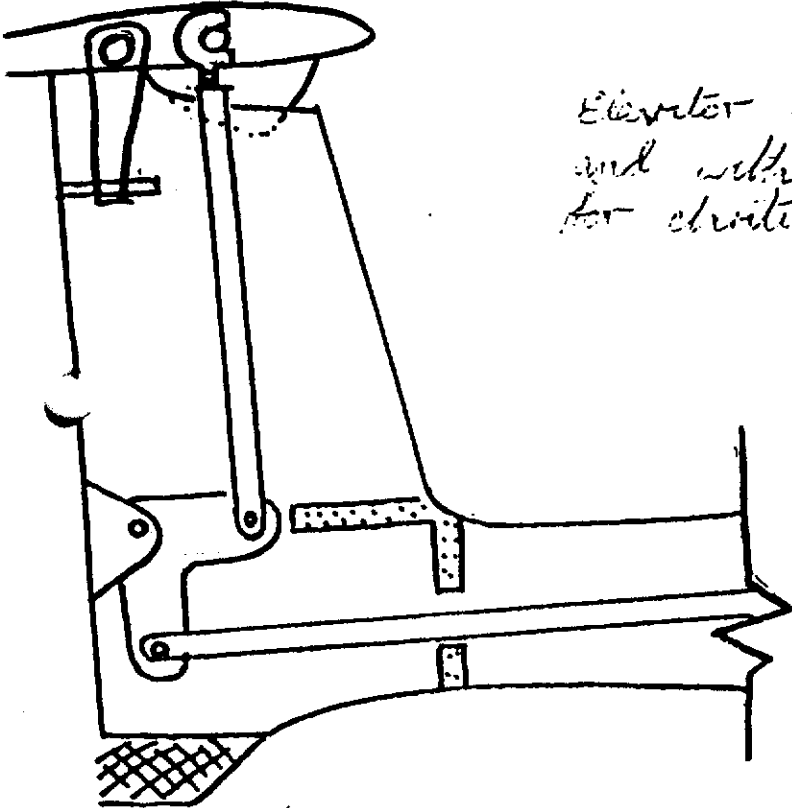
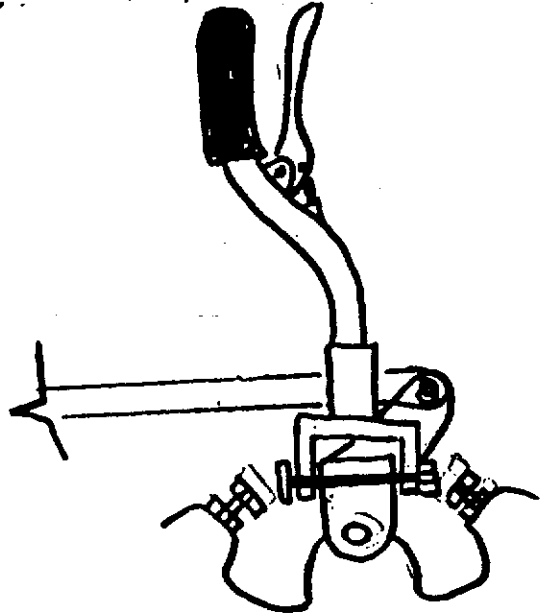
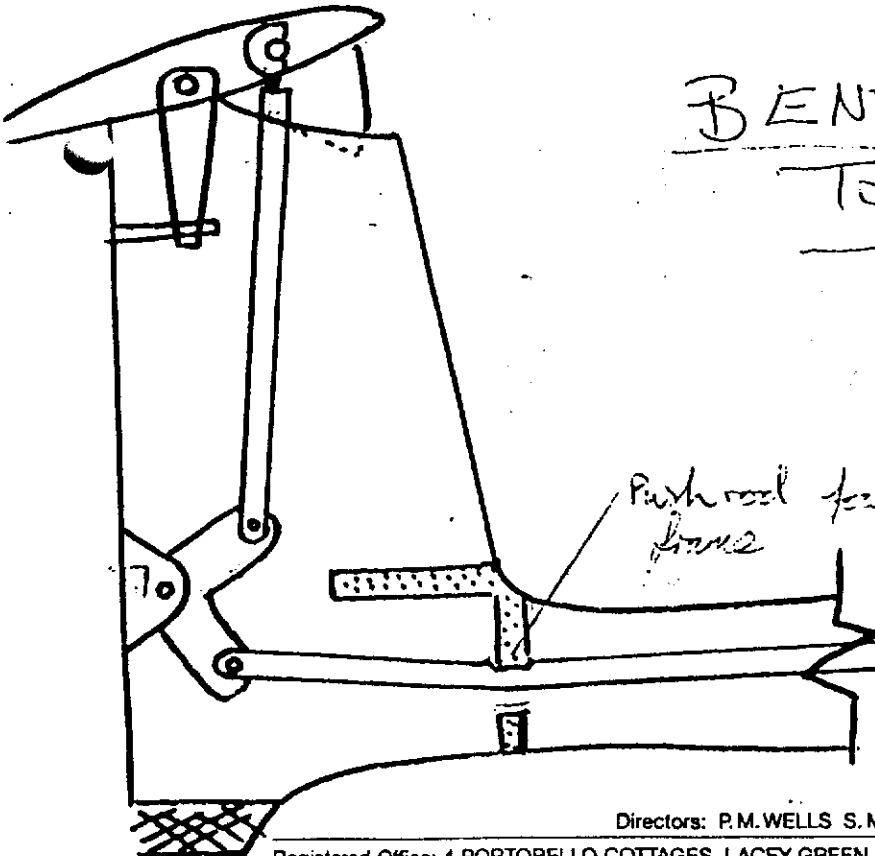
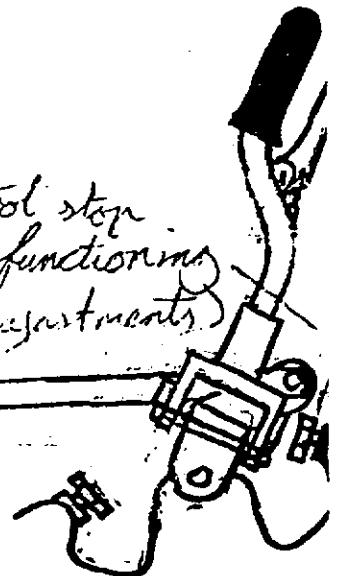
STND CIRCUAS B & A 1621

- 1.2 STD CIRRUS - Bent Elevator Push Rod fouls in frame at base of fin. (Reported by Peter Wells with diagram).
- 1.3 Bocian - Indications of "sloppy" airbrake operation on the ground, subsequently leading to failure in flight, caused by a fracture of the handgrip below the side of the front seat. (Reported by Coventry G.C.).

BENT PUSHROD
TO ELEVATOR

control stop not functioning (out of adjustment)

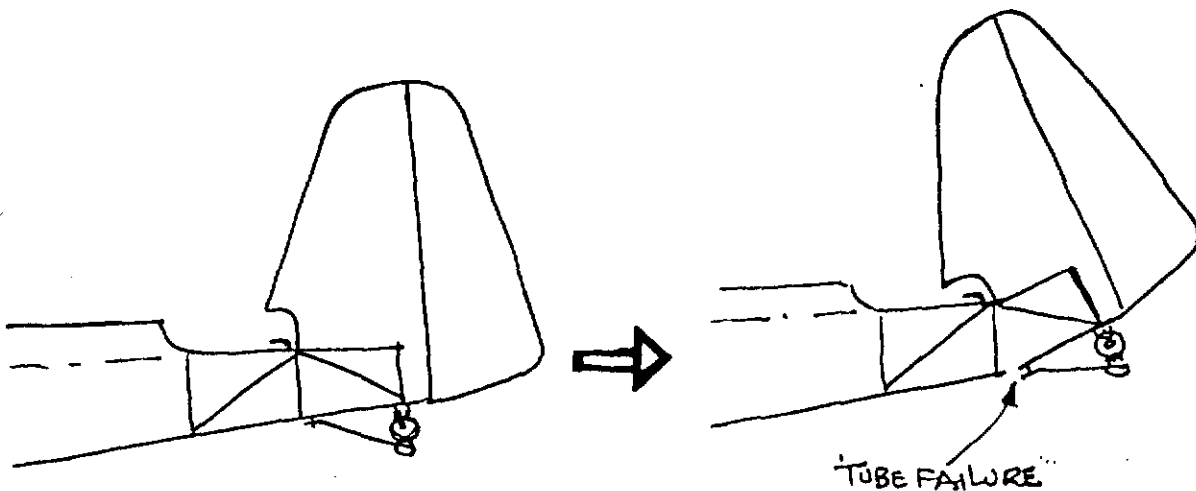
A. K13 "DMX"

WHILST ON LOAN TO ESSEX & SUFFOLK CLUB THIS GLIDER SUFFERED A FAILURE OF THE TUBES AT THE TAILSKID FRONT BOLT ON LANDING : AS PER SKETCH.

INSPECTION OF FAILURE SHOWED THIS TO BE FATIGUE PROBABLY INITIATED BY A HEAVY IMPACT OF THE TAIL SKID SOMETIME PREVIOUSLY - WHICH HAD NOT BEEN REPORTED. IT WAS NOTICED, ON STRIP DOWN, THAT THE TAILSKID FRONT BOLT HAD BEEN TIGHTENED SUCH THAT IT WOULD NOT ARTICULATE AS RUBBER DEFLECTED.

THIS WOULD INDUCE EXCESSIVE BENDING LOADS IN BOLT & ACCELERATE FAILURE.

SINCE THE ABOVE FAILURE PARTICULAR ATTENTION HAS BEEN PAID TO THIS AREA BUT 2ND "FAILURE" WAS ONLY NOTICED WITH GLIDER ON LAUNCH LINE IDENTIFIED BY BUCKLING OF FUSELAGE FABRIC. THIS GLIDER HAD HAD A BROKEN BOLT SOME TIME PREVIOUSLY. THERE WAS NO EVIDENCE OF TUBE DISTORTION AT THE TIME TH. BOLT WAS DRILLED OUT.

All such tubular structures may deteriorate significantly with both age (corrosion) and usage (damage and fatigue). Fabric should be removed for a detailed inspection.

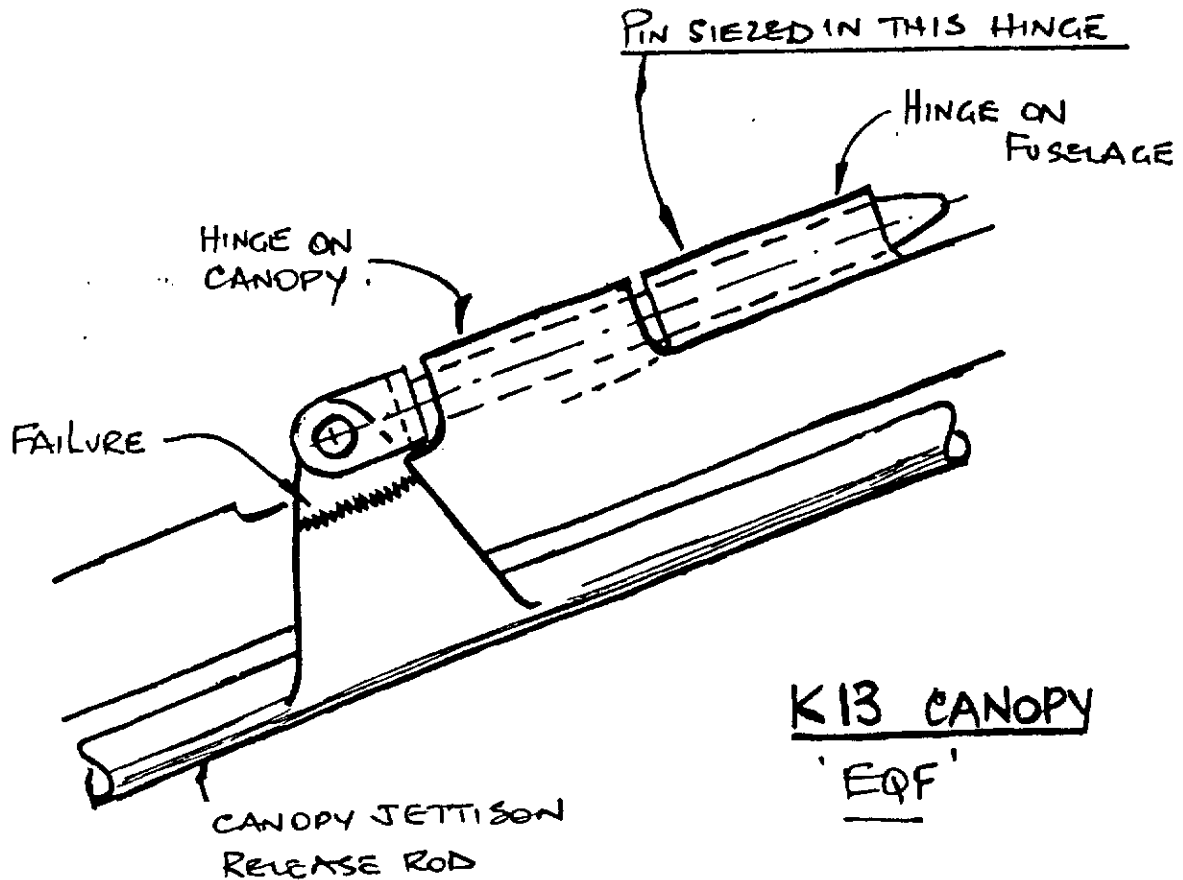
CANOPY JETTISON. K13

K13. FAILURE OF FORWARD OPERATING BRACKET
ON CANOPY JETTISON ROD; CAUSED BY SEIZURE
OF THE HINGE PIN IN FUSELAGE PORTION OF
CANOPY HINGE. DISCOVERED ON DE-RIG OF
GLIDER: FAILURE HAD BEEN OVERLOOKED ON DI.
ALTHOUGH HINGE WAS STILL OK THE CANOPY JETTISON
WAS INOPERATIVE IN THIS CONDITION.

BGA NOTE. LUBRICATION IS REQUIRED.!!

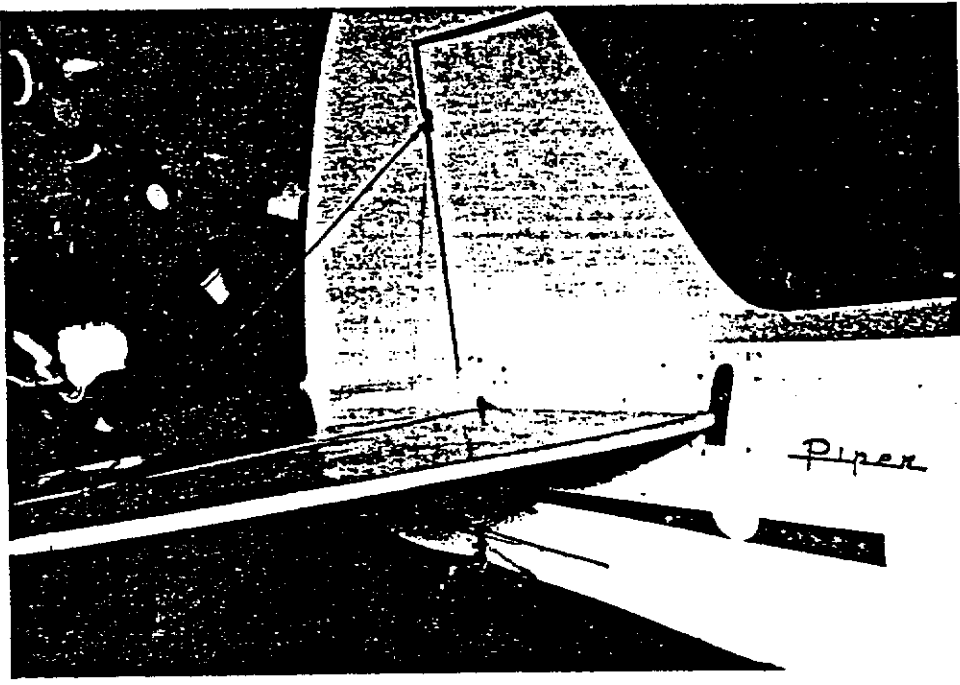
A Piper Pawnee 150 suffered an inflight tailplane attachment failure. Fortunately, the pilot managed to land the aircraft safely, although the landing was somewhat heavy.

The failure was caused by the fracture of the attachment tube to which the front spar of the right tailplane was attached. An Alert Airworthiness Directive was subsequently sent to all Piper Pawnee operators and the responses indicated that, although there had been no other incidents of front spar attachment failure, there had been a number of cracked rear spar attachments. The Airworthiness Directive was revised to include both spar attachments and to include repetitive inspection.

However, discussions with operators revealed that Piper Pawnee aircraft are often moved by lifting the tailplane prior to wheeling the aircraft and, because the 150 h.p. variant is only wire braced at the rear spar, (unlike the 235 and 265 versions which are wire braced at both spars), very high stresses can

be induced in the attachment tubes. Stress calculations have been carried out for maximum weight at maximum aft centre of gravity and, assuming two people are lifting by grasping the tailplane leading edge at points well away from the fuselage side the result is very high bending stresses which are thought to be the main contributory factor to

It is recommended that, if Piper Pawnee aircraft are moved by lifting the rear end, the tailplane is grasped at points immediately adjacent to the fuselage. The same advice also applies to Piper PA18 and PA22 aircraft which also have wire bracing only on the rear spar

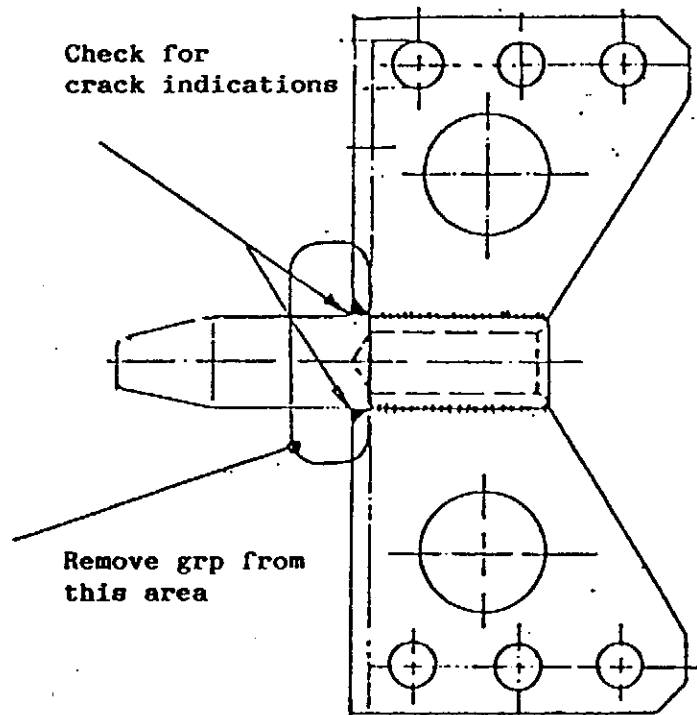
G109 SPIGOT FITTING

- (iii) Inspect the end of the weld and the spigot itself at the toe of the weld for cracks, using a x10 magnifying glass (four places) - see Figure A. There are two spigots per aircraft and cracks can occur on the top and on the bottom of the spigot.

- (iv) If a crack is suspected, and appears to be confined to the weld itself, ie does not extend circumferentially into the spigot, or where there is a lack of weld penetration, the wings may be replaced. The aircraft may be flown to a place where the existence of cracks can be confirmed or otherwise by NDT means, by an Organisation approved for that purpose by the CAA. The flight must be conducted with the pilot only on board. Abrupt manoeuvres and/or high speeds are prohibited. If a crack is confirmed either in the weld only or in the spigot itself, rectification must be carried out to the manufacturer's approved repair scheme before further flight.
Report the results of the inspections to the manufacturer and to the SDAU of the CAA.
