**BRITISH GLIDING ASSOCIATION**

**BGA TECHNICAL COMMITTEE**

**TECHNICAL NEWSHEET TNS 5/6/91**

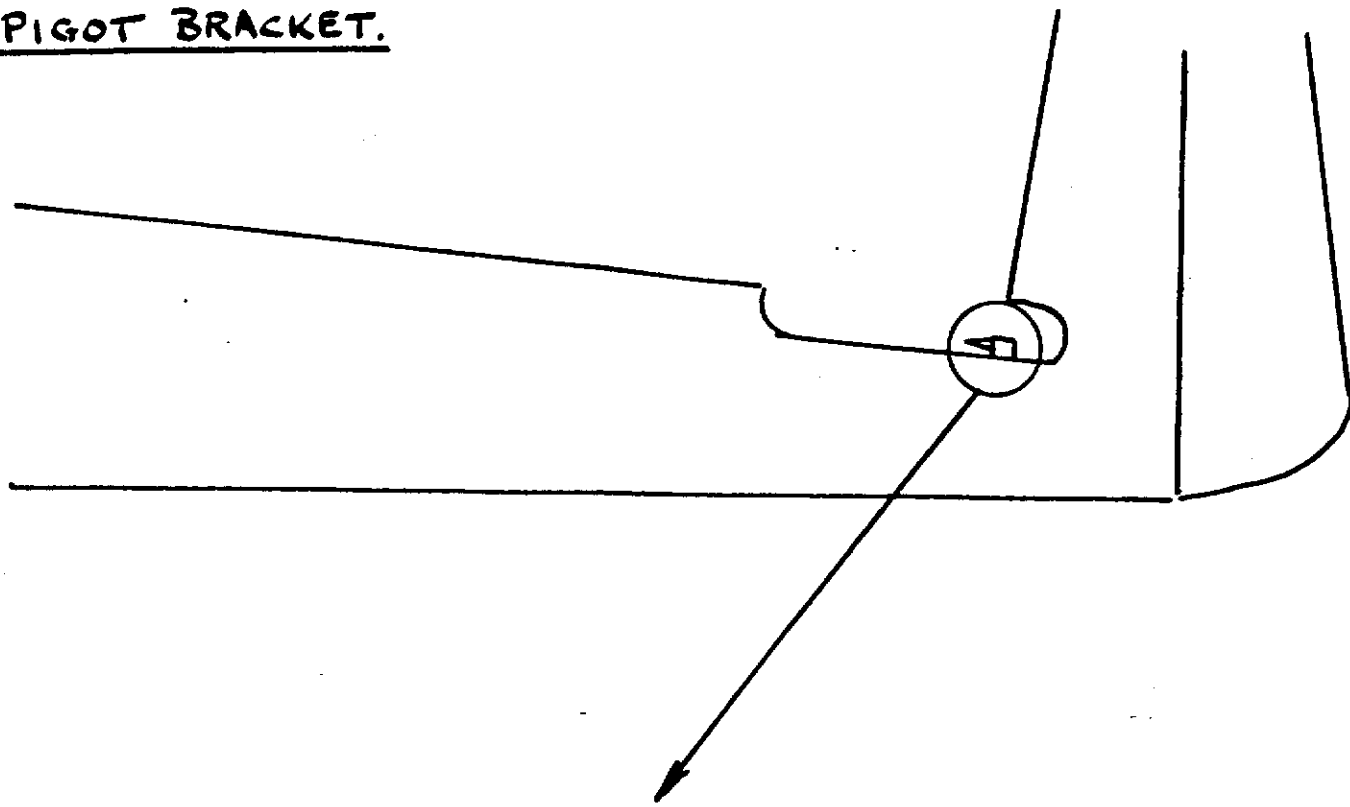
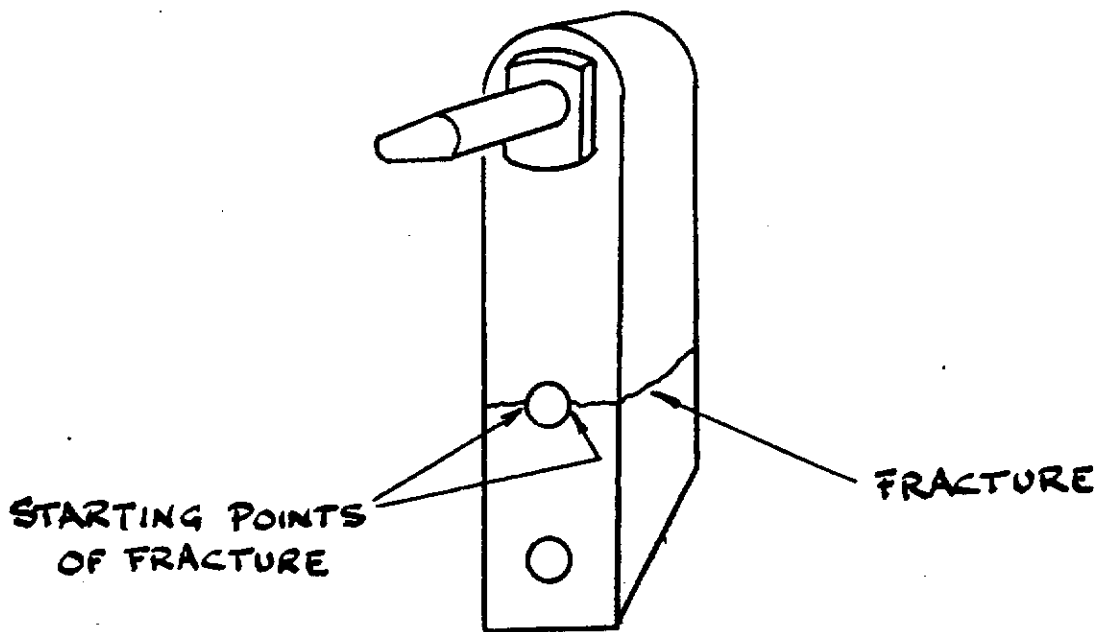
Ka 6 CR - FAILURE OF TAILPLANE ATTACHMENT  
SPIGOT BRACKET.

- 1.13. K6CR Tailplane Attachment Bracket Failures. This defect has been reported by Rex Flint - Trent Valley G.C. Sketch herewith.
- 1.14. WAXING OF OIL - TWO STROKE ENGINES. Extract from G.A.S.I.L. is illuminating.

WHILST CARRYING OUT DAILY INSPECTION, TAILPLANE MOVEMENT WAS DETECTED. REMOVAL OF TAILPLANE FOR FURTHER INVESTIGATION REVEALED THAT SPIGOT BRACKET HAD FRACTURED COMPLETELY, ABOUT THE TOP BOLT HOLE. DETAILED EXAMINATION OF THE FRACTURE INDICATED THAT THE BRACKET HAD BEEN IN A PARTIALLY FRACTURED STATE FOR SOME PREVIOUS TIME.

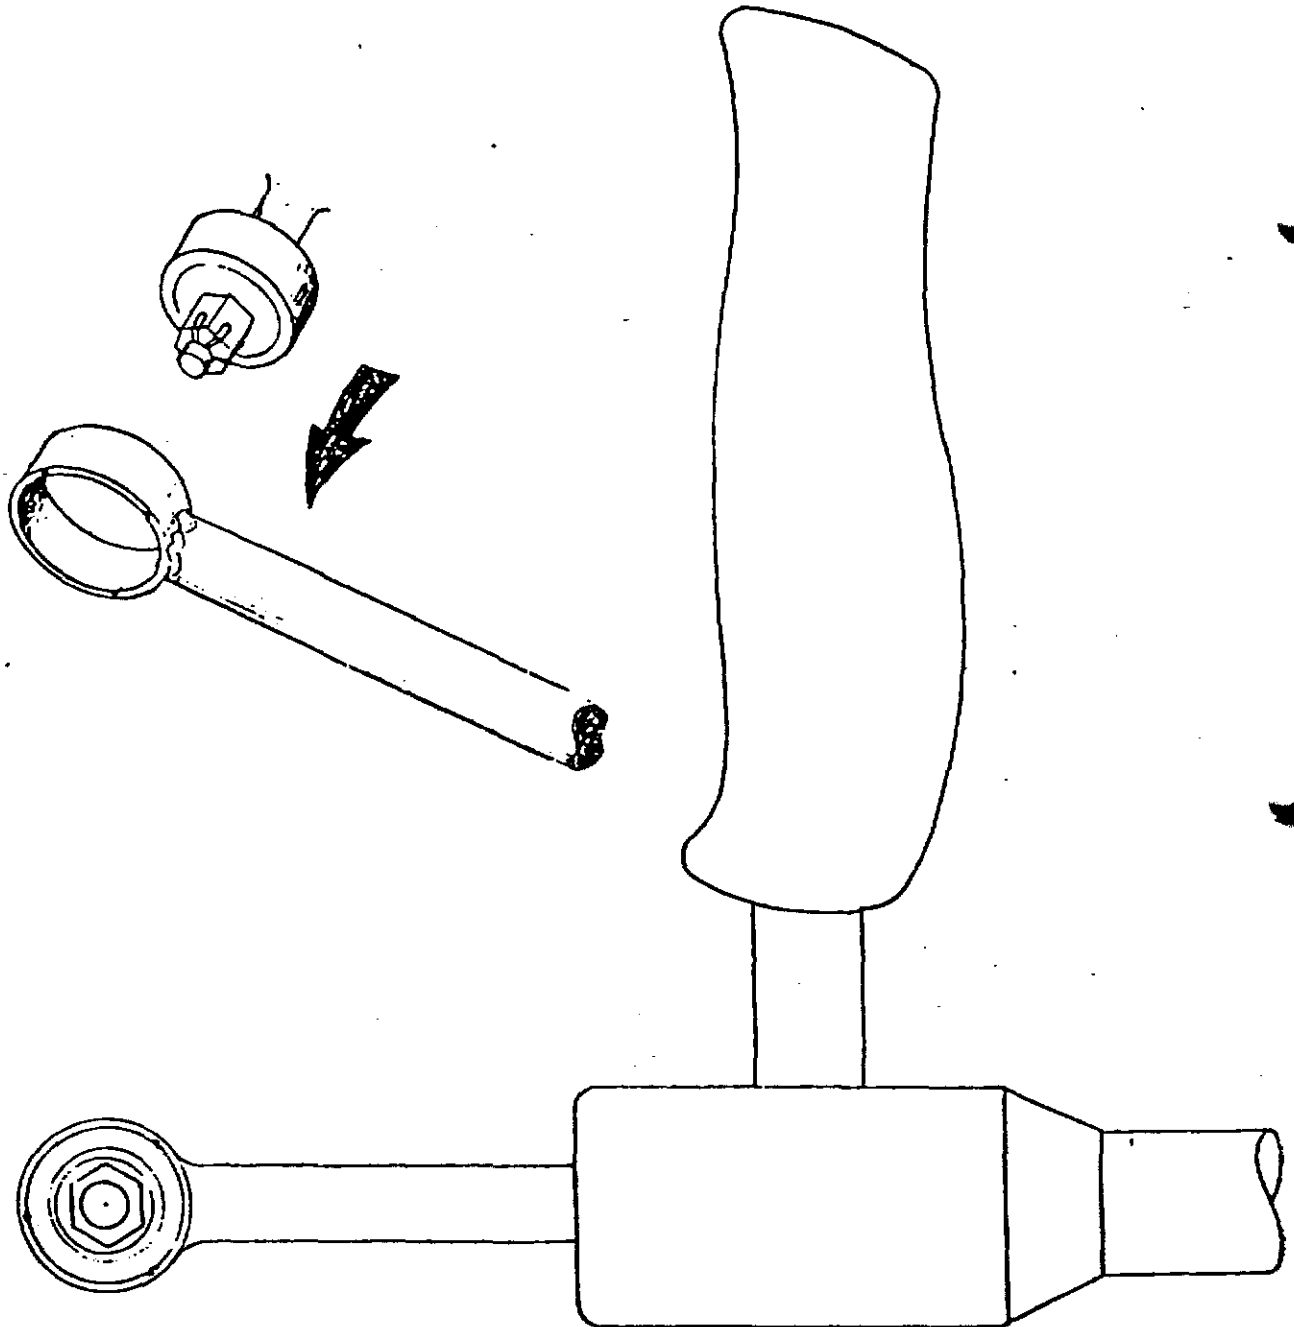
# Vega Undercarriage Lever.

## Failure of rod-end bearing assembly resulting in undercarriage collapse on takeoff.

The unibal race is a light interference fit in a steel eye welded to the rod end. Retention is assisted by three light peening marks impressed into the eye. The eye detached from the bearing and fell free into the cockpit releasing the undercarriage lock. The assembly may have been weakened by operation of the lever from outside and across the cockpit when fitting the belly trolley.

Re-fitting the unibal race with heavier peening and Loctite 'Bearing Fit' 641, available in 5ml packs from Bearing Services, plus greater care in ground operation should prevent further problems.

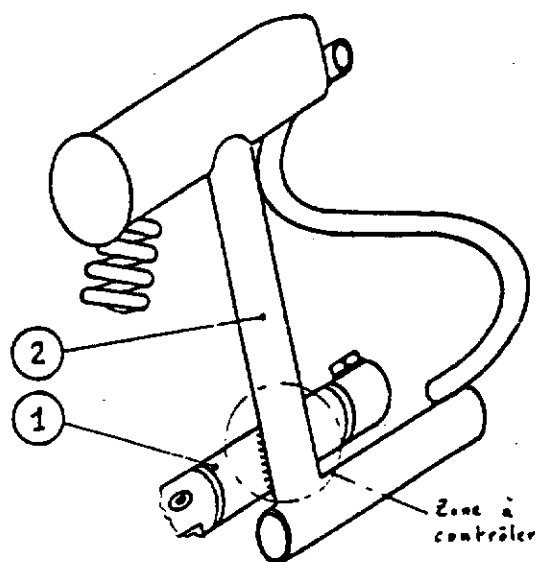
Nous avons constaté sur un planeur accidenté une crique au niveau de la soudure entre le tube d'articulation et le tube vertical d'une pédale (voir croquis ci-dessous). Ce planeur ayant des pédales de palonnier de même type que les planeurs cités en objet, il est demandé de :

a) contrôler l'état de la soudure entre le tube d'articulation (repère 1) et le tube vertical (repère 2) sur les deux pédales de palonnier afin d'y déceler un éventuel début de crique.

b) prendre contact avec S.N.CENTRAIR en cas de constatation de crique.

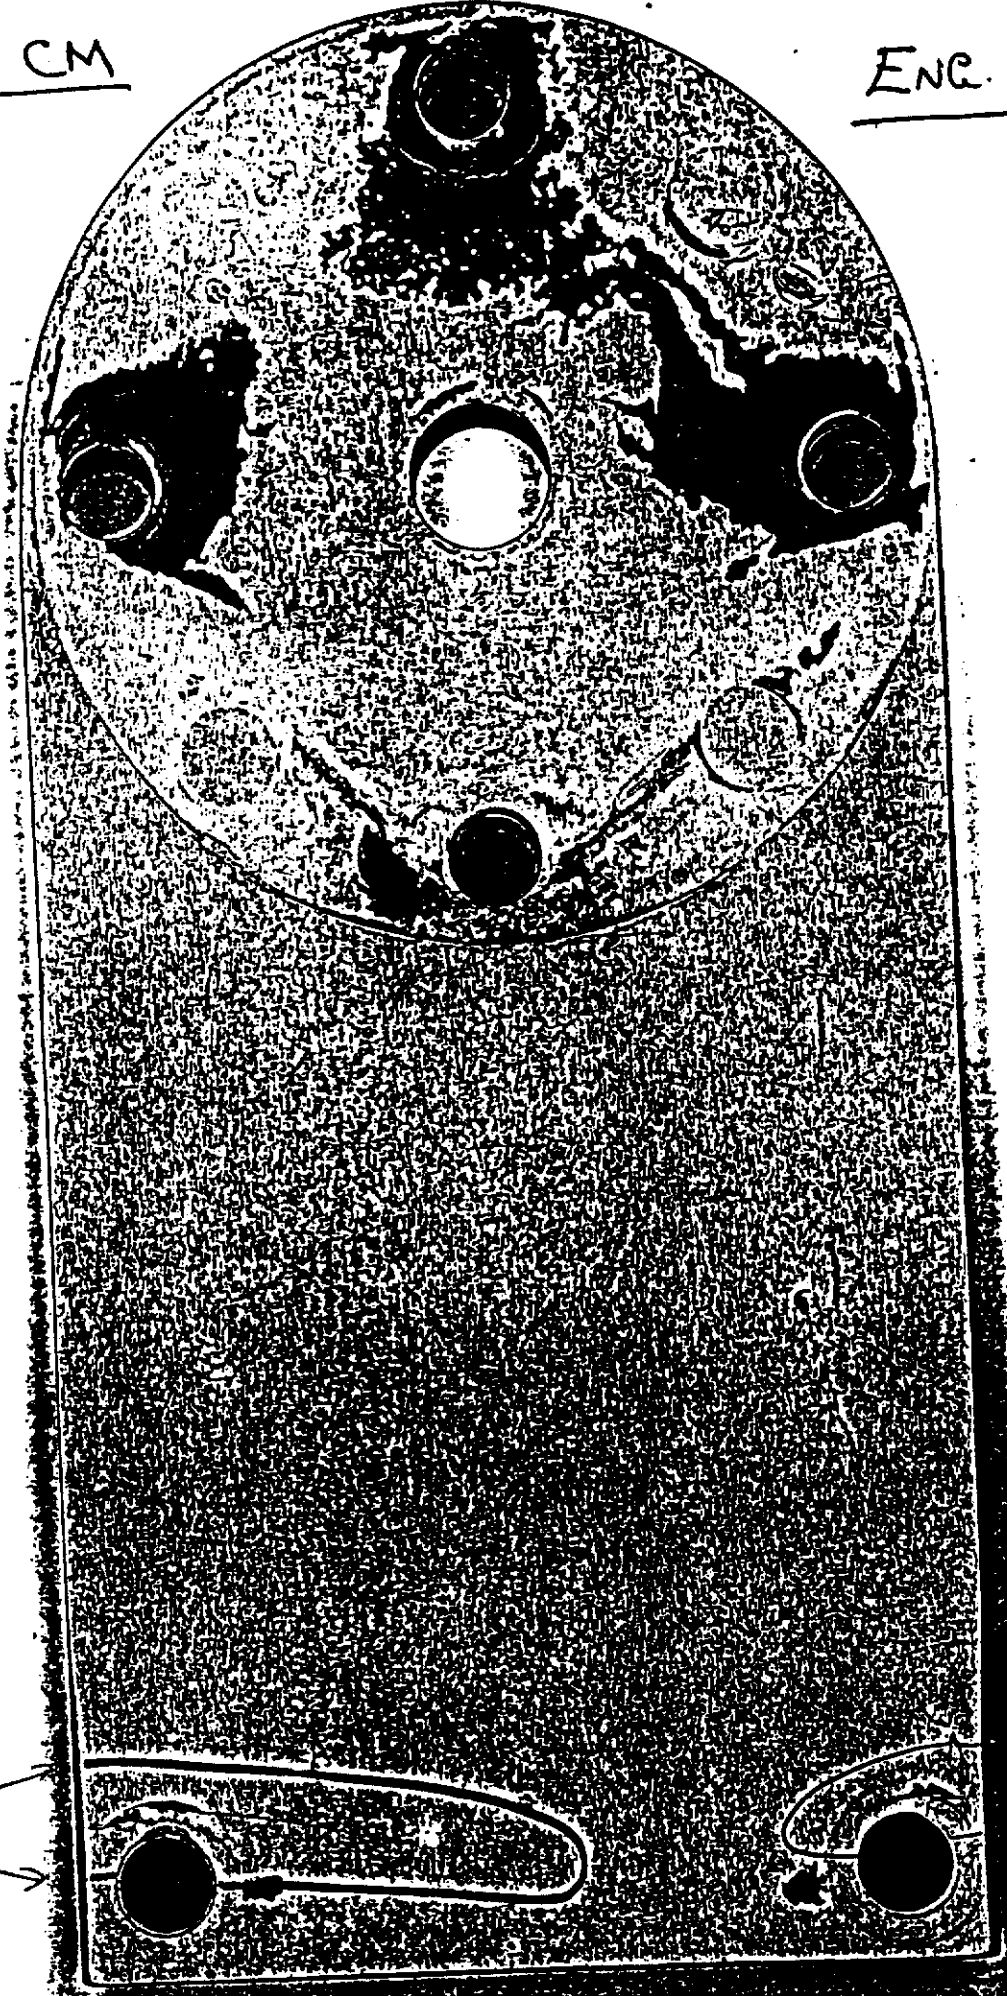
- 1.12. JANUS CM - ENGINE MOUNTING PLATE - Recurring failures in Japan. Sketch herewith illustrates cracks after 55 hours. Second failure occurred 5 hrs later. In the UK we may not have flown 50 hrs between accidents!

CRACKED

Area of Cracking
