BRITISH GLIDING ASSOCIATION

BGA TECHNICAL COMMITTEE

TECHNICAL NEWSHEET TNS 7/8/91

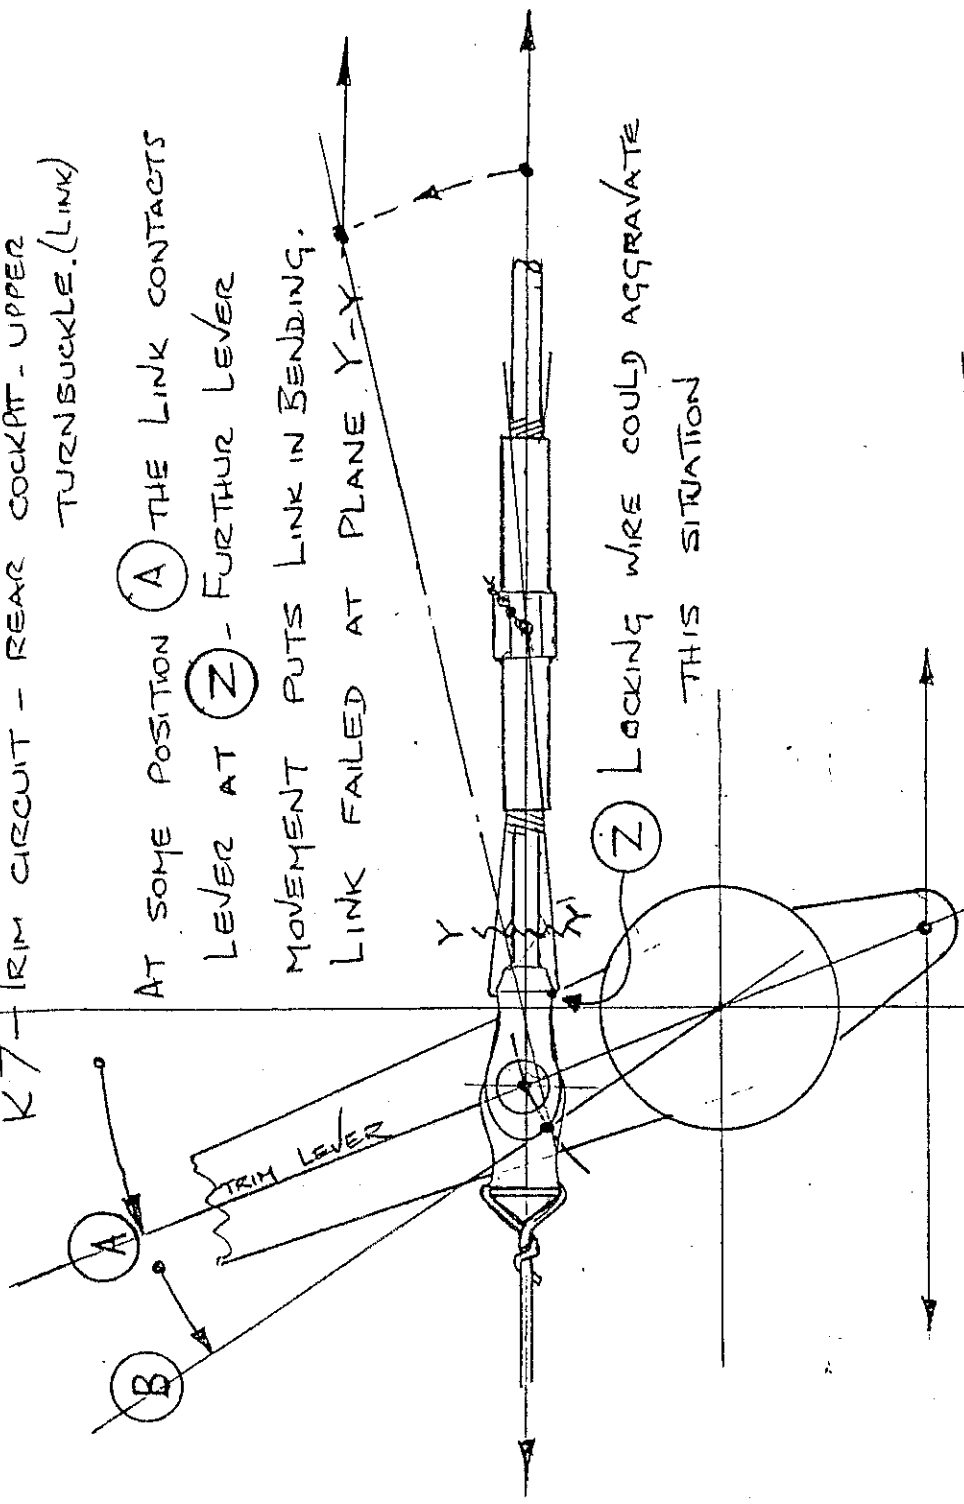
K7 - TRIM CIRCUIT - REAR COCKPIT - UPPER  
TURNBUCKLE. (LINK)

- 1.7. KA7 Trim Cable Failure. Diagram is self explanatory.  
Reported by P.A. Ward - Marchington.
  - 1.8. Olympia 2 Cracks in Elevators & Ailerons, as illustrated herewith.  
Reported by Ian Hipkin - Highland G.C.

AT SOME POSITION (A) THE LINK CONTACTS  
LEVER AT (Z) - FURTHER LEVER  
MOVEMENT PUTS LINK IN BENDING.  
LINK FAILED AT PLANE Y-Y

(Z) LOCKING WIRE COULD AGGRAVATE  
THIS SITUATION

FAILURE OF TRIM TURNBUCKLE  
P.A. WARD - MARCHINGTON G.C.

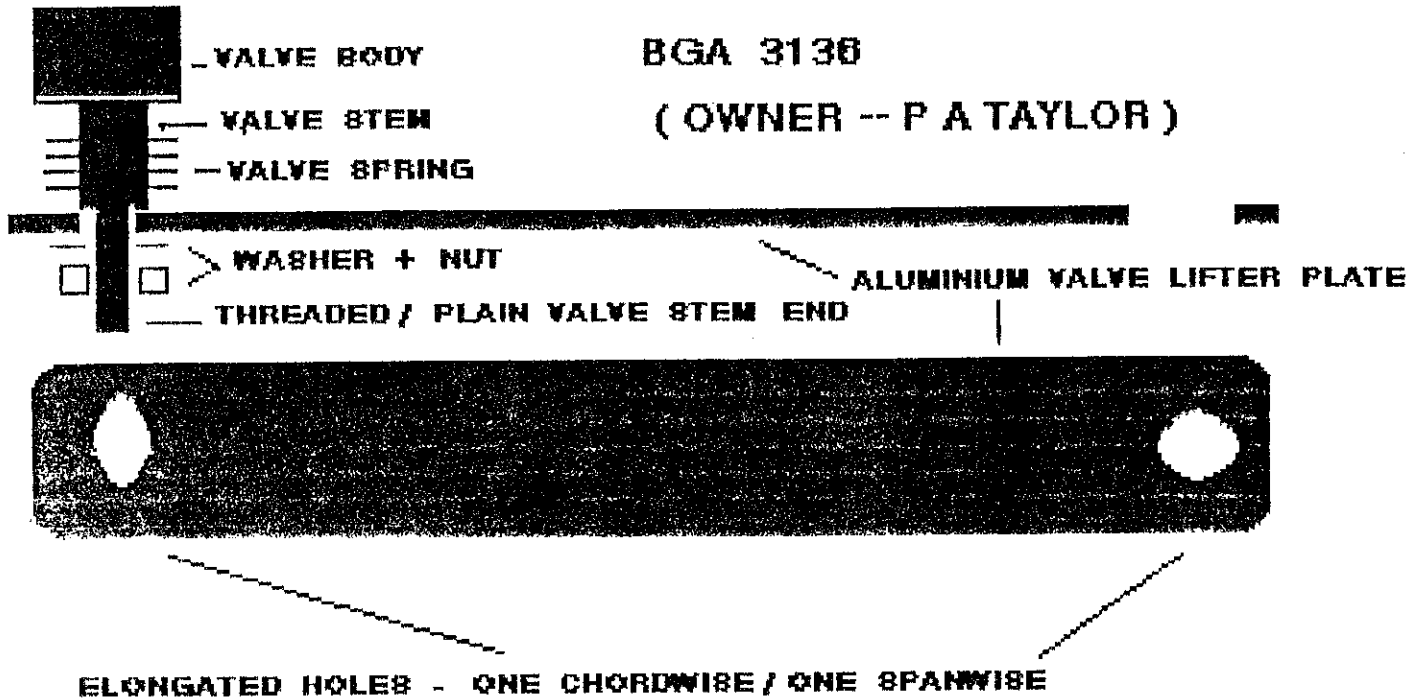
VENTUS TURBO SERIAL No 35

- 2.4. Ex RAF/ATC SLINGSBY T61(F) S.L.M.G's - Guidelines on Civil Certification are copied herewith.
- 2.5. Turbo Ventus - failure to start.
- 1) Failure of the Valve Lifter, illustrated herein.

FOLLOWING FAILURE TO START IN AIR DUE TO ENGINE NOT SPINNING UP IN AIRSTREAM INVESTIGATION REVEALED HOLES IN ALUMINIUM VALVE LIFTER PLATE HAD BECOME ENLARGED AND ELONGATED AS PER SKETCH.

THIS HAD ALLOWED ONE OF THE TWO VALVE STEMS TO PASS THROUGH THE PLATE HOLE SUCH THAT ACTIVATION OF THE VALVE LIFTER HANDLE FAILED TO LIFT THAT VALVE.

THE ELONGATION OF THE HOLES WAS UNDOUBTEDLY THE RESULT OF VIBRATION, ONE HOLE IN PARTICULAR WAS SURROUNDED BY A CONSIDERABLE BURR.

THIS PARTICULAR ENGINE HAS RUN FOR A TOTAL OF 31 HOURS IN 873 AIRFRAME HOURS.

I STRONGLY RECOMMEND ALL SOLO ENGINES BE CHECKED AS A MATTER OF URGENCY. COULD THIS HAVE ANY RELEVANCE TO THE RECENT TURBO VENTUS FATALITY? I SUGGEST THE ALUMINIUM PLATE NEEDS REPLACING WITH A STEEL PLATE, OR APPROPRIATELY SIZED STEEL WASHERS BE INTRODUCED ON BOTH SIDES OF THE ALUMINIUM PLATE.
