BRITISH GLIDING ASSOCIATION

BGA TECHNICAL COMMITTEE

TECHNICAL NEWSHEET TNS 11/12/91

PART 1 Airworthiness "AGGRO"

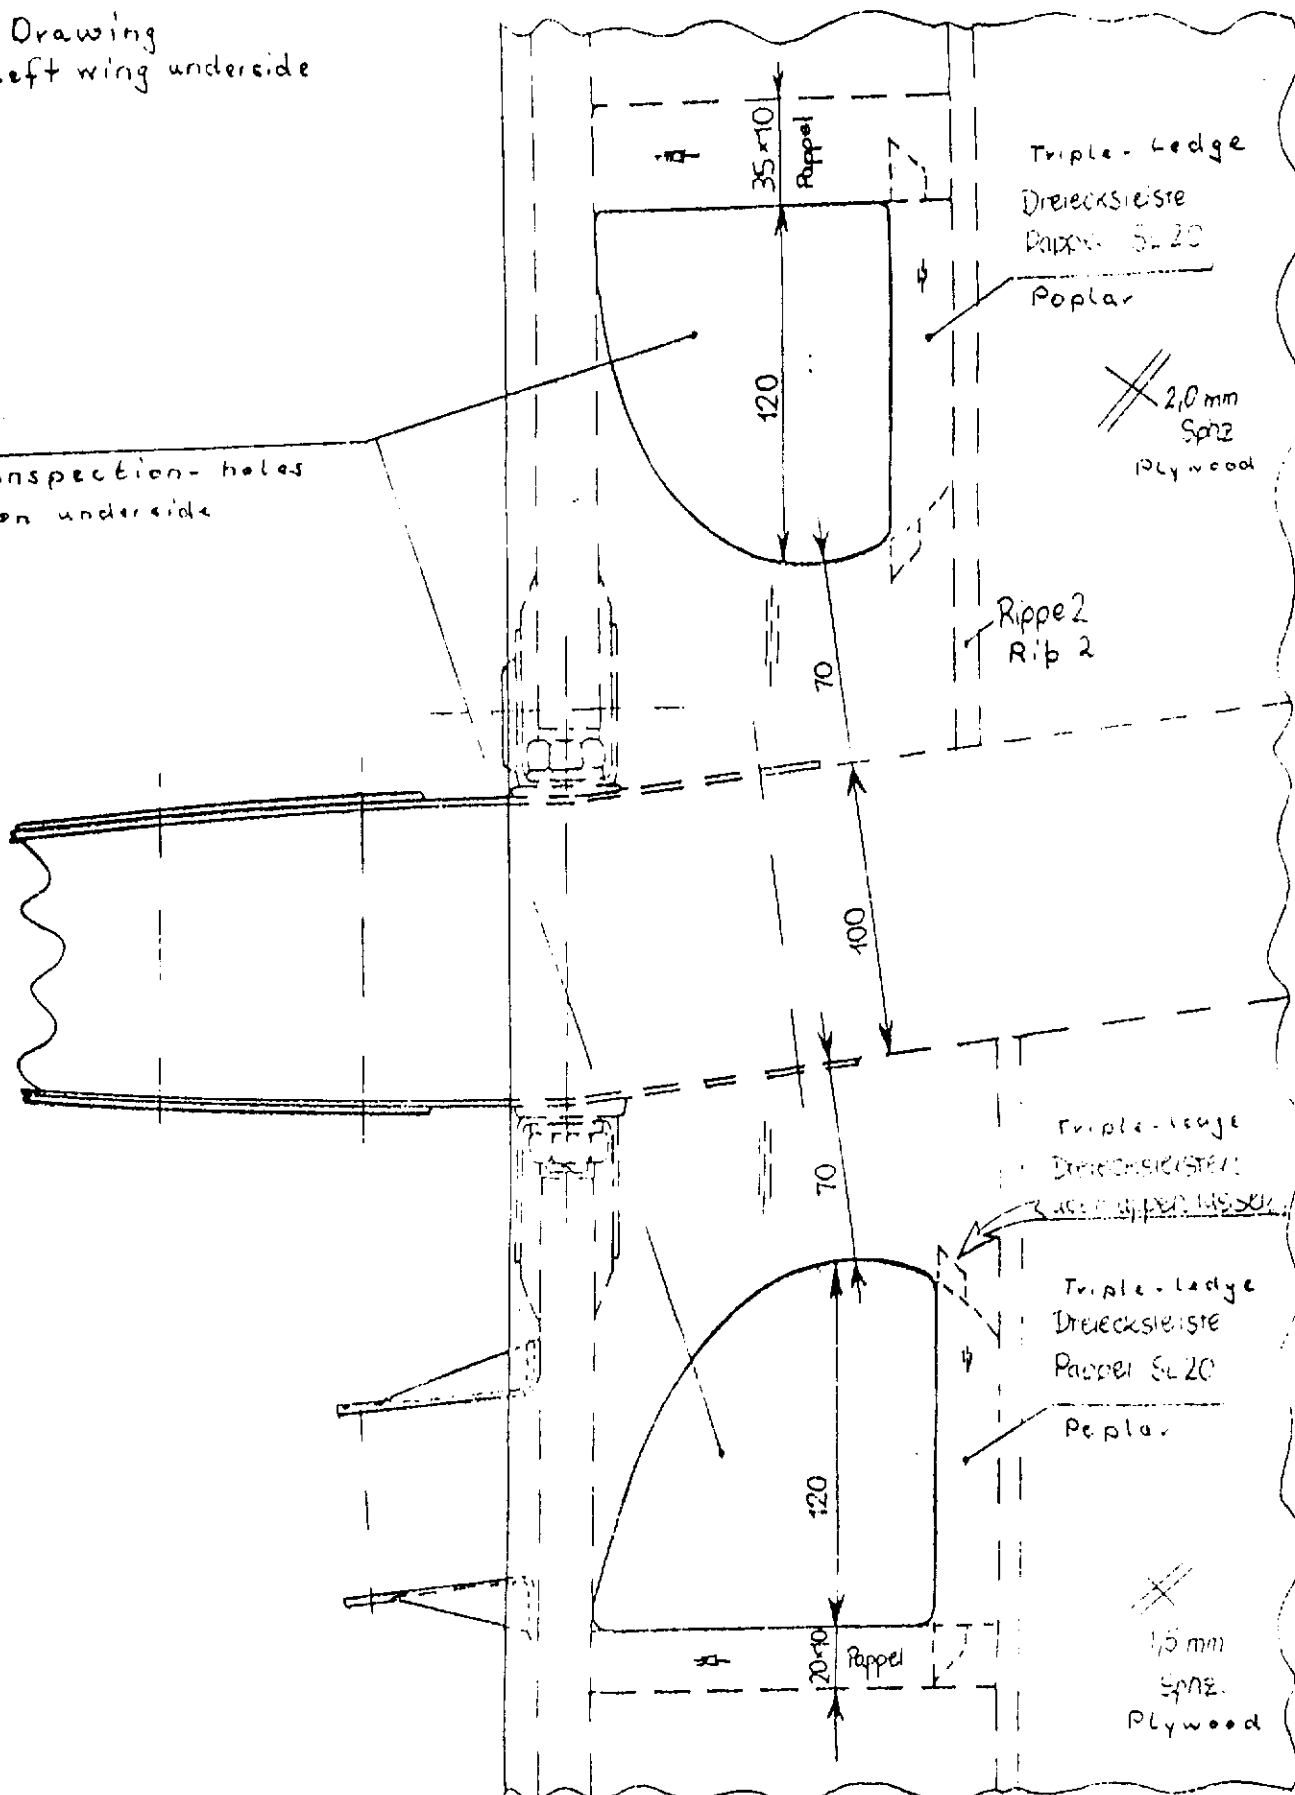
Drawing
left wing underside

KA. 13Subject:

Inspection of the main-fittings

Affected Sailplane:German Type Certificate No. 267
AS - K 13
Serial No. 13618 - 13686 incl. and
Serial No. 13689, all with addition A.B.Compliance:Action 1. and 1.1. before next flight
Action 2. before next flight
Action 3. if necessary before next flightReason:Possible non-observance of the tolerance on
the backside of the main fitting-holes can
lead to an slight movement from the main
fitting to the end spar.Action 1.Affected Serial No. 13618 A.B. - 13665 A.B.
and No. 13667 A.B. - 13670 A.B.Check the main-fitting for possible traces,
which show to a movement of the fitting and
end spar. It looks like cracks in the varnish
between metall and wood. This controll have to
be done in rebuilded condition.Action 1.1.Check the bolts in front of the root-ribs.
Therefor take a pin, 550 mm long with 9,5 mm
diameter into the bolts and work with hand-
power. The controll have to be done out of the
backside of the wing end spar. If there is no

Out of action 1. is following check to do:
Untie the nuts M 18 x 1,5 mm of all bolts.
Replace the bolts 50 mm out of the holes and
measure the holes in the spar - wood and the
fitting - metall. The holes diameter 18 mmØ
is authoritative. The bolts behind the root -
ribs are to check from the underside of the wing.
For that purpose see the drawing sheet 3. If
there is no deviation, replace the bolts in the
old position and also the nuts.
Unconditional is the right place of the wedge-
shaped discs. Powerment of the bolts is 75 lbs/ft.

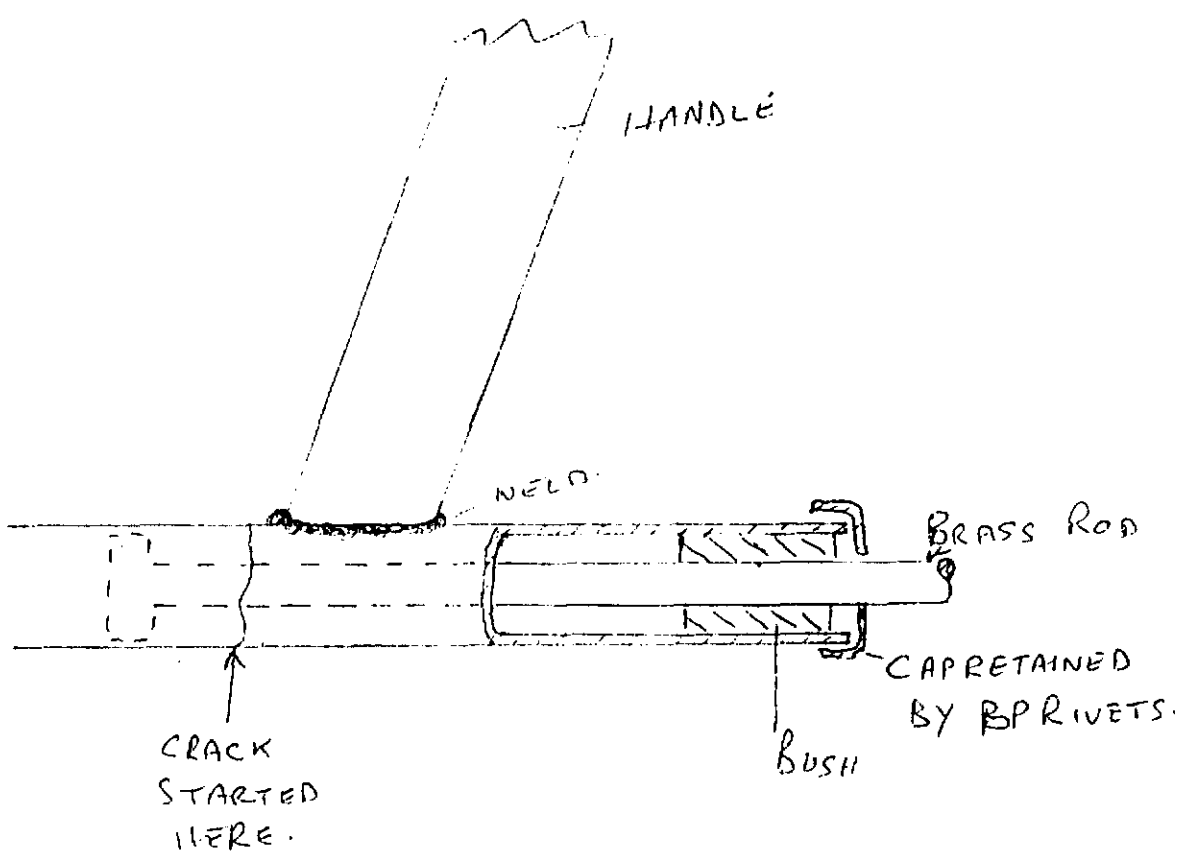
KA. 23

- 1.3. KA 23 Air/Wheel Brake - operating lever found fractured at the weld. (Sketch herewith from Ron Hawkes, Midland G.C.).
- 1.4. KA 13 Inspection & Main Fittings. Service Bulletin 13 herewith, refers to possible loose bolts in Jubi built gliders. (Reported previously to BGA in TNS 1/2/91).

K23 Found with air/wheel brake operating rod fractured just aft of the handle, after a field landing. Had this happened before the landing the pilot could have been left with airbrakes fully deployed and unable to retract them.

Previously, half a dozen flights before, the pilot on D.I. had complained the brake operation had suddenly become stiff. A little oil on the brass rod restored a normal feel, but the fatigue crack was continuing apace.

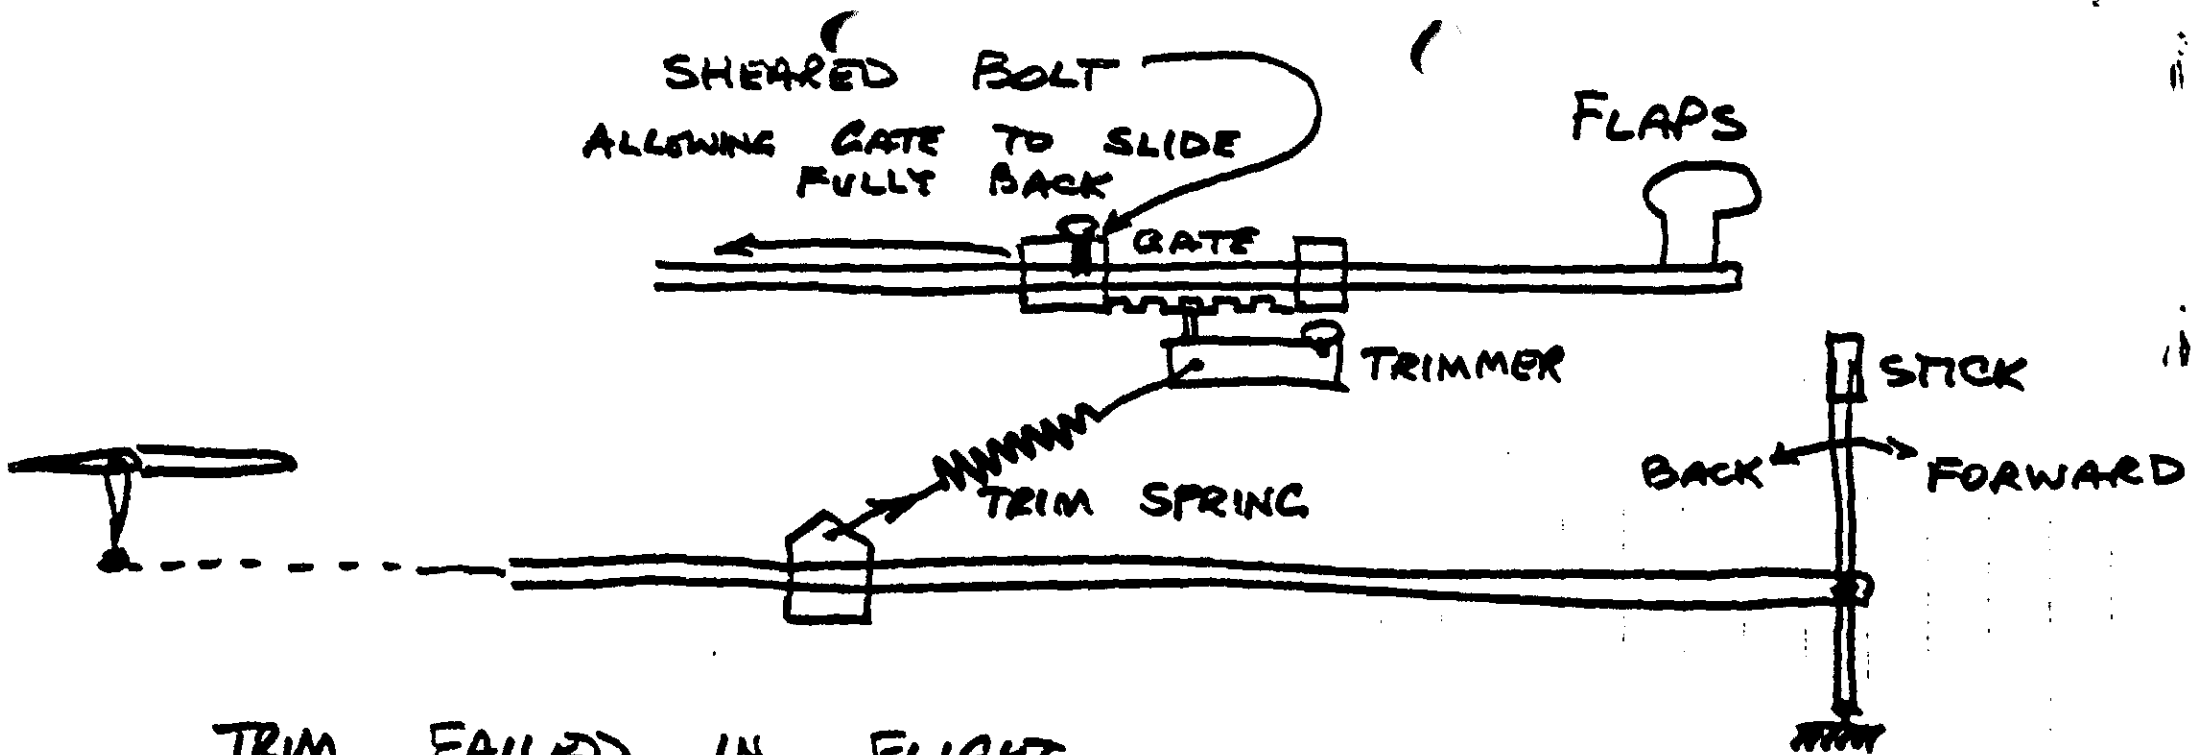
TRIM FAILED IN FLIGHT

- 1.12. Nimbus 2C. Failure Of Trim System. Sketch from A. Pickles of Lasham is self explanatory.
- 1.13. Control Stops Removed (KA6E). Stops at the base of the control column were manufactured and fitted to establish correct range of operation! These stops had been missing for some time, and BGA Inspectors had failed to notice. Ref items 12, 13 and 14 of BGA Airworthiness Report Form 267! (Reported by Chiltern Sailplanes).

NIMBUS 2 2491 .

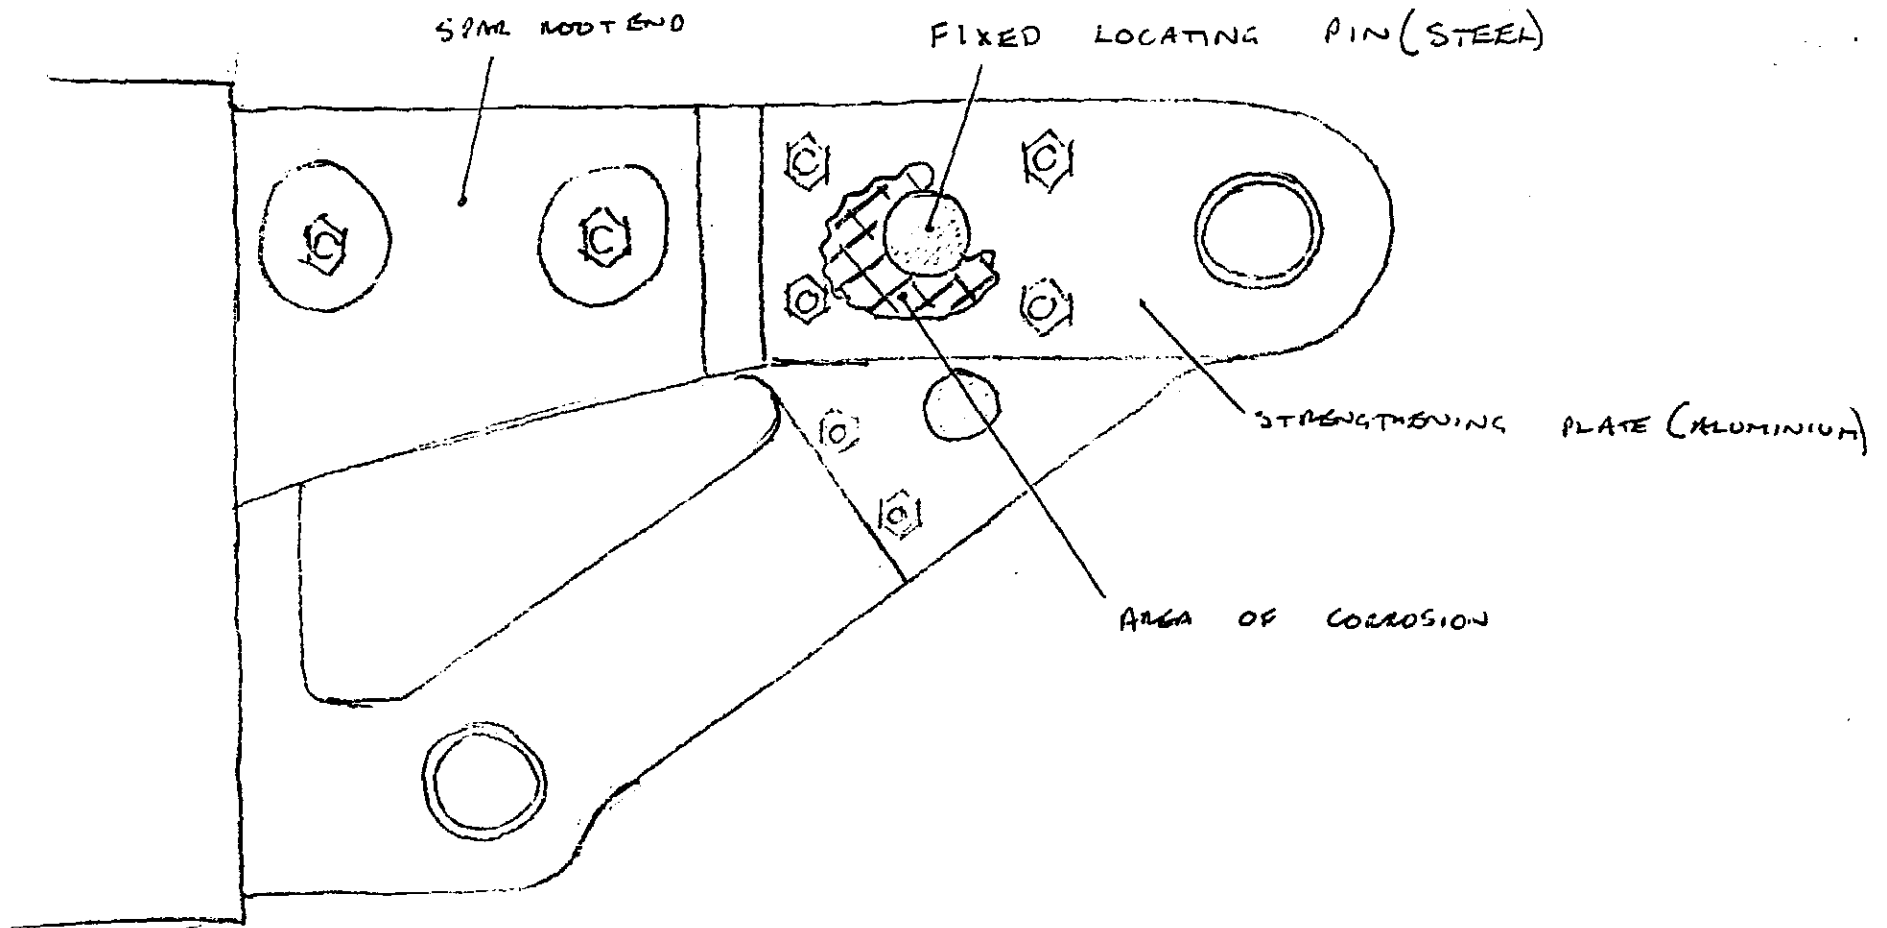
PORT WING ROOT FITTINGS

- 1.9. DART 15 - Corrosion of Wing Root Fittings. Sketch attached refers to corrosion of aluminium strengthening

plates. (Reported by Parker Sailplanes).

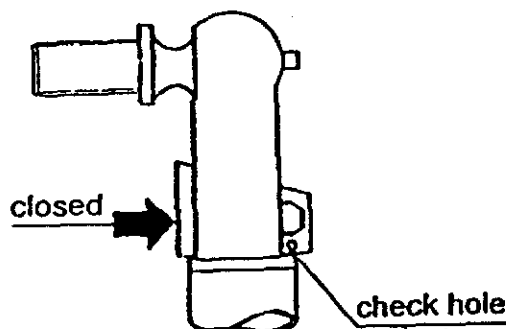
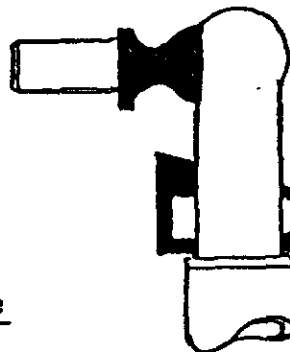
Figure 1.

The correct and incorrect assembly of the couplings must be pointed out by Daily Inspector Examiners and understood by Daily Inspectors and is shown in figure 1.

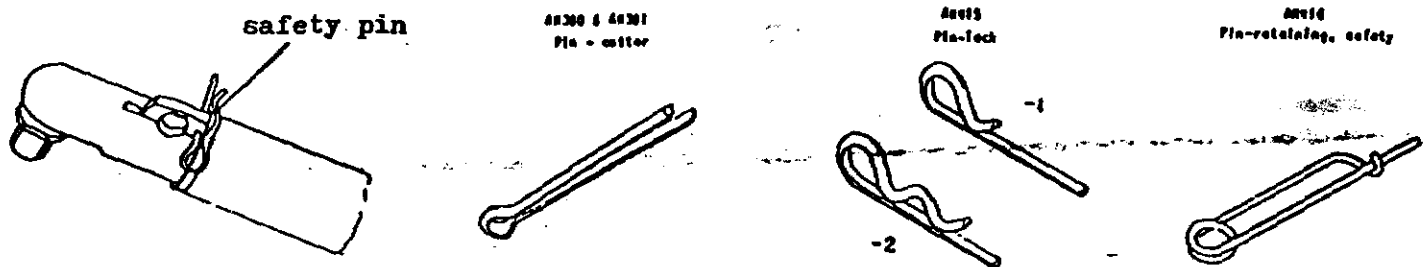
Figure 2.

Safety pins may be any of the types shown in figure 2.

After the above date all l'Hotellier couplings having a check hole must be fitted with a 1 mm diameter SAFETY pin. This pin must be checked at each Daily inspection.

Each SAFETY pin installation must be checked for clearance through the full travel of each control system.

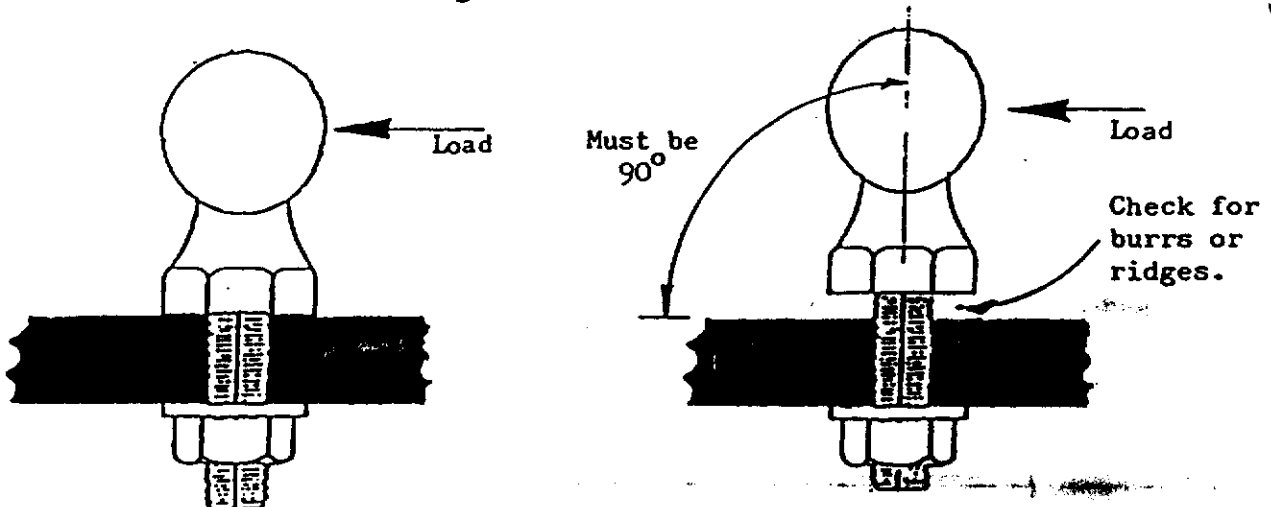
Figure 3.

Daily and Form 2 Inspectors must look for looseness of balls, i.e. loose nuts, broken tab washers, worn threads etc. Any of these defects will allow them to wind out or loosen. Any looseness can cause bending failure and cracking of the shank at the underside of the flange.

Shoulder firmly in contact prevents the threaded section bending.

Any gap under the shoulder causes bending/loosening of the thread.

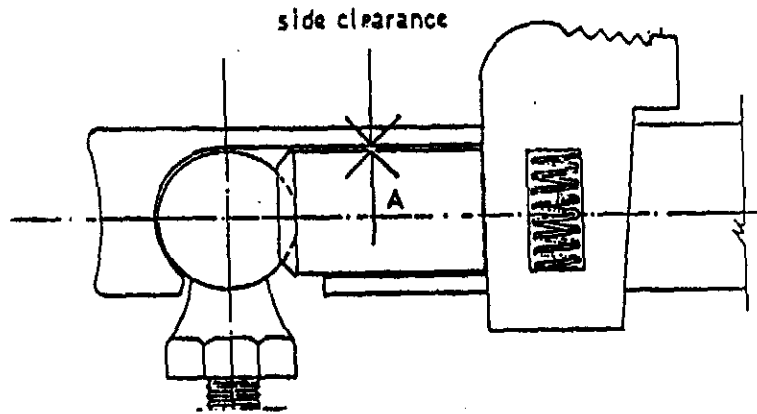
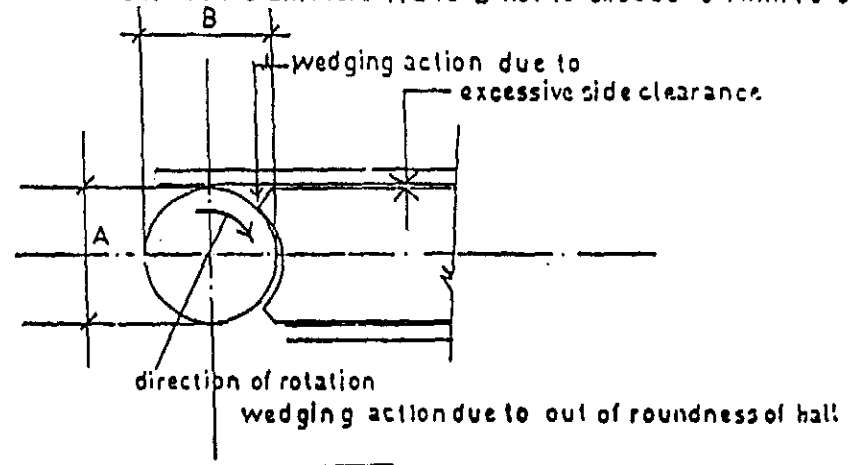
SKETCH 1

difference between diameters A and B not to exceed 0.1mm (0.004 inch)

All balls to be checked for wear, as per figure 4. sketch 1 and 4, at 100 hour intervals and during Form 2 Inspections.

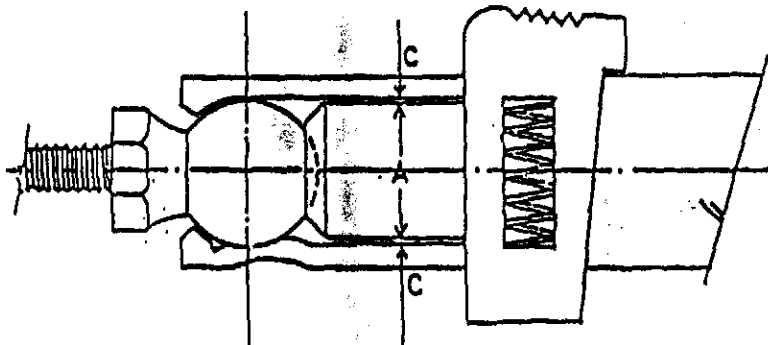
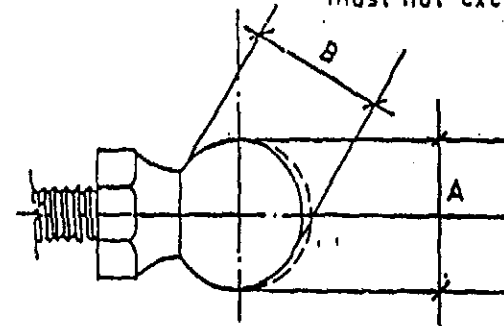
SKETCH 2

C plus C must not exceed 0.15mm (0.006 inch)

the difference between A and B must not exceed 0.1mm (0.004 inch)

All fittings to be checked during Form 2 Inspections in accordance with figure 4 sketch 1 and 2.
