BRITISH GLIDING ASSOCIATION

BGA TECHNICAL COMMITTEE

TECHNICAL NEWSHEET    TNS 9/10/91

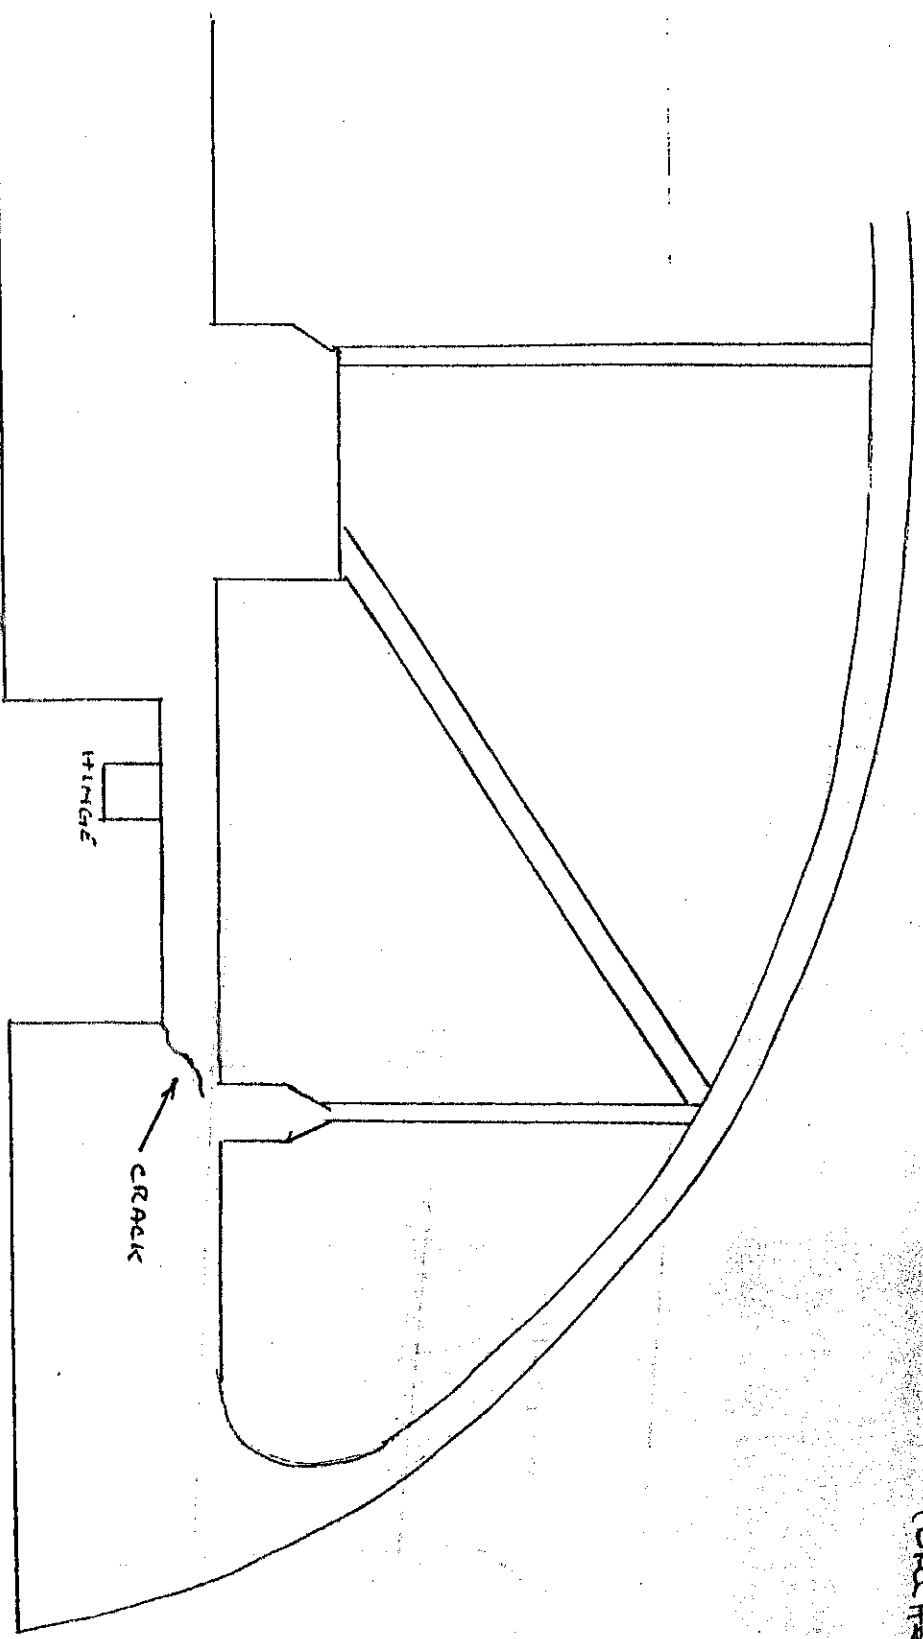
OLYMPIA 2B  
ELEVATORS / ALERONS  
CRACKS

- 1.7.    Slingsby Dart.    Defective Panel in the wing root - Sketch from Ian Hipkin - Highlands G.C. is self explanatory.
- 1.8.    OLY 2 - Cracks in Elevators & Ailerons.    Sketch from Ian Hipkin may have been omitted from TNS 7/8/91.

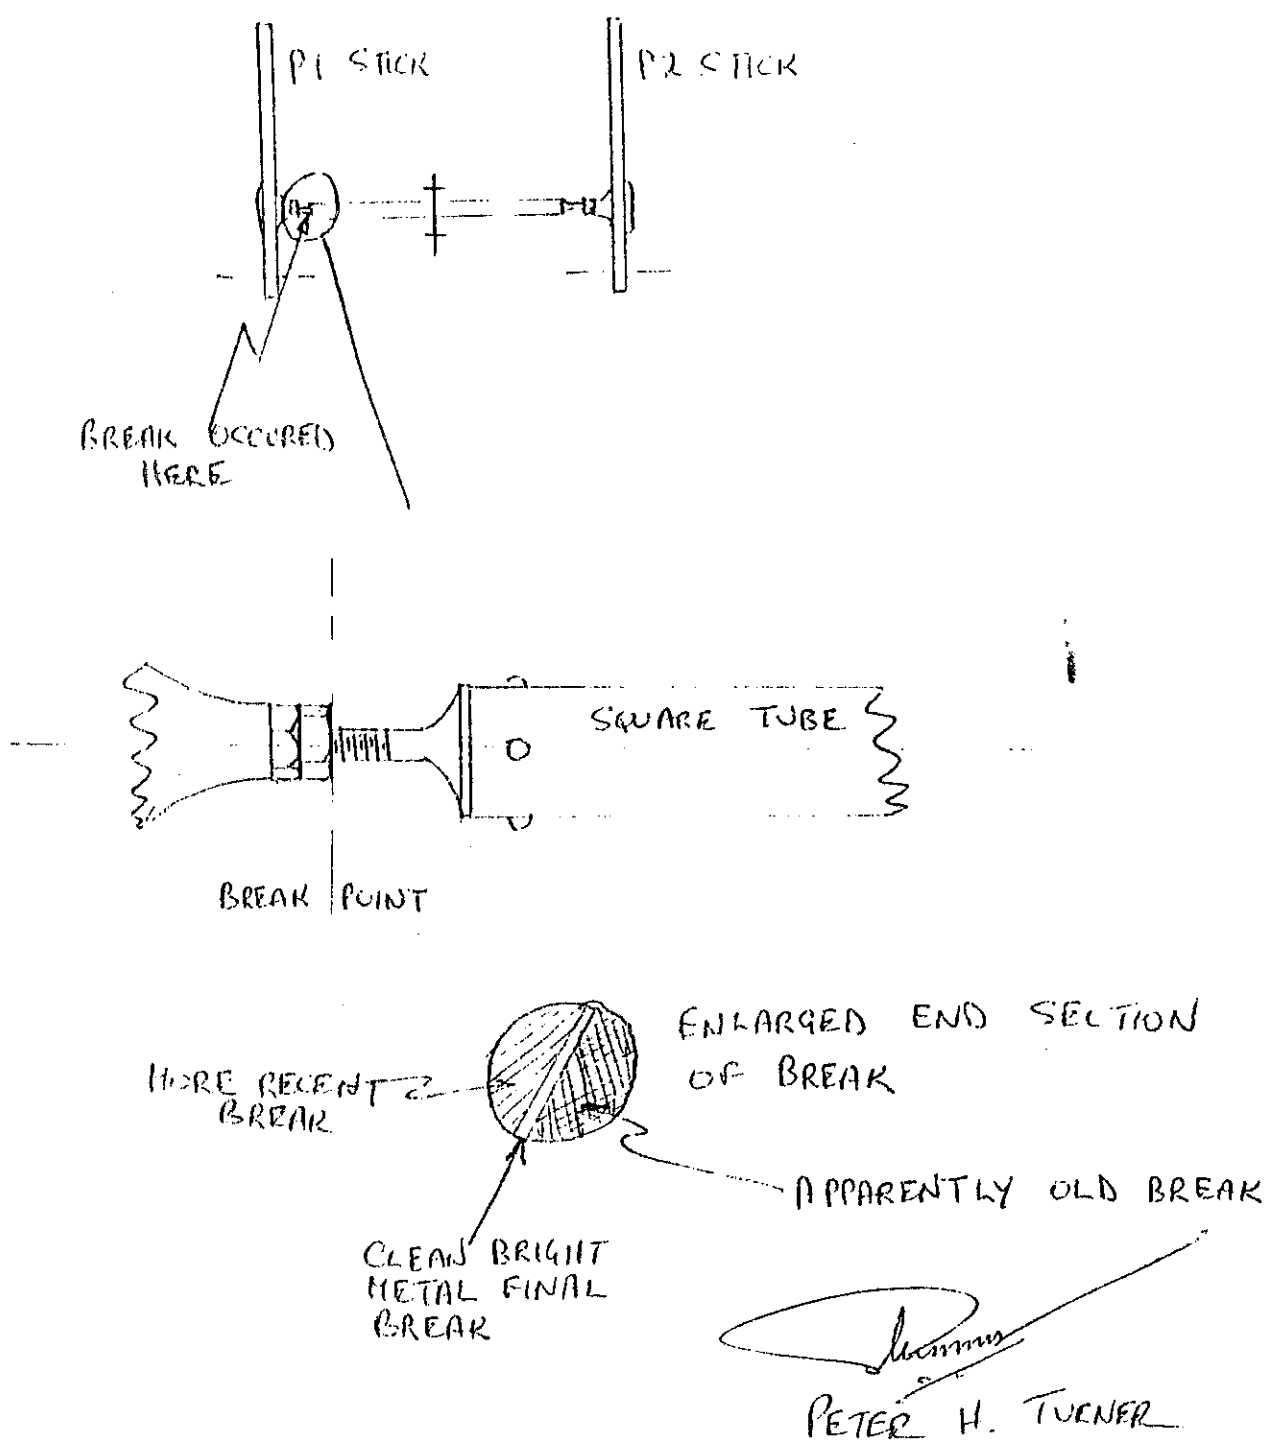
# T.21 AILERON ROD FAILURE.

- 1.4.    T.21. Undemanded Aileron Disconnect - due to fracture of the rod-end between the two control sticks. First reported in TNS 6/83. Sketch herewith illustrates the failure, probably induced by treading on it? Why not paint it bright RED?

I will, shortly, complete and return the Incident Report and will send the broken parts to yourselves for inspection if required. From visual in situ inspection there appears to be two separate previous cracks with the final break only about 1 mm wide. The crack has occurred at the maximum stress point where a thick section is suddenly reduced to a thin section and this thin section is also threaded at this point.

T216. DUKER CONTROL STICK.  
PORT SIDE CONTROL ROD.  
BROKE OFF - IN FLIGHT.

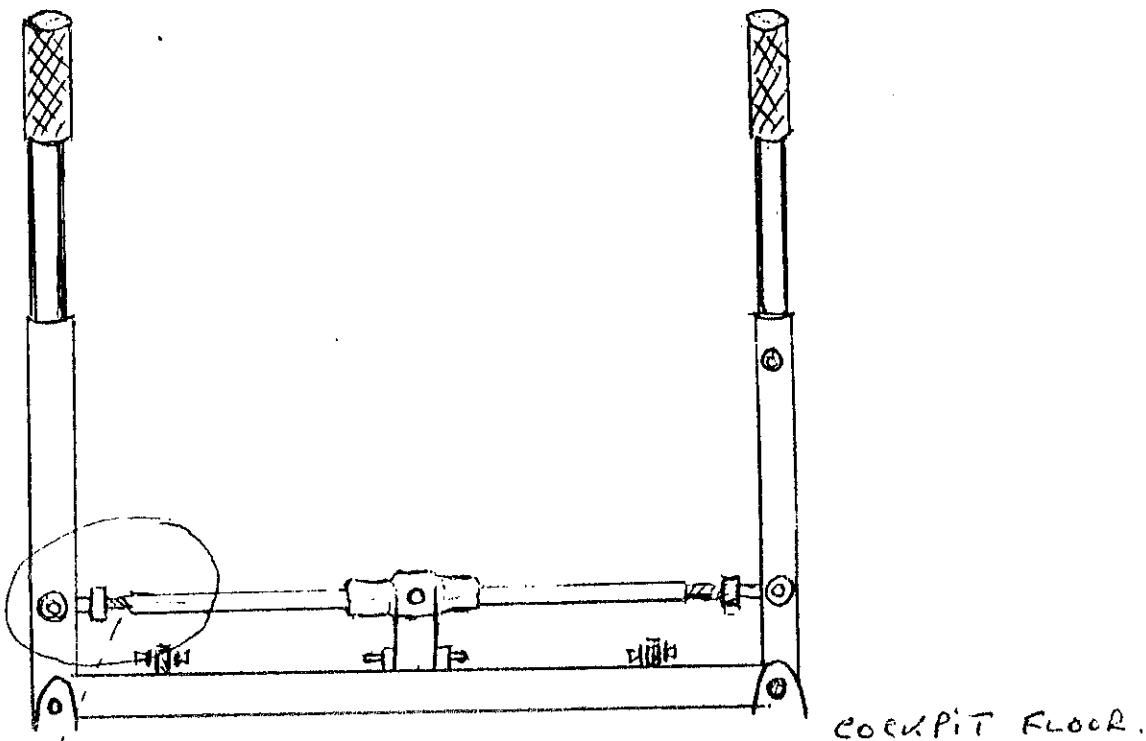
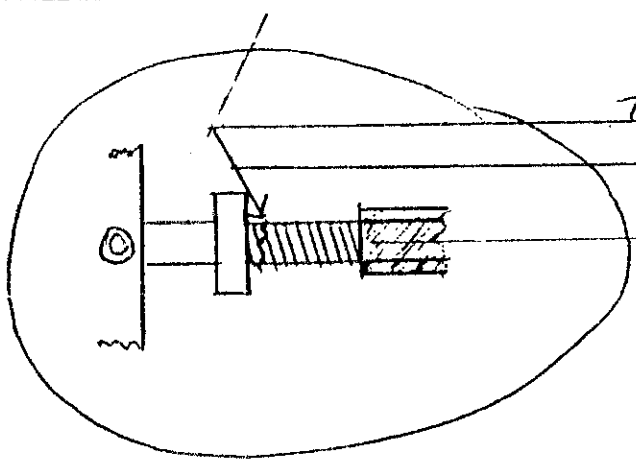
THREADED PART OF  
CONTROL ROD BROKE HERE.

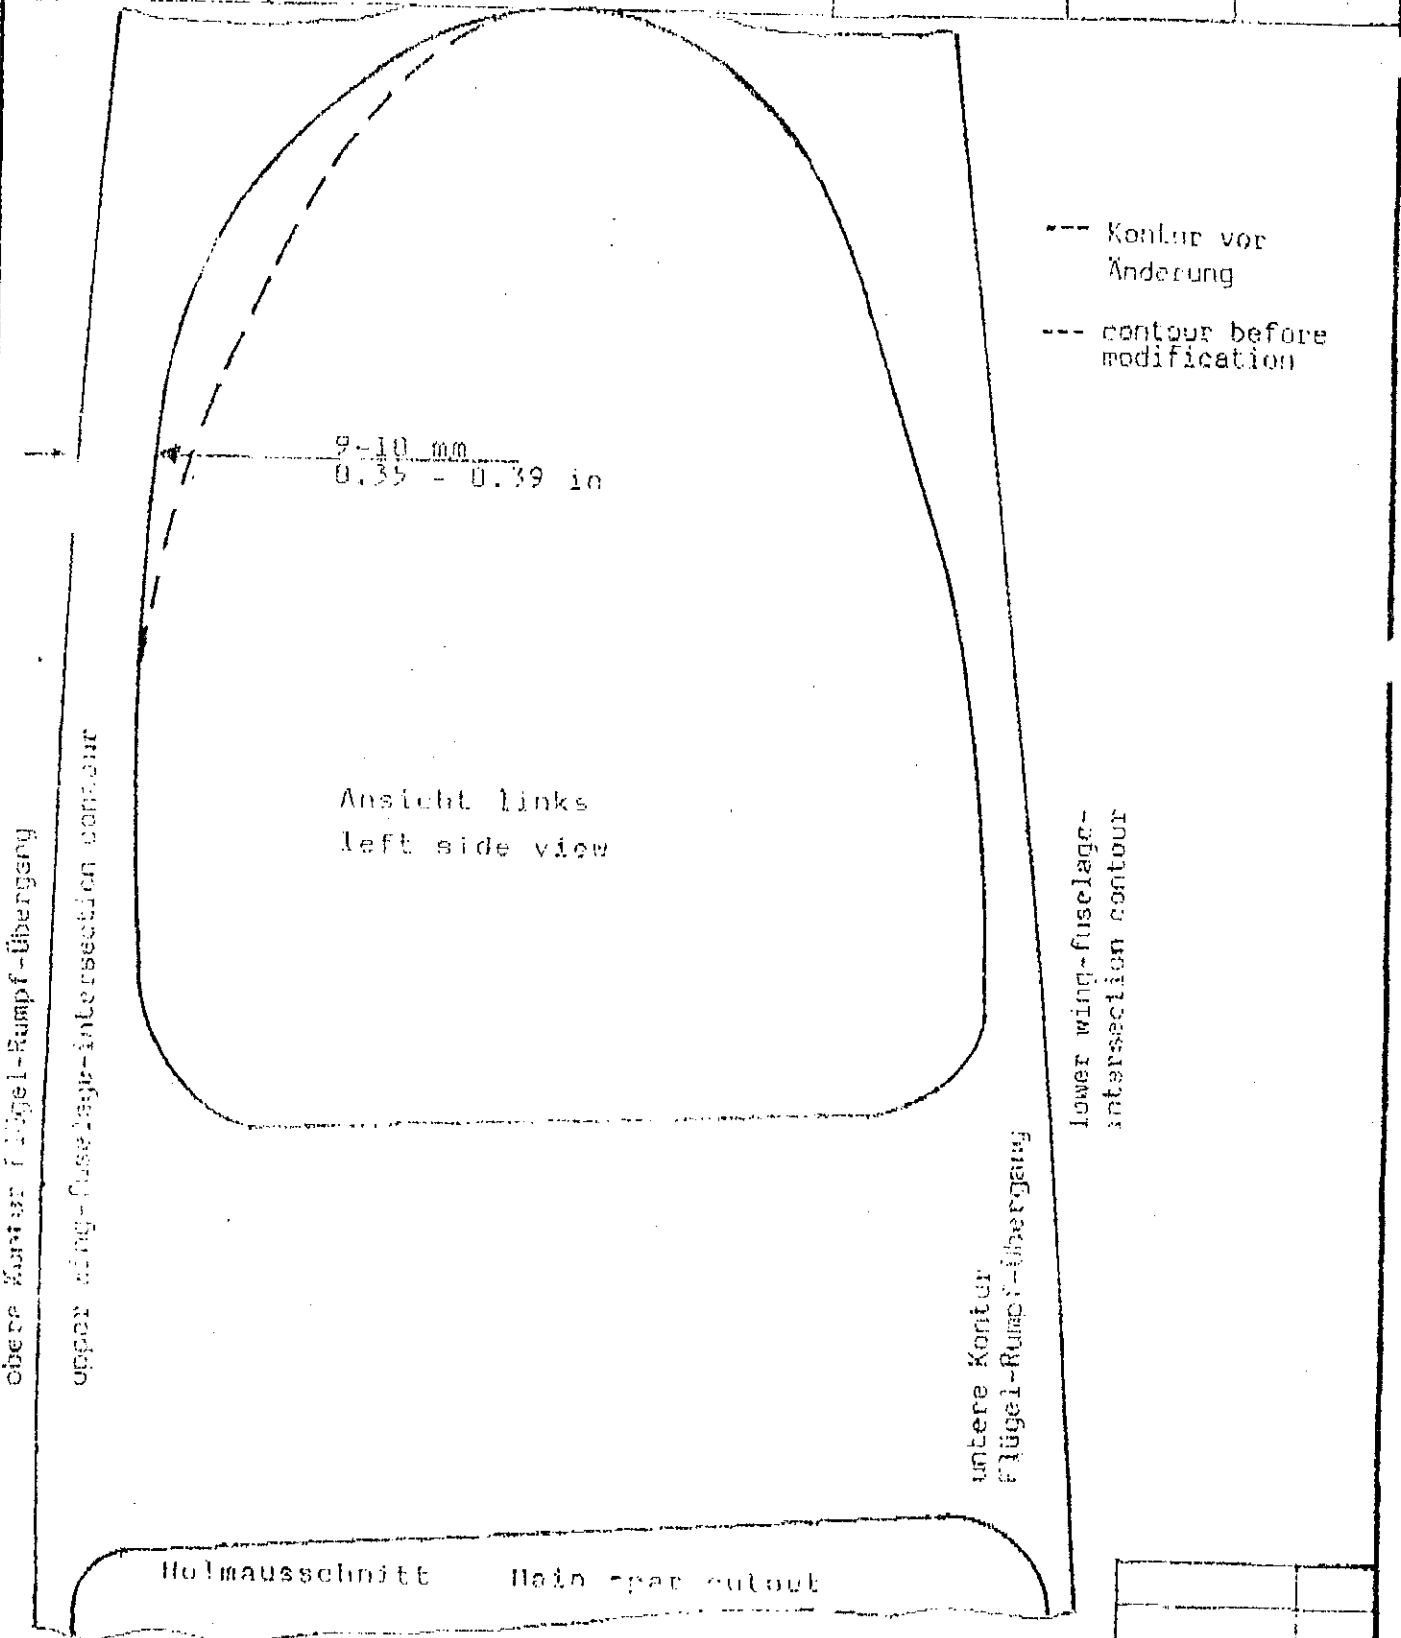
: In one case the deflector was bent to the rear during careless rigging of the wings, that the aileron movement was blocked.

- : 1.) Check deflector for straightness. If bent, parts must be exchanged.
- : 2.) Enlarge fuselage cutout in connector region to upper rear according to included drawing 4I-86 to prevent jamming in case of inadvertently bent deflectors.

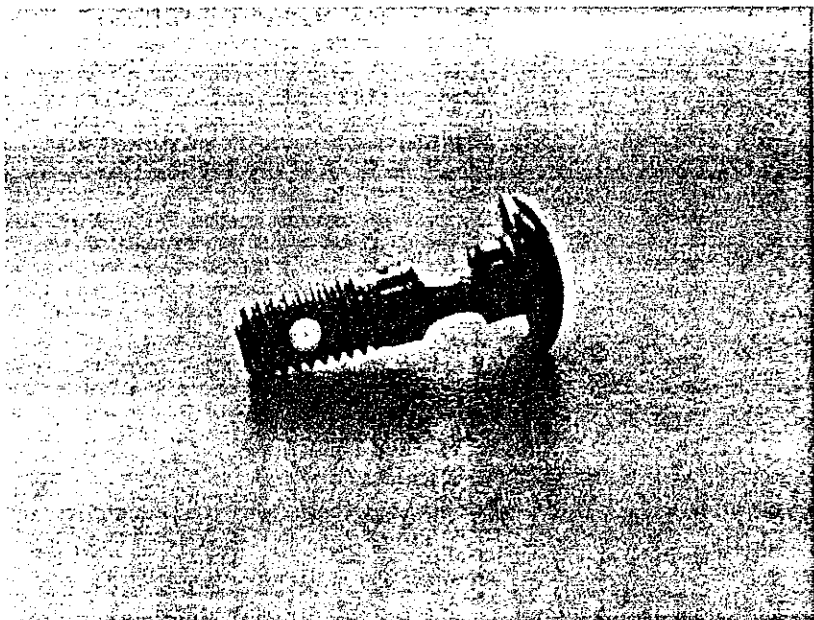
### E4. BADLY WORN CLEVIS BOLT

During initial annual inspection for British Certification, excessive play was noted at the flap operating chain to lever connection. On removing the AN23-10 bolt it was found to have been worn to approximately 1/16 inch diameter. The operating lever was also slightly elongated at the attachment hole. There were no apparent signs of lubrication. The aircraft had recently completed an annual check in the United States and had been issued with an export C of A.

Several similar cases of excess wear of this bolt appear in the CAA database.
