BRITISH GLIDING ASSOCIATION

BGA TECHNICAL COMMITTEE

TECHNICAL NEWSHEET TNS 5/6/92

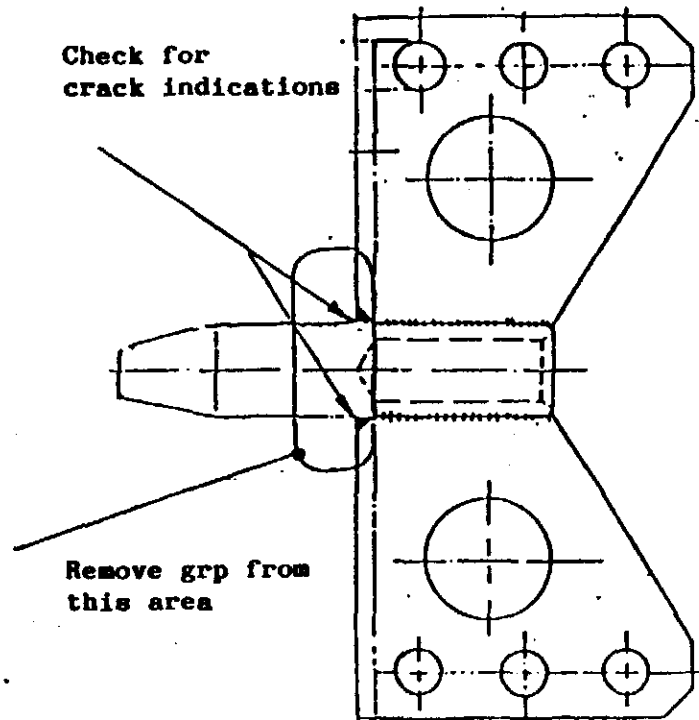
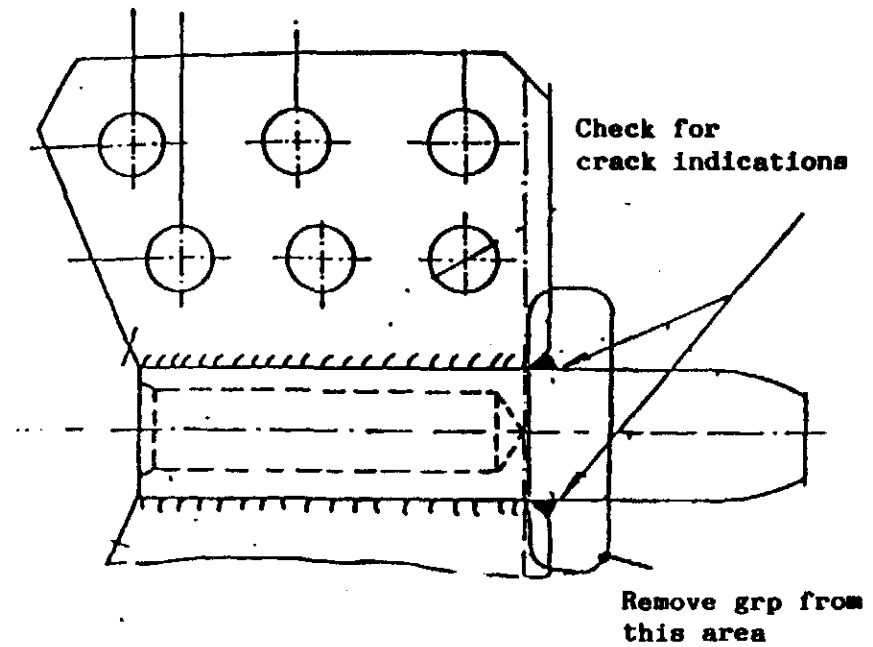
FIGURE A
(Not to Scale)

Abrupt manoeuvres and/or high speeds are prohibited. If a crack is confirmed either in the weld only or in the spigot itself, rectification must be carried out to the manufacturer's approved repair scheme before further flight.

- (v) Where the spigots are found to be not cracked either after the actions of (iii) or (iv) above, reprotect the area where the grp has been removed, either with a lacquer or a brushed coat of epoxy resin. Refit the wings to the instructions in the Flight Manual. Repeat the instructions commencing at (i) above except that only the re-protection has now to be removed, at intervals not exceeding 300 flight hours.

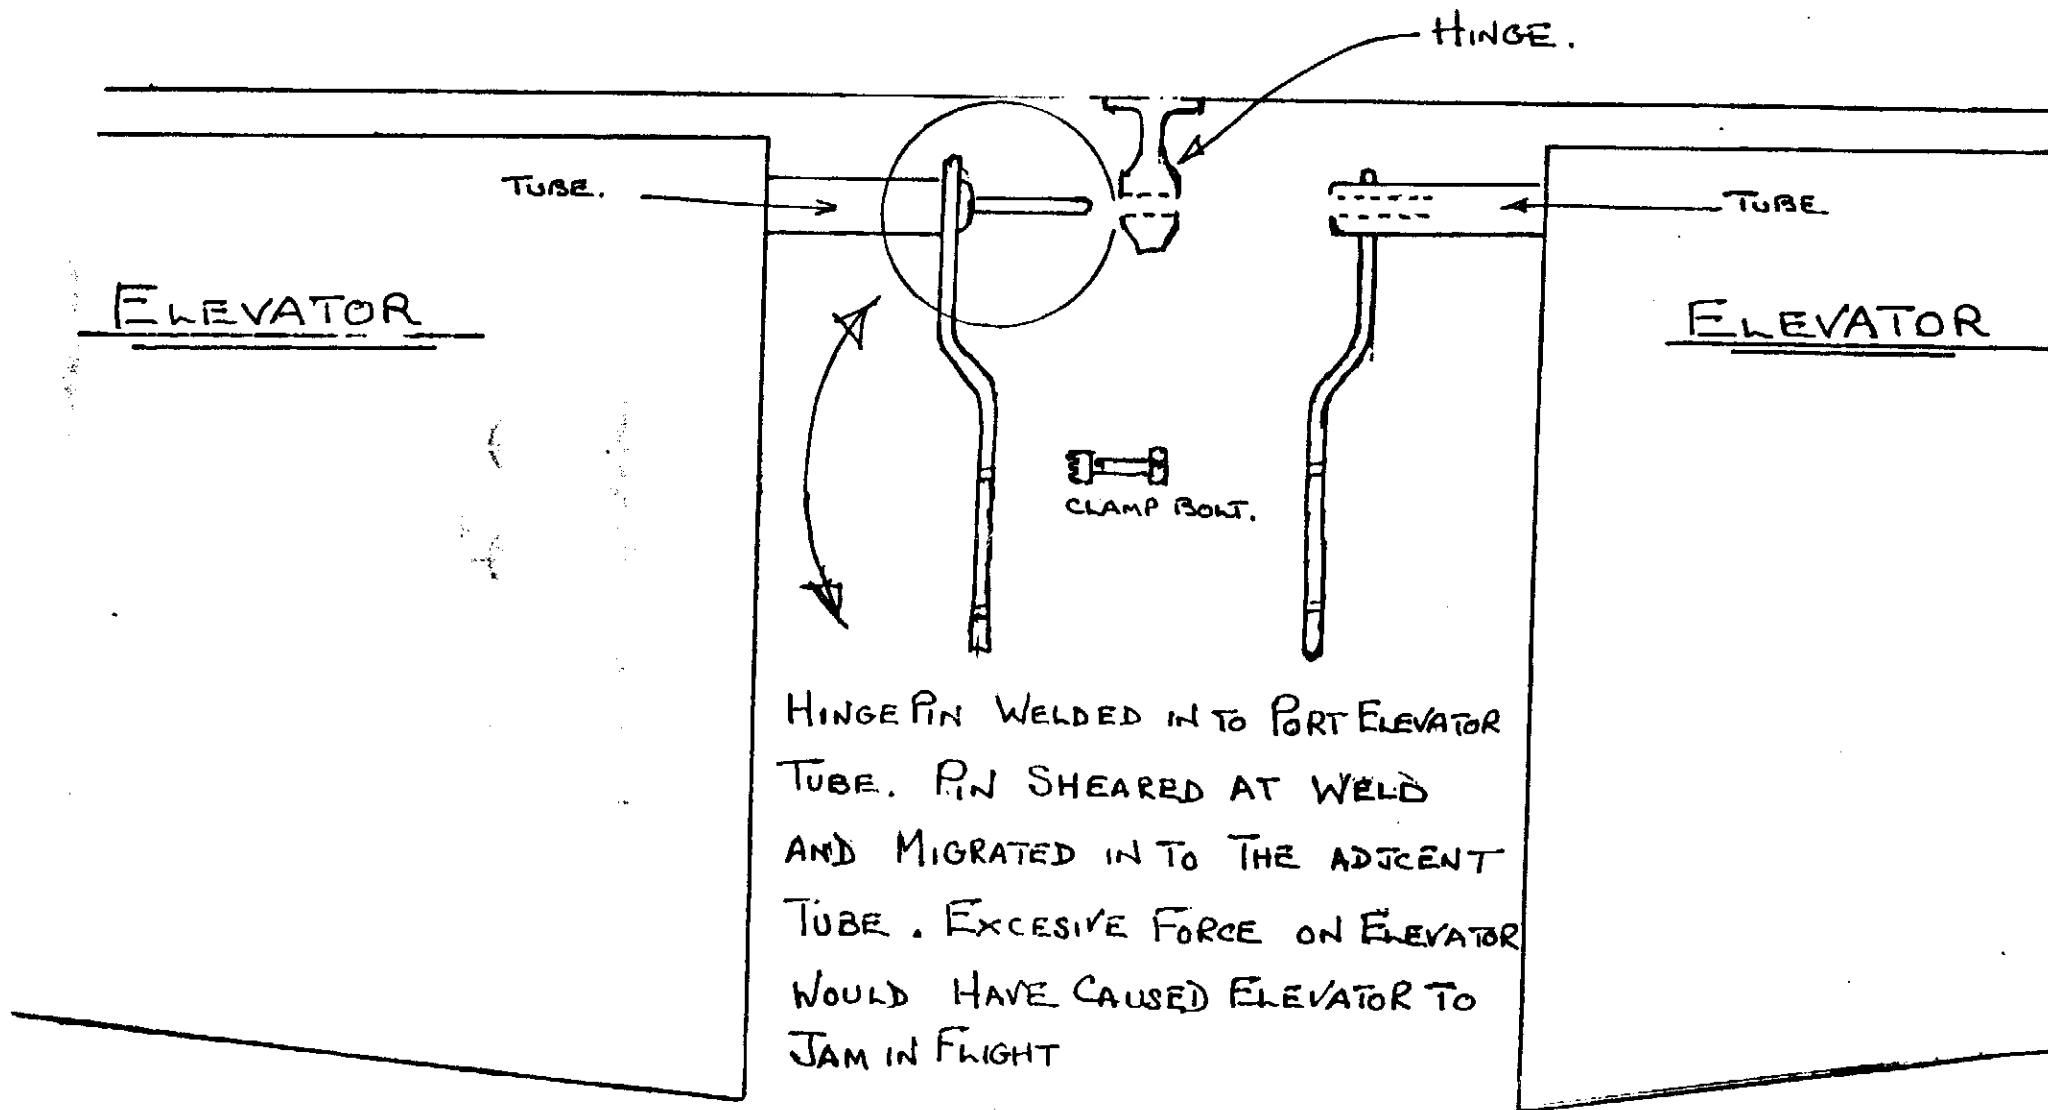
TAILPLANE.

- 1.10 ZUGVOGEL 111B, damage to elevator hinge pin at the weld. Sketch by Colin Sanders herewith, illustrates the problem.
- 1.11 ASTIR STD II. Undercarriage Lever attachment cracked. Sketch herewith from Mr. G.R. Clark - Portsmouth Naval G.C.

HINGE PIN WELDED IN TO PORT ELEVATOR
TUBE. PIN SHEARED AT WELD
AND MIGRATED IN TO THE ADJACENT
TUBE. EXCESSIVE FORCE ON ELEVATOR
WOULD HAVE CAUSED ELEVATOR TO
JAM IN FLIGHT

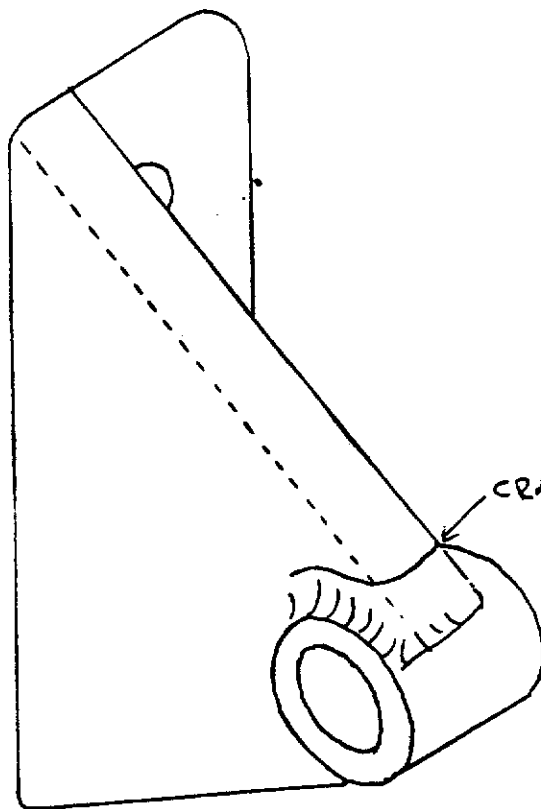
KAB

- 1.2 Grob G.109's Airworthiness Directives. Revised list herewith dated April 1992 (Issue 8), must be checked on Scheduled Maintenance.
- 1.3 KA8 Elevator Hinge Cracked. Sketch from Rattlesden G.C. is self explanatory.

PLEASE SEE BELOW A SKETCH OF A KB ELEVATOR HINGE
FOUND CRACKED. ALSO FOUND RECENTLY WAS A KB TOP
RUDDER HINGE, OF THE SAME DESIGN, CRACKED IN A SIMILAR WAY.
THESE RUDDER HINGES ARE ALREADY ^{THE} A SUBJECT OF T.N.S.'S

CRACKED HERE, RUNNING ROUND
THE OUTSIDE OF THE WELD

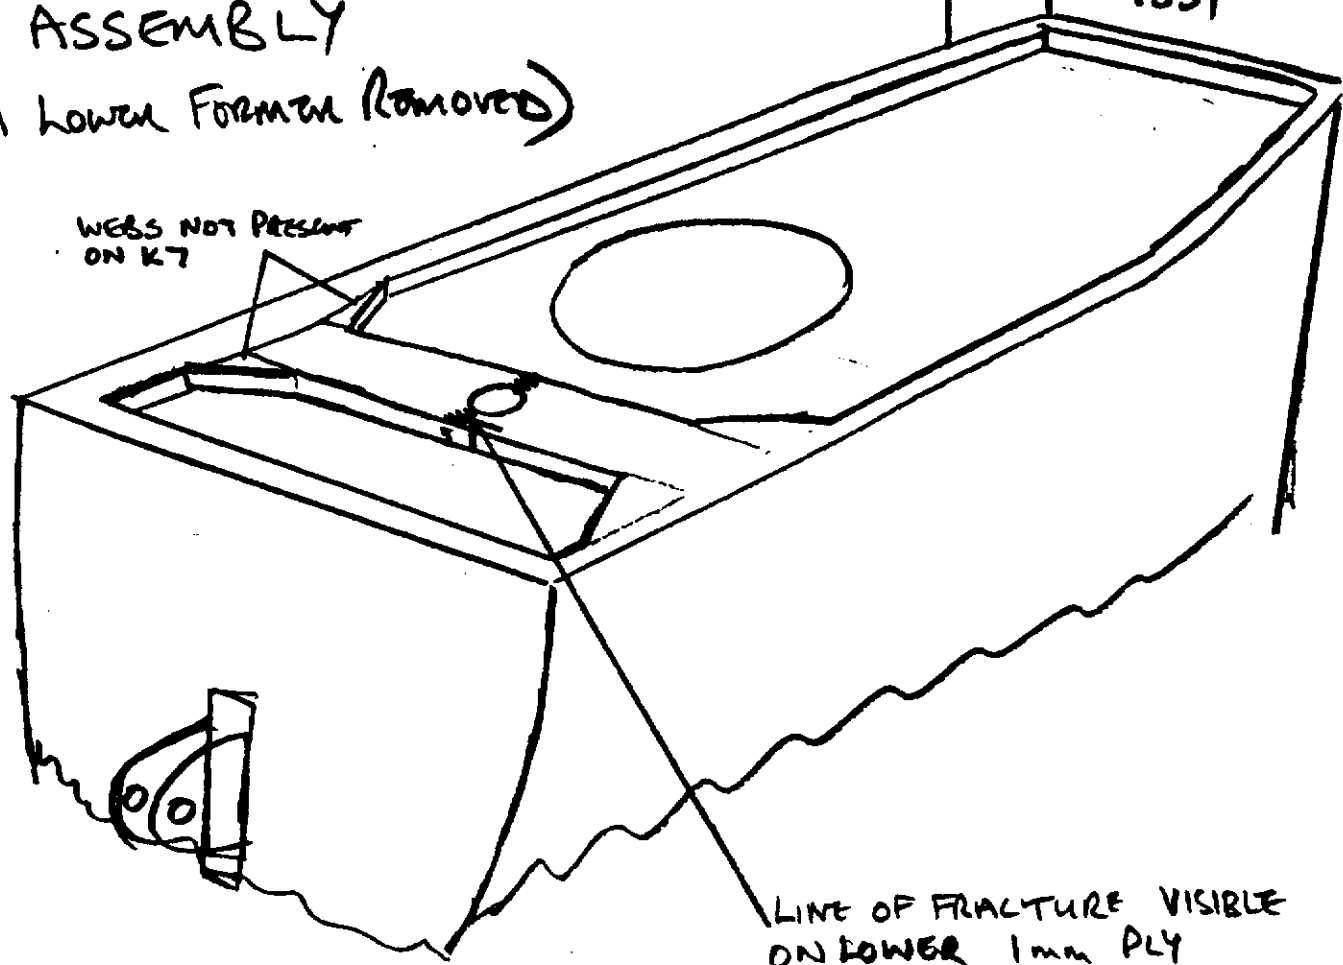
ASK 13 & ASK 7
 FIN ASSEMBLY
 (WITH LOWER FORMER REMOVED)

- 1.12 ASK7 & ASK13 Fin Post Damage. Sketch from Steve Wilkinson - Portsmouth Naval G.C. points you towards the problem area.
- 1.13 "Turbo" Engine Vibration Levels can be so high that instruments disintegrate and fill the cockpit with debris! Reported by RAFGSA Cranwell. (Possible advert for Loctite?).
- 1.14 PA18 (Piper Cubs) Failure of the Tailplane Trim Actuator. AAIB Bulletin 4/92 herewith, refers to this recurring problem.
- 1.15 CAA Airworthiness Notice No. 88 herewith requires action to fit LOW BUS BAR WARNING SYSTEMS, on aircraft (including SLMG's), unless the owner/operator applies for a dispensation.
- 1.16 Grob G.109 Aileron / Airbrake Bellcrank - attachment plate and studs found corroded when applying TM 817-29 inspection procedure.

LINE OF FRACTURE VISIBLE
 ON LOWER 1mm PLY
 FORMER

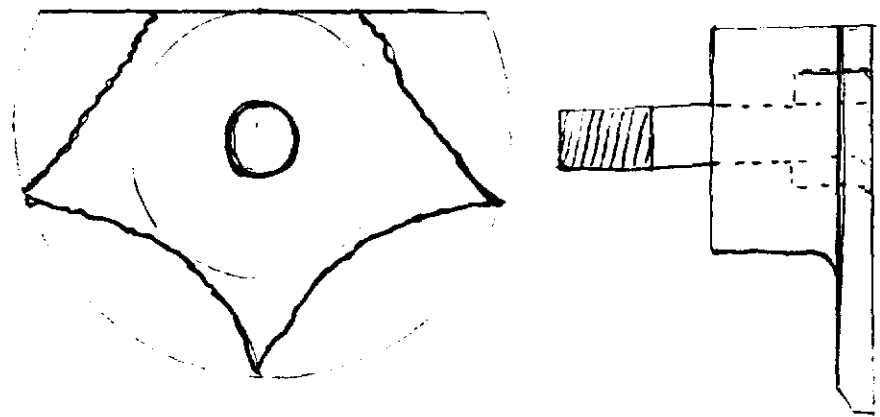
ASTIR. II.

Astir Std II under carriage Lever Retaining Bolt Attachment Plate is cracked in four places.

Whilst carrying out annual C of A the bracket was found to be loose inside the fibre glass sandwich which holds it to the fuselage side wall. Starring of the Gel coat on the outside in line with the leading edge of the bracket was noticed. Further investigation was then carried out.

Four layers of matt were removed which retain the bracket to the fuselage side wall. The bracket was then accessible and found to be cracked in four places.

The bracket seems to be made of a brittle cast alloy.

CRACKED IN FOUR PLACES AS INDICATED

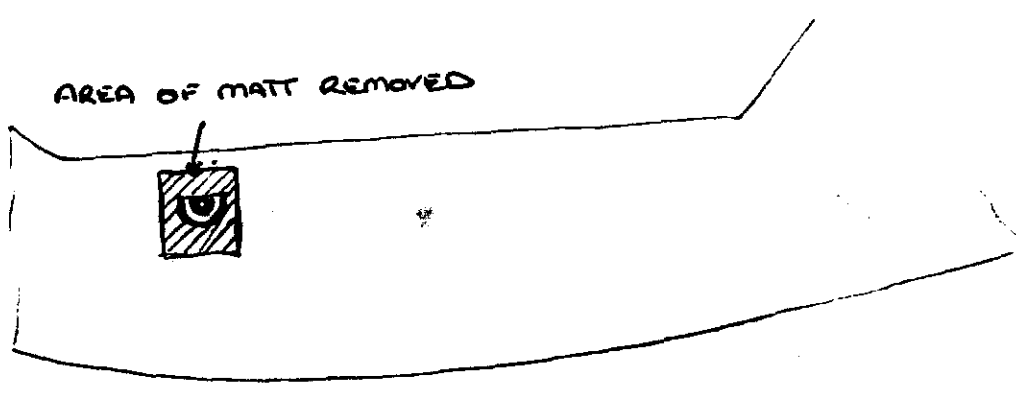
AREA OF MATT REMOVED

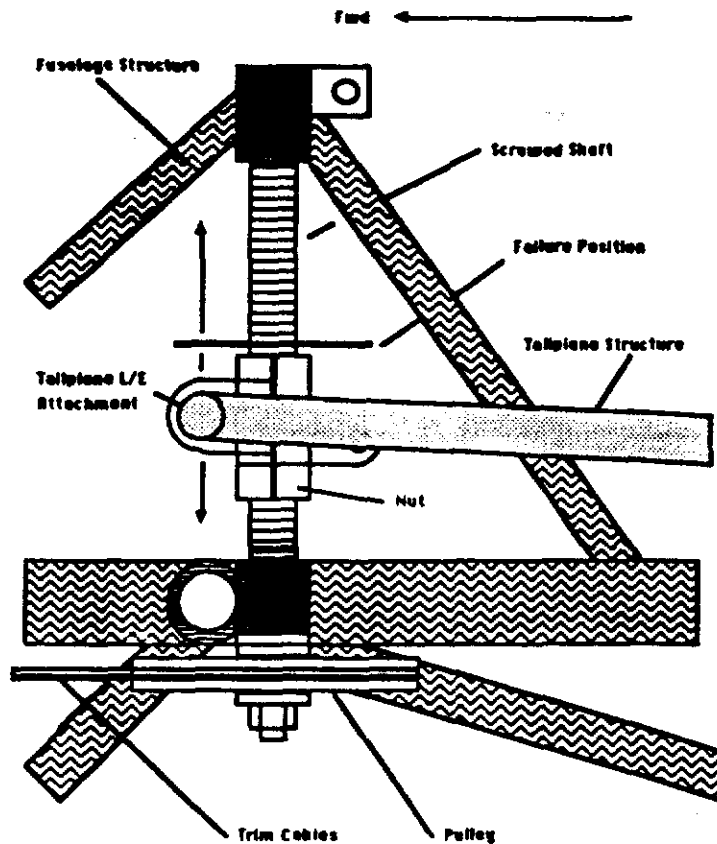
Tailplane Trim Mechanism Installation - Schematic

The shaft had failed at its mid-point within a region which exhibited excessive wear on the screw thread. Evidence of fatigue cracking was present on the fracture surfaces, originating from the entire circumference of the thread root. Metallurgical examination of the screw material showed it to conform to the manufacturer's specification.

The shaft was fitted to the aircraft in March 1984 and had accumulated a total time of 2,448 hours. Data extracted from the records showed that, on average over the life of the screw, the aircraft had achieved 6.89 aerotows per hour, with a total number of flights of 16,866. The last recorded maintenance on the screw was in August 1991, 102 hours before the failure, when it was found to be 'loose'. It was re-shimmed, tested and found to be satisfactory. Comments were made by an experienced engineer on type to the effect that any excessive shimming used to eliminate side play on the tailplane front or rear attachments can result in high friction in the system and introduce side loads on the screw. He also stated that a check for increased friction should be accomplished after such shimming. There is no related guidance given in the Maintenance Manual on this subject.
