BRITISH GLIDING ASSOCIATION

BGA TECHNICAL COMMITTEE

TECHNICAL NEWSHEET TNS 1/2/92

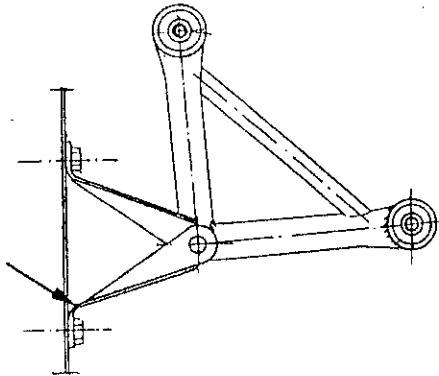
Reason:
 On some gliders of the model ASK 13 the bearing brackets of the airbrake control circuit have broken at the wing root rib. The failure was caused by too high toggle forces which resulted from a wrong adjustment of the toggle in the airbrake control circuit.

1. Carefully inspect the bearing brackets of the airbrake control circuit at the wing root ribs as well as the root ribs themselves for damage, cracks etc. In case of doubt the paint must be removed off the bracket. In most cases the breaks were found at the bottom of the front bearing bracket; refer to the drawing on Sheet 2 of this TN !
 Where damages at one bearing bracket are found, this part must be exchanged; where a root rib is damaged, it requires repair.

2. Check the toggle force as described under Point 3.) and where necessary adjust.
3. Adjustment Instructions For Airbrake Toggle
 - 3.1 Undo the airbrake return spring at the front operating lever in the cockpit.

- 3.2 The airbrake toggle - each side separately - must be adjusted such that a force of approx. 3 to 4 daN is obtained at the front airbrake operating lever when measured from above (measurement distance from the pivot point of the operating lever towards the hand grip = 300 mm).

- 3.3 Adjustment of the toggle force is done by turning in or out the adjusting heads in the fuselage. If the correct adjustment values cannot be achieved here, the thickness of the airbrake stop blocks inside the wings must either be increased or cut back.

- 3.4 Take care that the toggle must not go over the dead point which would cause the airbrakes to extend again.
- 3.5 For both airbrakes together, the hand forces must not exceed approx. 6 daN, when measured at the front airbrake operating lever from above.
- 3.6 Re-fit the airbrake return spring at the front operating lever in the cockpit.
4. This Technical Note must be inserted as appendix into the ASK 13 Flight and Maintenance Manual and this action must be entered into the "Amendments" on page 2.
5. The inspection of the bearing brackets and of the toggle force of the airbrake control circuit (as described under points 1. thru 3.) must be included from now on within each annual C. of A. inspection.

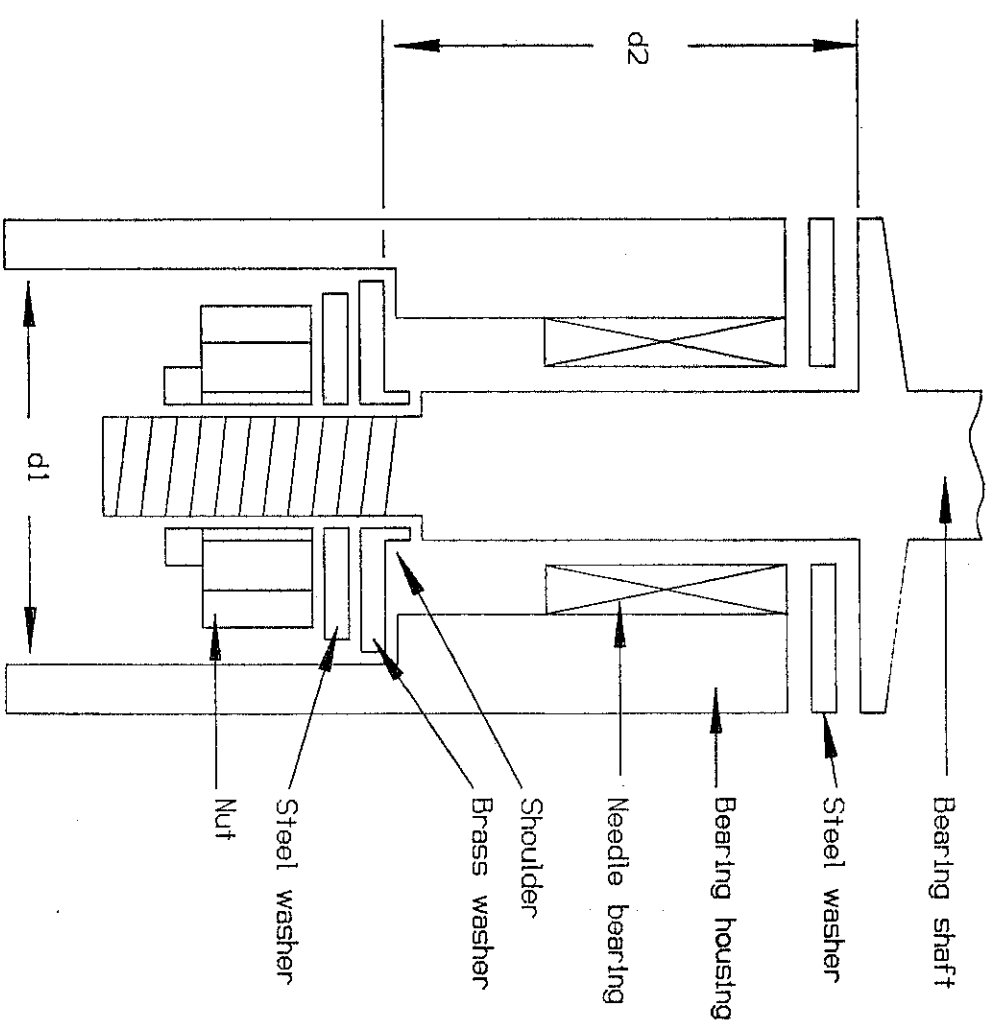
Loose Rudder Fixing, LS6-17.5

- 1 Outside diameter of brass washer is similar to 'd1'. So brass washer binds against bearing housing.
- 2 'd2' is too short. So assembly is difficult to move when nut is tightened.
- 3 After several movements of rudder the nut becomes loose and the assembly becomes free. Everything seems to be OK.
- 4 But the nut is no longer tight!

- 1 About 0.5 mm has been removed from the outside diameter of the brass washer.
- 2 The steel washer (was 1.5 mm thick) has been replaced by a washer made from brass shim-stock (0.4 mm thick).

Fit modified brass washer having smaller outside diameter and longer shoulder. Tighten assembly and check free play. Reduce length of shoulder to get perfect fit with just a little play.

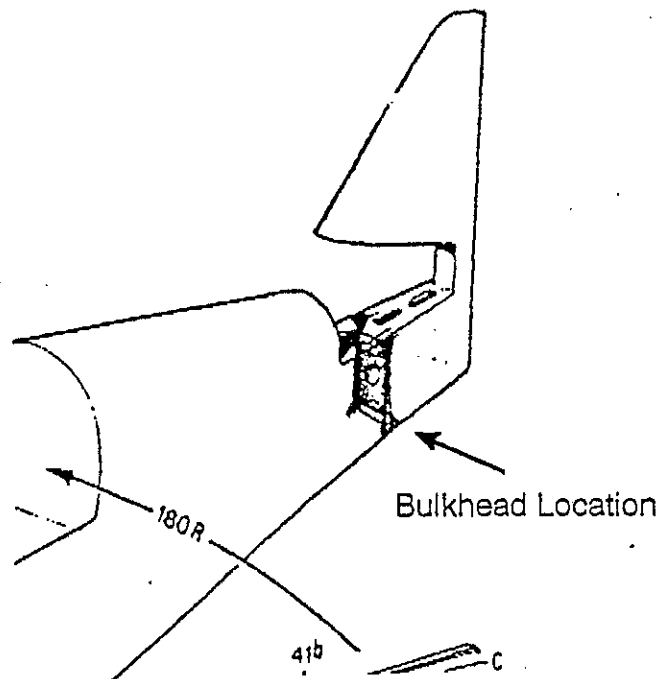
During scheduled maintenance and defect rectification, it was noticed that the bulkhead adjacent to the stabilator main attachment point was loose on the left hand fuselage side frame. Further investigation revealed that the bulkhead had separated from the frame along the glued joint for approximately 60% of its length.

The extent of the defect on one aircraft was considerably greater than any other. It was found that the failure in most cases was along a manufactured glue joint, i.e.

glue failure or incorrectly glued joints. One aircraft suffered from failure of the side frame, possibly due to poor wood grain used in manufacture, since the failure occurred along the heavy

grain section. The aircraft concerned were late model aircraft, each having flown approximately 1800 hours. The drawing shows the area to look for.

The manufacturer was advised and a repair scheme obtained, incorporated and the aircraft returned to service.
