BRITISH GLIDING ASSOCIATION

BGA TECHNICAL COMMITTEE

TECHNICAL NEWSHEET TNS 3/4/92

- PART 1 Airworthiness "AGGRO" Please add to the 1992 BGA Red Pages. (Compendium of Airworthiness Directives, Mandatory Modifications and Special Inspections).

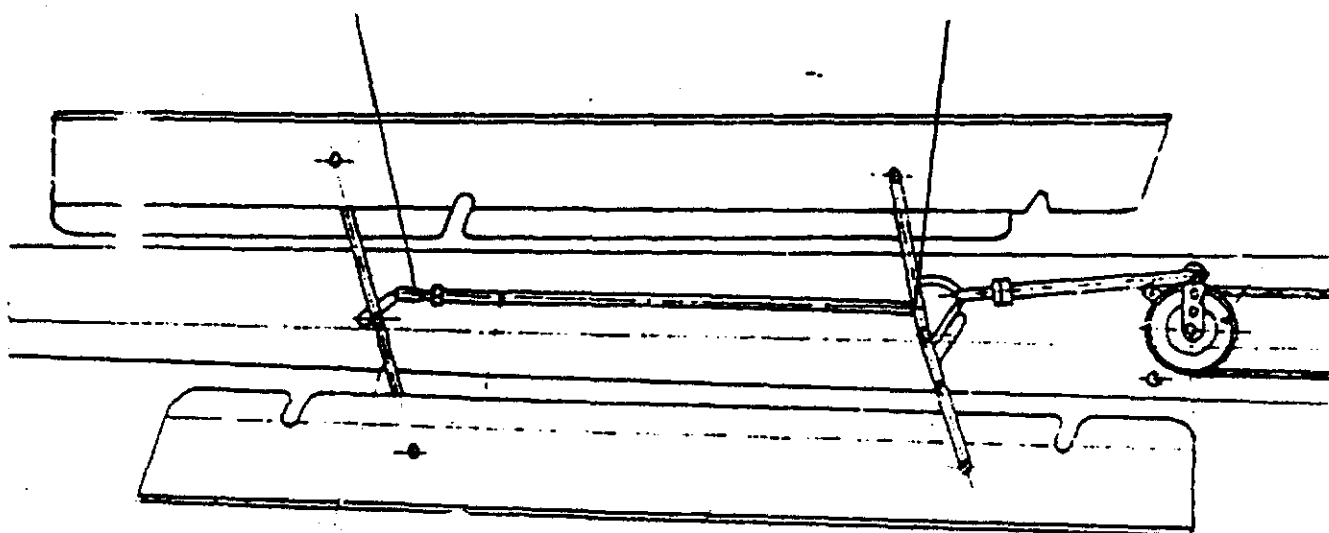
Airbrake Push Full Rod Fork End.

- 1.1. Bocian Speed-brake control Rod-End Fork broken - sketch herewith (Reported by Angus G.C. - Arbroath).
 - 1.2. Slingsby Kestrel - Control drive unit cracked at the weld - (Sketch herewith).

On inspection it was found that one leg of the fork end was broken off at the inboard end of the Push Full rod on the Port Wing Airbrake

Broken Fork End Leg

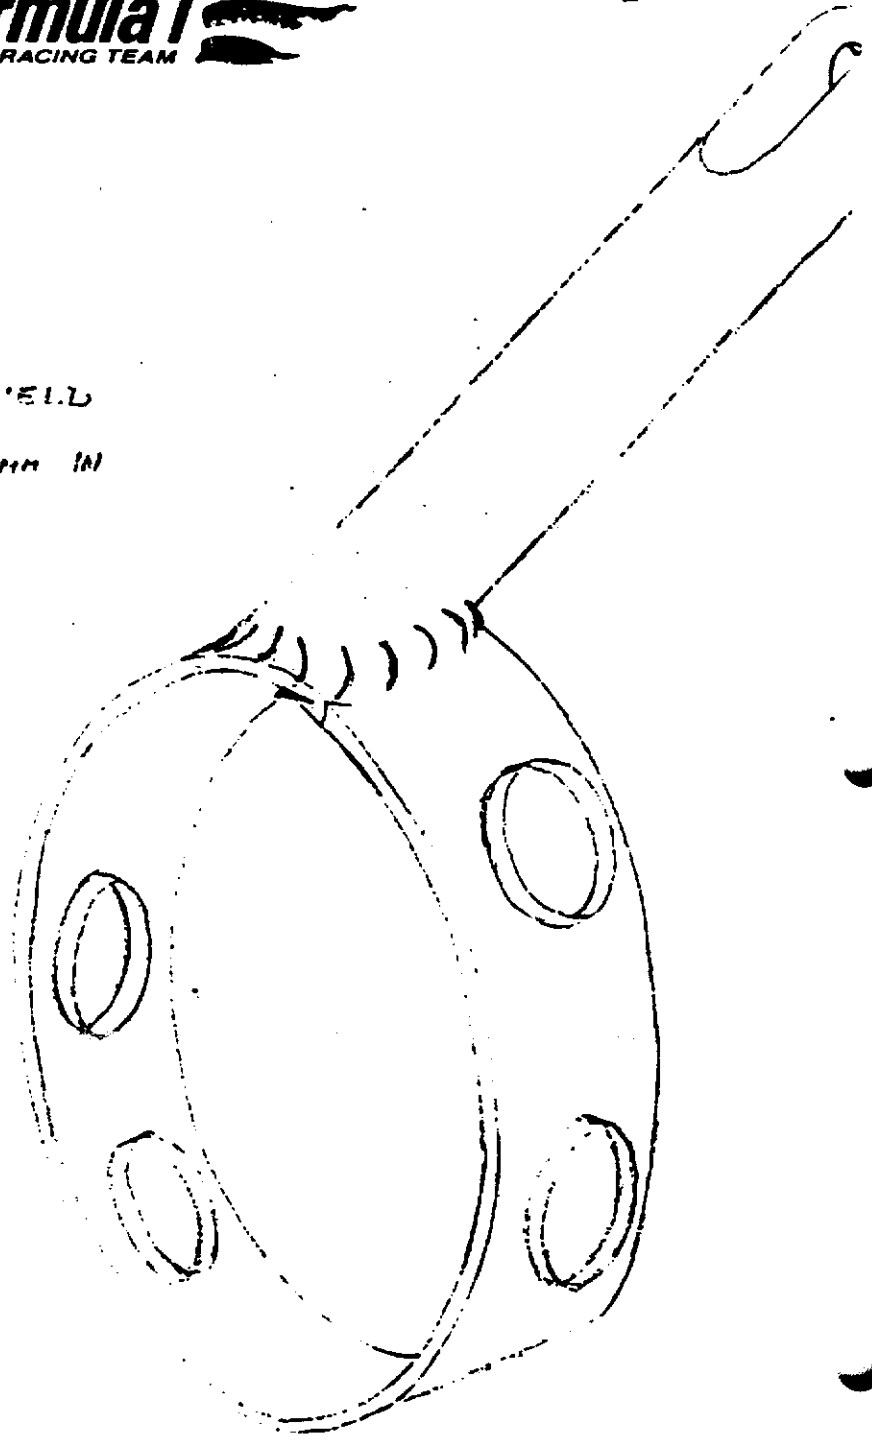
SLINGSBY Kestrel

CRACKED AT BASE OF WELD
AT THIS POINT APPROX 2mm IN
FROM EDGE.

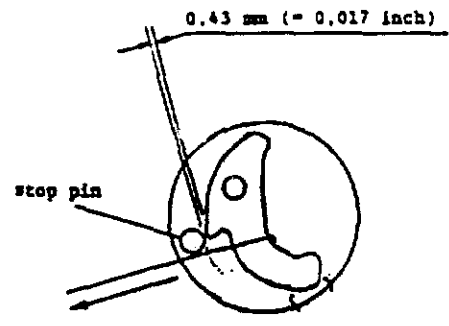
GROB 2500 ENGINE

Procedure: During engine inspections too less clearance between flyweights and stop pin has been found.

Action: To prevent a possible damage of the magnetos or the engine, an inspection for the clearance between flyweights and stop pin is required. Perform as follows:

- a. Pull the flyweight outwards by using a proper tool (for example a stiff, bended wire), measure the clearance and note the value. The clearance must have a minimum of 0,43 mm (=0,017 inch).
 - b. Repeat the measurement for the second flyweight.

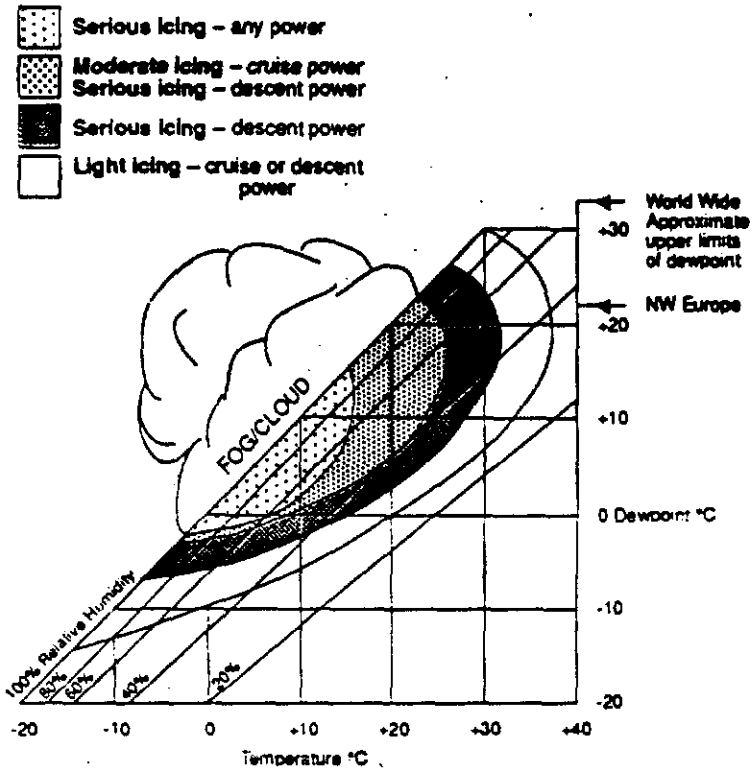
See Chart above, extracted from Safety Sense Leaflet 14, 'Piston Engine Icing'.

Carb icing is most likely at low power settings or at idle (due to the massive temperature drop around the throttle butterfly at the low manifold pressure that results from reduced or idle rpm).

danger which can catch pilots out at any time. **USE THE CARBURETTOR HEAT REGULARLY AND GIVE IT TIME TO WORK! CONSIDER THE CARB HEAT CONTROL TO BE AN ON/OFF CONTROL, ie FULL ON OR FULL OFF.**
