BRITISH GLIDING ASSOCIATION

BGA TECHNICAL COMMITTEE

TECHNICAL NEWSHEET TNS 11/12/92

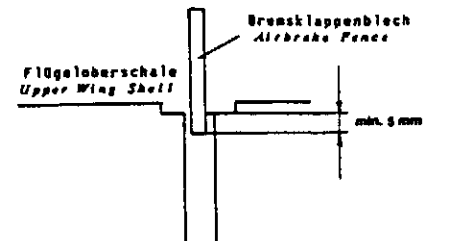
Procedure: Excessive wear of the airbrake stops - undetected during periodic inspections - may allow the airbrakes to extend beyond their normal value and cause jamming of the airbrake fence on the upper shell of the wing.

1. Inspection of the airbrake stops
As a precautionary action, the airbrake stops (outboard edge of the airbrake boxes) must be inspected for condition and wear. Cracks in the gelcoat around the outboard end of the airbrake box may indicate damage to the GRP laminate underneath. With the airbrakes fully extended wear to the airbrake stops must be checked; assure that the outer airbrake swivel levers are in contact with the stops during this check: The lower edge of the airbrake fence must overlap the bottom of the airbrake cap recess in the upper wing shell by 5 mm min. (see drawing below) Normal wear is acceptable as long as the upper condition is fulfilled.

2. Repair of the airbrake stops
If, during the inspection according to action 1, an excessive wear of these stops is found, a repair according to the Repair Instructions must be performed prior to the next take-off.

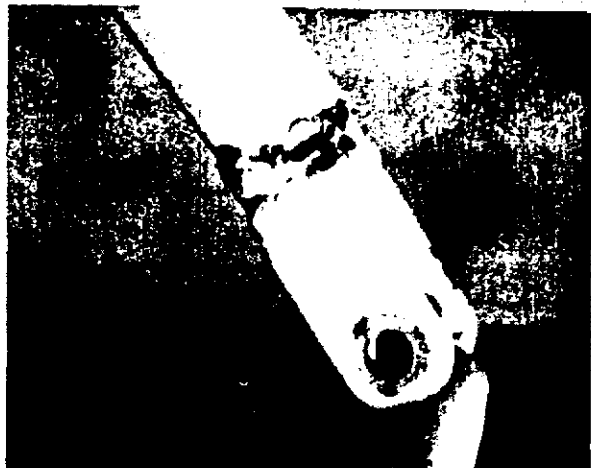
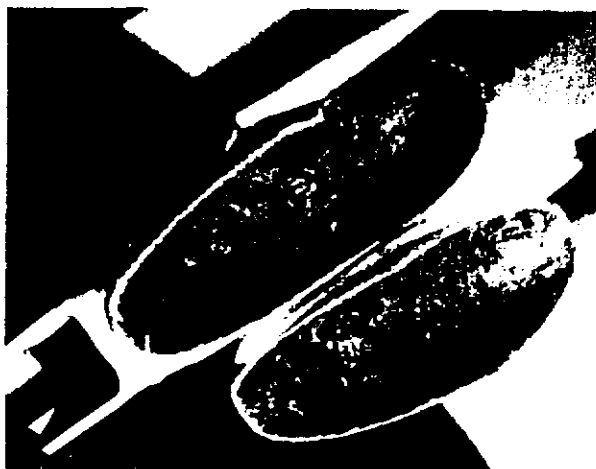
SHORT DESCRIPTION: Thursday, July 30th, 1992, Pilot B. made a training flight on his Nimbus 3 T starting and landing "on rough grass strip" of Rieti airport, Italy. Next mornings preflight check showed the total failure of the elevator function: The vertical tube acting on the elevator was broken on its lower end showing heavy rust. Fortunately a fatal accident was avoided. The possibility of "a very singular case" was refuted by the following facts:

- A. This report gave rise to an endoscopic control of the same tube of Ventus bT HB-2169, year of construction 1985. Result: heavy rust inside the tube. Fotos 3, 4 Max Bachmann.

- E. Results of additional investigations: Since 1987 - after revealing the rust problem ? - the vertical tube was provided at its lower end with a 6 mm Ø drainhole and the little screw controlhole at the upper end was closed. No warning or recall was adressed to earlier customers. Also, later rust water flow out of the vertical rear tube, when the fuselage was turned in upside down position, had no sufficient warning effect.

Vertical drive tubes without drain holes must be inspected as soon as possible, and modified or replaced. (Leaflet herewith).

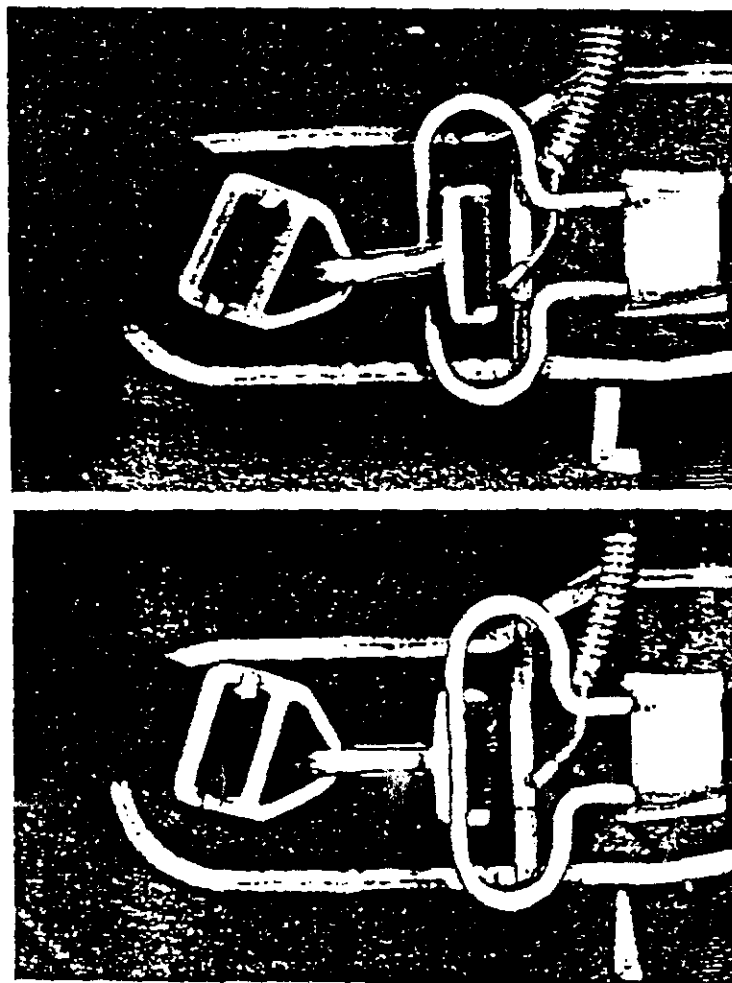
This was discovered after the student stepped out of the glider.

This topic is associated with parachutes with a chest fastening near to the 'D' ring. It is possible to pass the clip through the 'D' ring before clipping to the buckle. The implications if you had to bail out are almost certainly fatal.
