BRITISH GLIDING ASSOCIATION

BGA TECHNICAL COMMITTEE

TECHNICAL NEWSHEET TNS 7/8/92

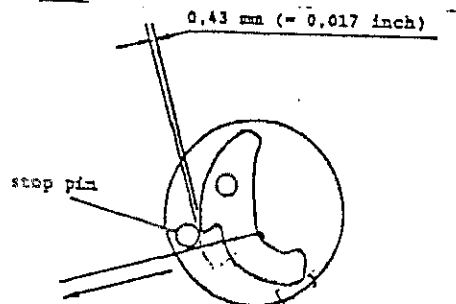
I. Clearance flyweight and stop pin (measured at the heel)

**Procedure:** During engine inspections too less clearance between flyweights and stop pin has been found.

a. Pull the flyweight outwards by using a proper tool (for example a stiff, bended wire), measure the clearance and note the value. The clearance must have a minimum of 0,43 mm (=0,017 inch).

Warning: If the clearance is less than 0,43 mm (=0,017 inch), further operation of the engine with this magneto is not allowed, and the manufacturer must be contacted immediately.

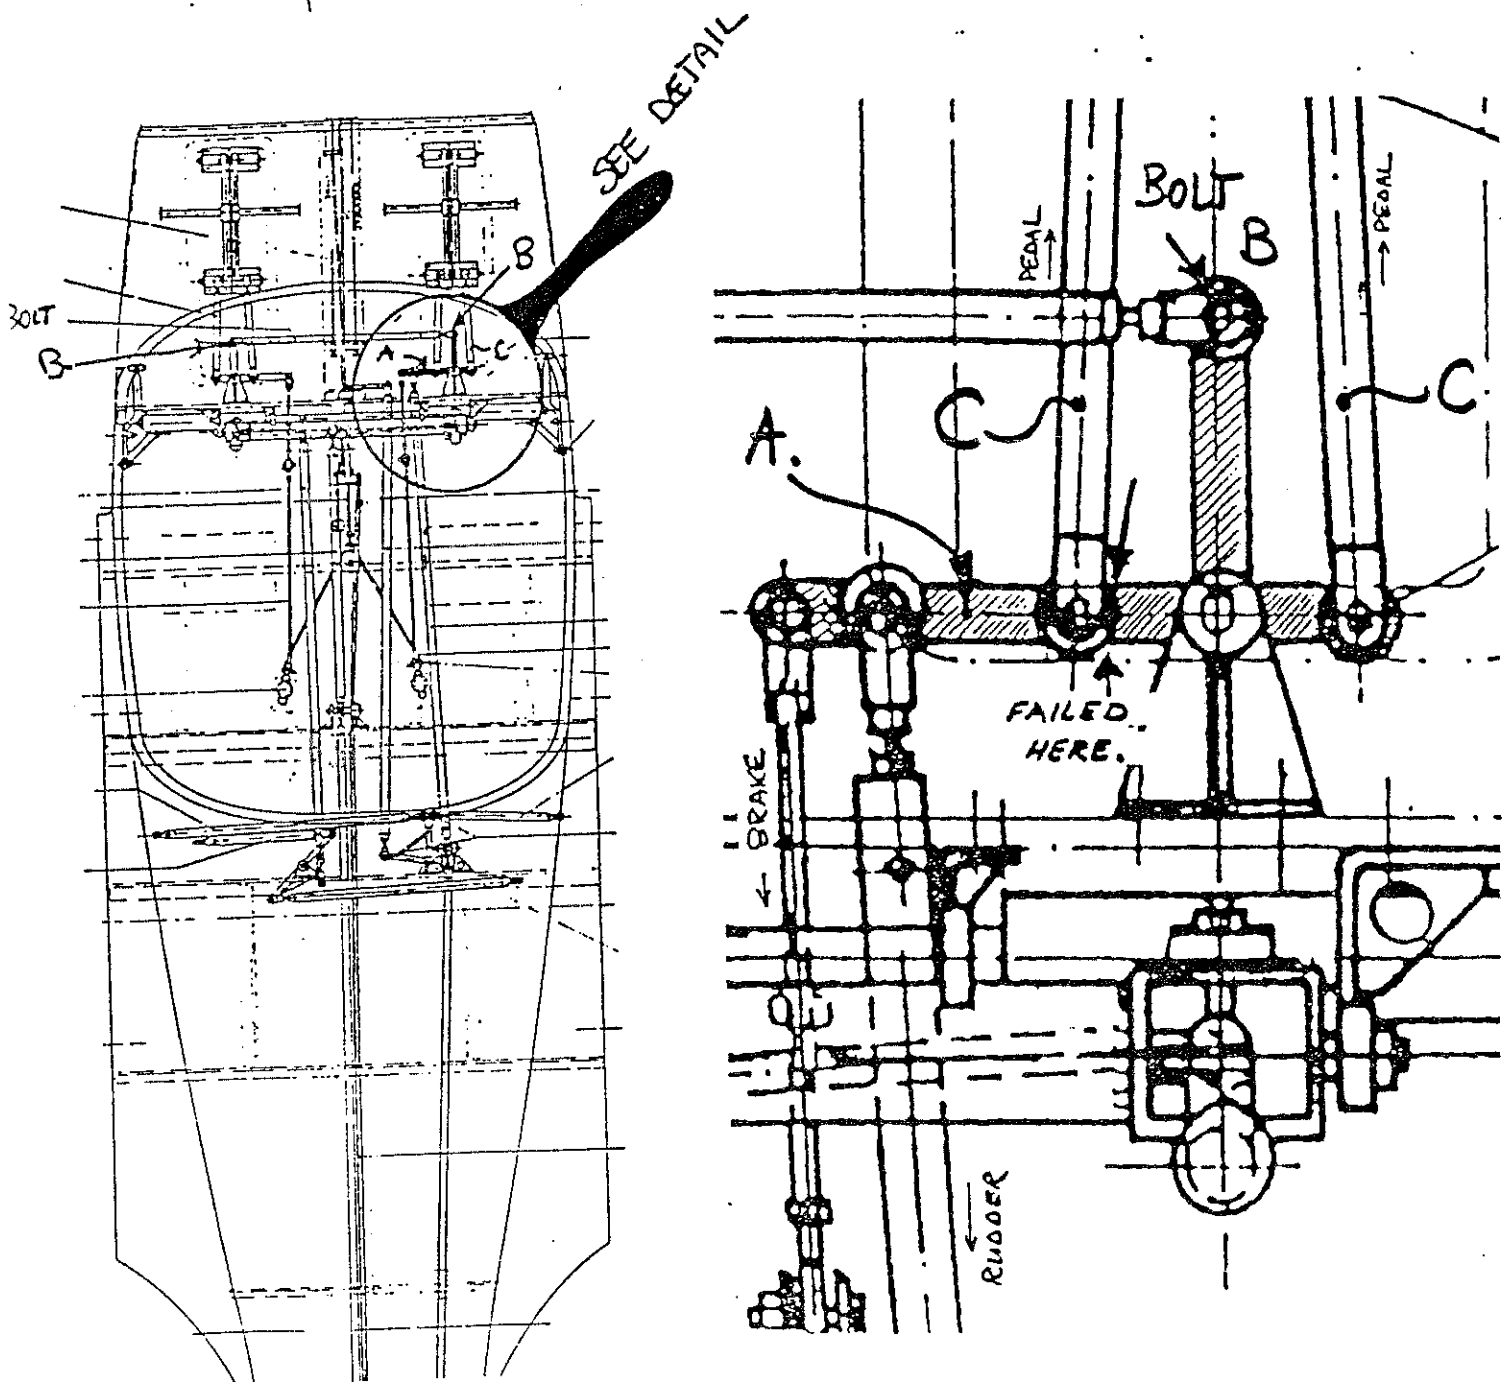
SUBJECT : GLOB G109 - RUDDER BELLCRANCK (A)  
FAILURE

The G109 motorsailplane PH-789 (s/n 6038) experienced a RH Rudder Bellcrank Failure in flight. An uneventful landing was made. The aircraft had 3285 hours.

The Bellcrank (ref. A in fig. 1) failed at the location of a bearing and a weld.

During the inspection it was also noticed that the bolts B (RH and LH) were both installed head-down i.s.o. head-up as per installation drawing 109-4200 (11-03-1991).

The bolts were intentionally installed reversed to give clearance to the rudder pedal rods (C).

The head-up installation would have resulted in an interference between the bolt and the rods.

1. RLD will issue an AD (BLA) for a one time inspection of the Bellcrank and the bolt installation.
2. Grob will be informed and requested to advise about the method of inspection and future actions.
3. LBA will be informed.
4. The failed parts will be sent to Grob (via the a/c owner).

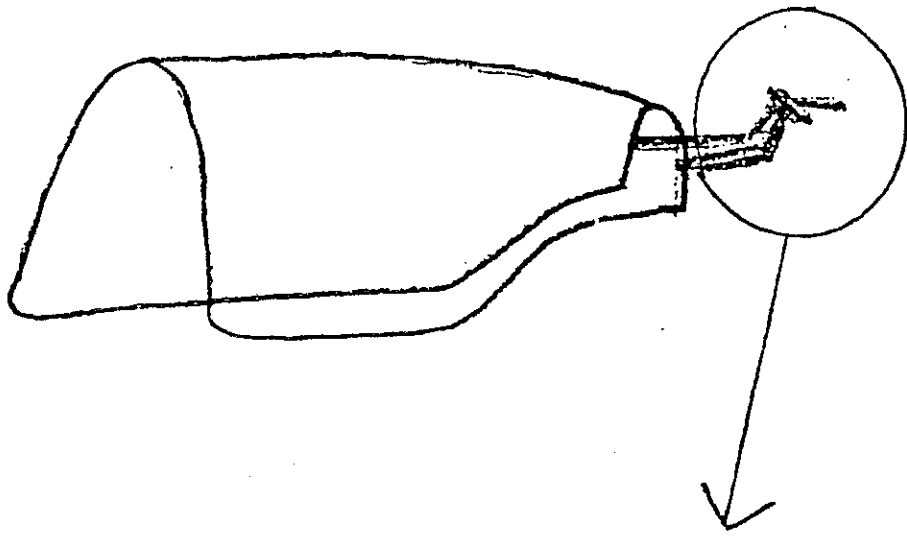
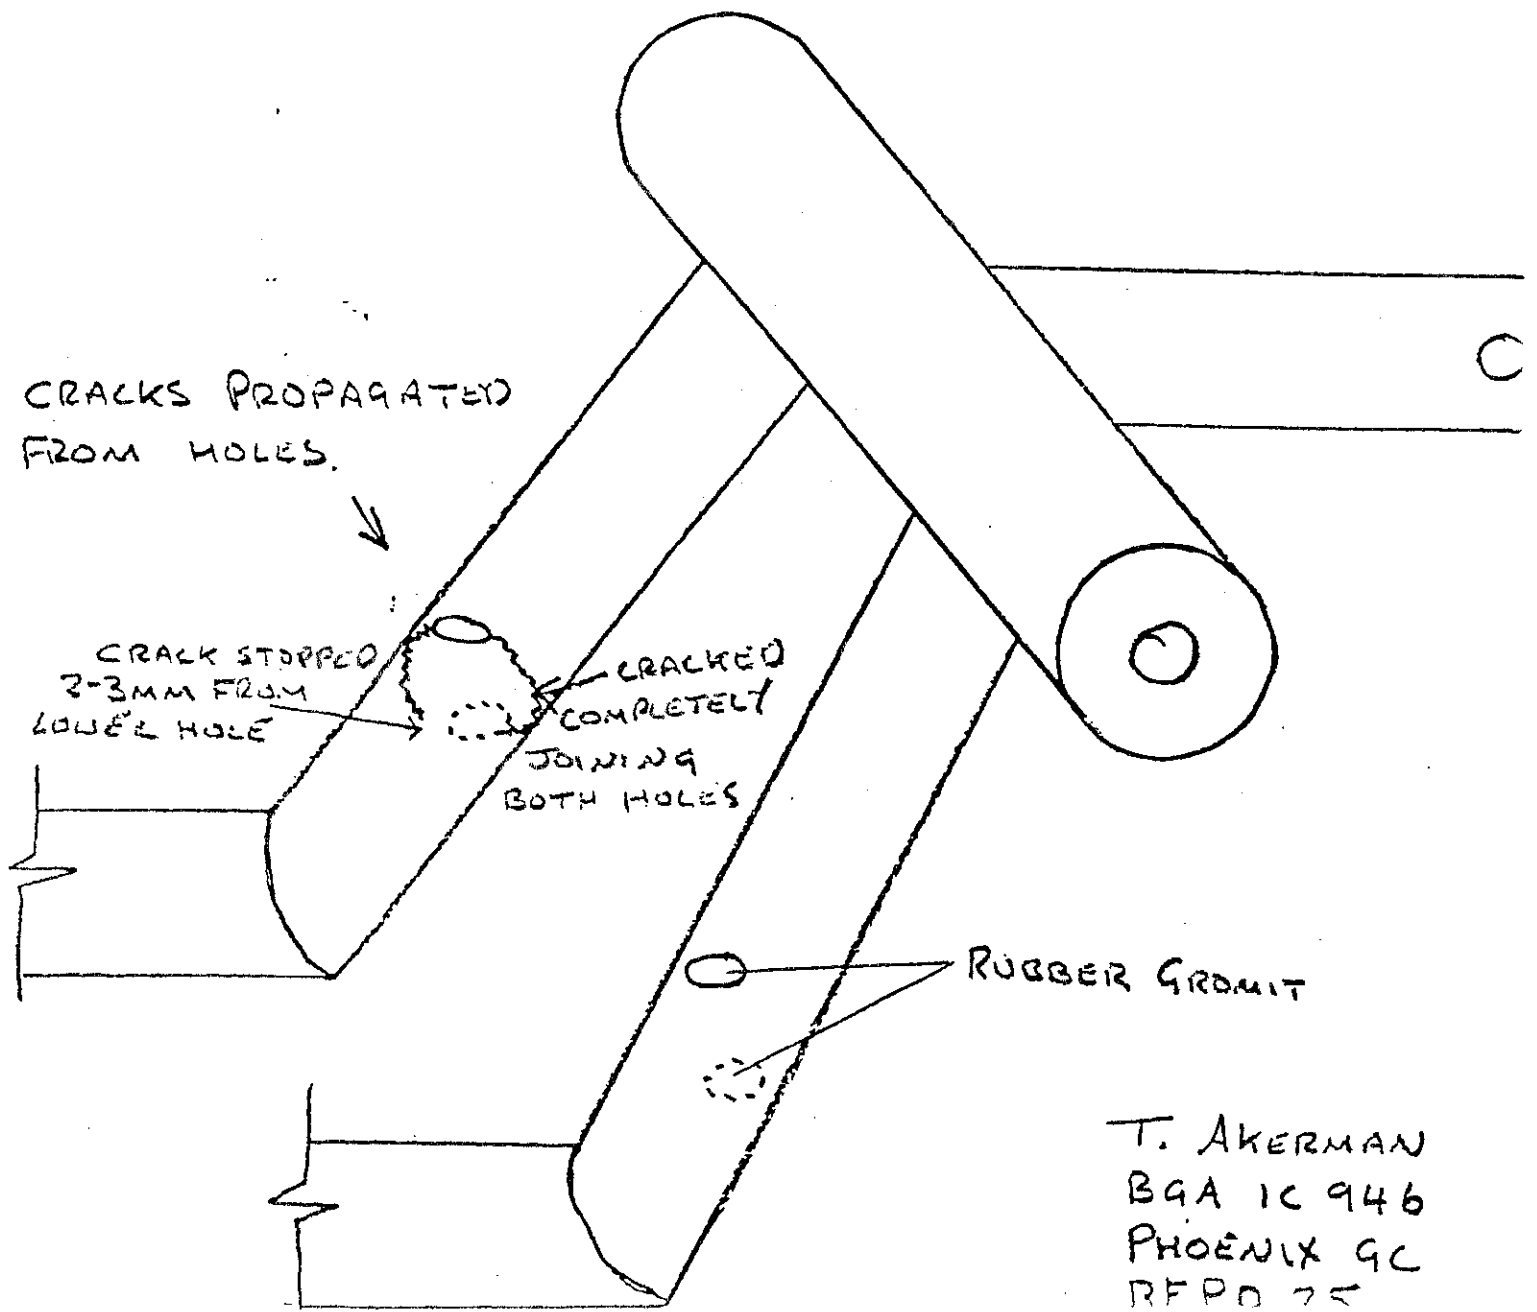
# K21 REAR CANOPY

- 1.3. KA21 Recurring Failure of Rear Canopy Structure. Sketch from Phoenix G.C. RAF Germany, herewith. This structure is designed to fail when jettisoned, so repairs must not invalidate this feature.

CRACKS PROPAGATED FROM HOLES.

CRACK STOPPED 2-3MM FROM LOWER HOLE

CRACKED COMPLETELY JOINING BOTH HOLES

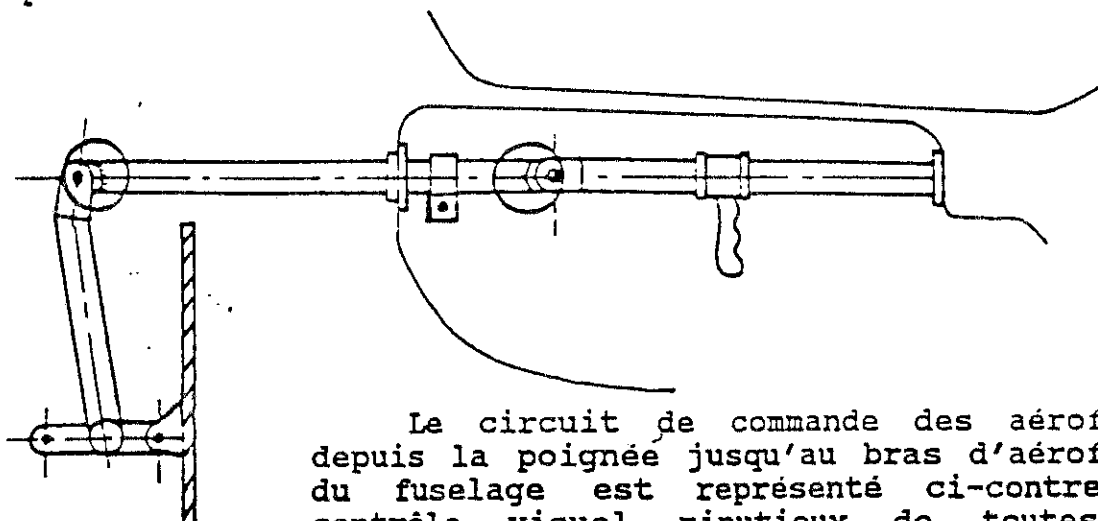
Nous tenons à attirer l'attention des utilisateurs sur l'importance de ces inspections et notamment sur la chaîne de commande des aérofreins dans le fuselage laquelle est particulièrement sollicitée.

Le circuit de commande des aérofreins depuis la poignée jusqu'au bras d'aérofreins du fuselage est représenté ci-contre. Un contrôle visuel minutieux de toutes les parties soudées et en particulier des parties encerclées doit être effectué, si besoin, à l'aide d'un miroir et d'une lampe et après nettoyage, afin d'y déceler un éventuel début de crique.

- d'effectuer le contrôle décrit ci-dessus sur chaque planeur lors de la prochaine visite de petit entretien.

- de prendre contact avec S.N. CENTRAIR en cas de constatation de crique.

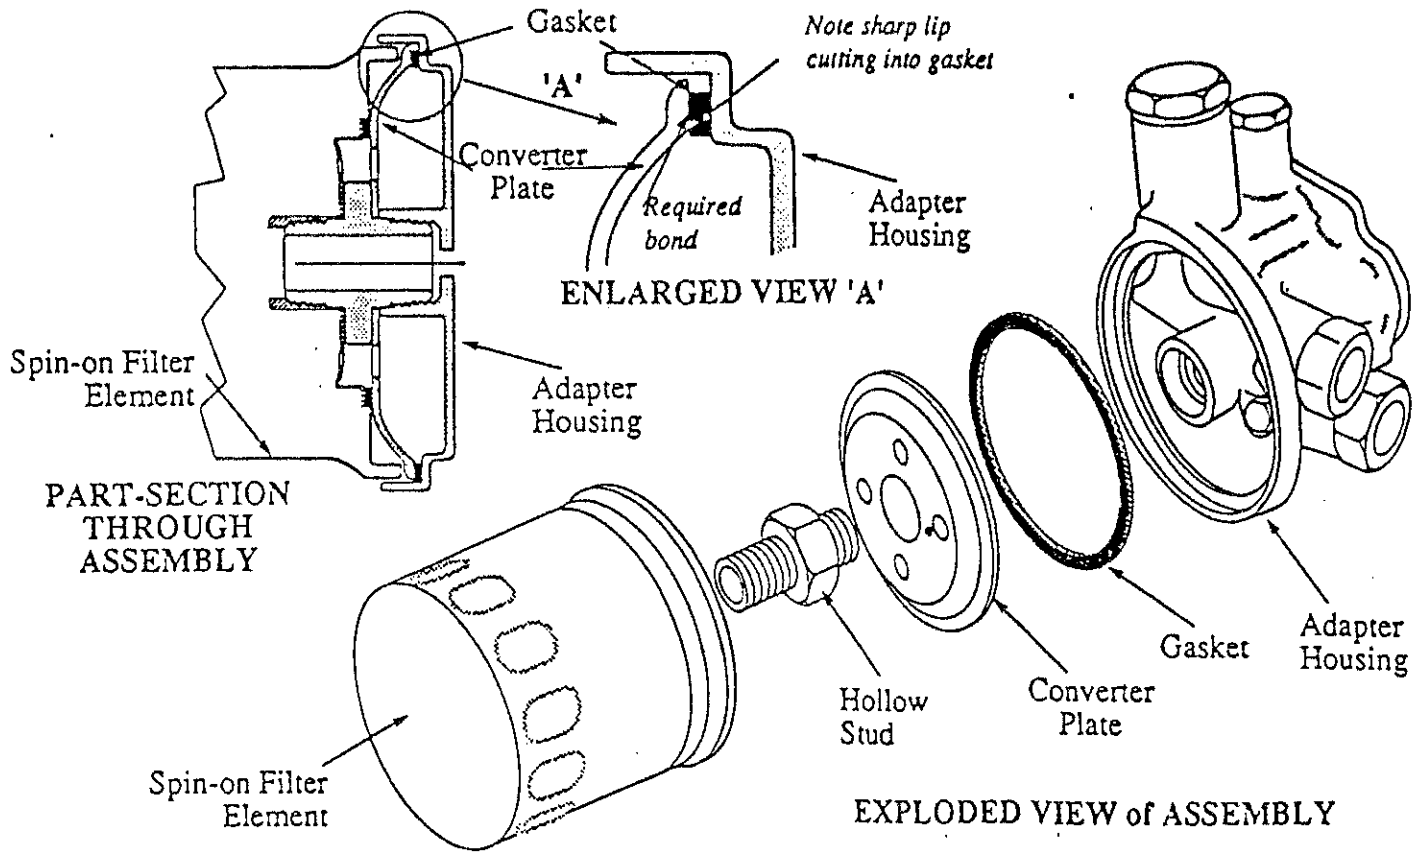
- 1.13. Oil Filter Assemblies (applicable Tugs & SLMG's) Failure of the bonded gasket - Diagram from GASIL herewith alerts you to possible failure.
- 1.14. KA 18 Weight & Balance. T/Note 3 gives the following revisions. Gross Weight 738 lbs (335 kg). C.G. Range 7.87" (200MM) - 14.92" (379MM). C.G. Datum L/E Rib 3. A/C levelled - Tangent Rib 3 horizontal. Pilot C G 19.0" (485MM) Tech/Note 3 Revisions may not have been included in BGA C's.of.A. (Research by Jim Tucker - Southdown G.C.).

Note yellow dye-mark on lip of plate & gasket

Note cuts & indentation on face of gasket
