**BRITISH GLIDING ASSOCIATION**

**BGA TECHNICAL COMMITTEE**

**TECHNICAL NEWSHEET TNS 9/10/92**

**PART 1** Airworthiness "AGGRO" Please add to the BGA 1992 Red Pages.

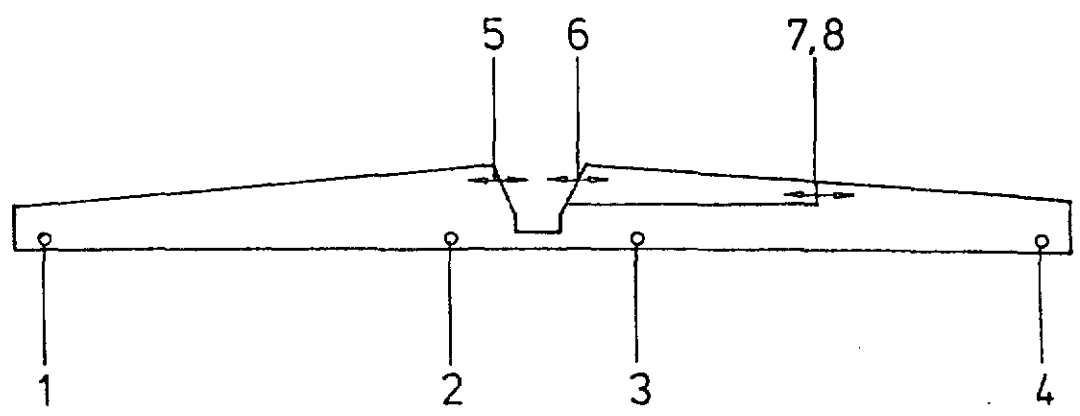
Elevator bottom side

1. Check for provided and open drain holes at the following positions (quantity: 8):

If drain holes are provided at these positions, check whether they are open. If so, no further action is required.

2. If drain holes are not provided at these positions, drill drain holes of  $\phi$  6 mm or  $\phi$  4 mm according to the figures shown on pages 3 and 4.

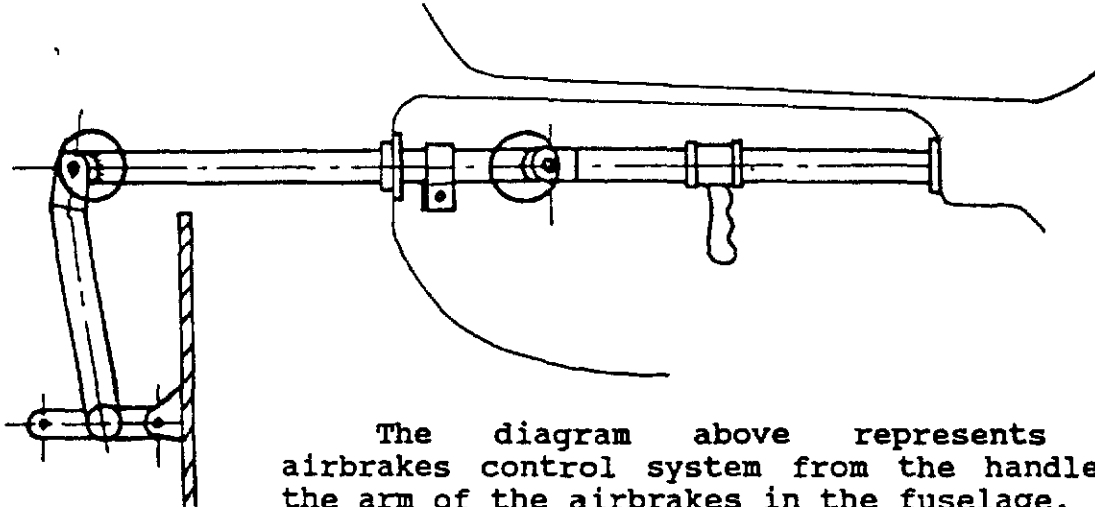
The pilots attention is drawn to the importance of these inspections, especially to the airbrakes control sequence in the fuselage which is particularly sollicitated.

The diagram above represents the airbrakes control system from the handle to the arm of the airbrakes in the fuselage. All weld parts and especially all above encircled parts should be very carefully eye-checked. If necessary and after cleaning, use a mirror or a lamp to check if there is any crack starts.

- To inspect each glider as it is described above during the next small maintenance inspection.

- To contact SN CENTRAIR in case of cracks.

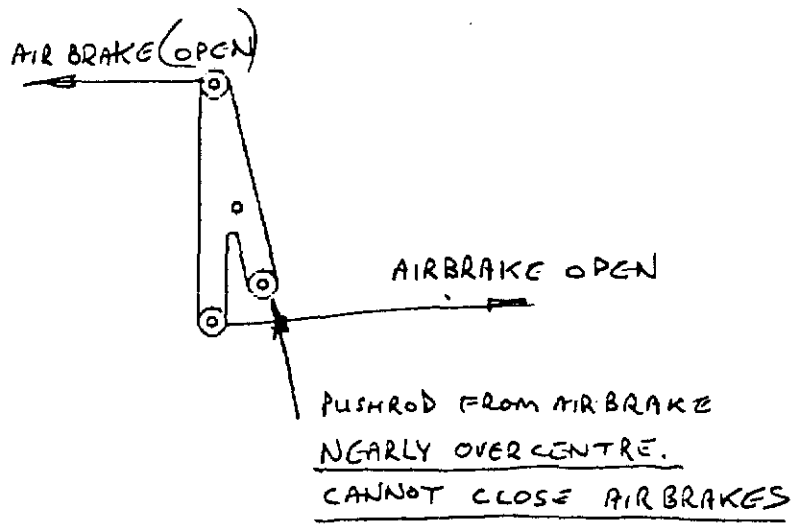
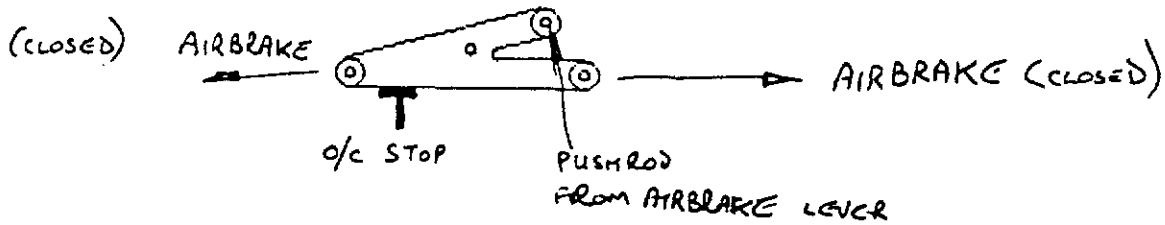
SF. 27.A      See text overleaf

At our recent Annual Shutdown we stripped and cleaned all the control linkage bearings and on replacing them found that the starboard airbrake paddle was not flush with the wing surface when closed so the rod was adjusted to achieve the desired condition. The aircraft functioned satisfactorily until the incident. Upon examination after the incident it was found that the brakes did not go overcentre and lock properly. This was at the end of the recent very hot weather and it is thought that something must have expanded/contracted such that the starboard brake paddle whilst being flush was preventing the overcentre mechanism from functioning correctly (the mechanism is on the port wing). When re-adjusted the mechanism worked correctly.

About a year ago, due to members either landing with full airbrake or attempting to shorten the landing run with fierce application of the brake and rubbing the nose of the aircraft on the runway causing substantial damage to the underside of the nose, we decided to disconnect the wheel brake, a band brake operated at the back end of the airbrake lever travel. That solved that problem!!

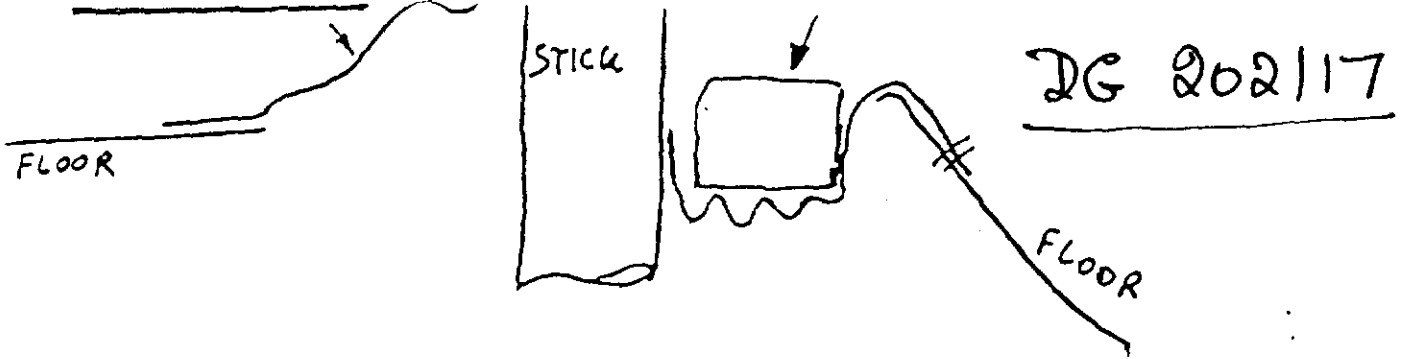
CROSS SECTION OF STICK  
LOOKING FROM LEFT HAND SIDE

POSSIBLE ELEVATOR JAM BY MICROPHONE

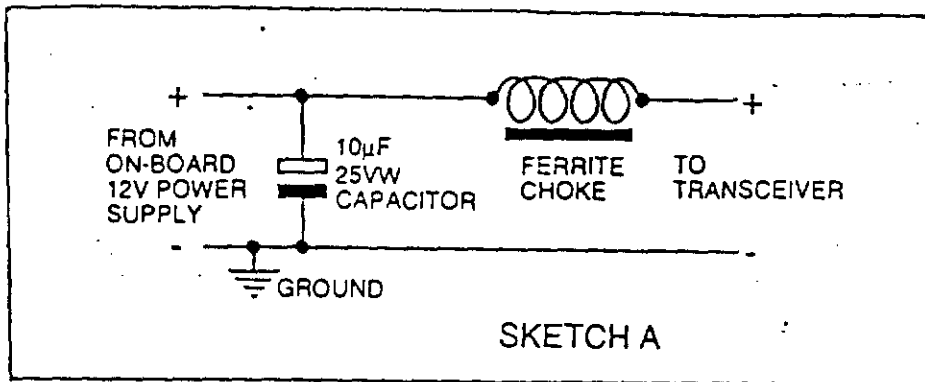
1. Generator or Gyro motor whine is most likely when using on board power. The power line to the transceiver needs a filter. This is in the form of a wire wound 'choke' (obtainable from car radio installers) placed in series with the positive line, and an electrolytic capacitor in the range 10,000.µF (25V W) connected across pos. and neg. lines. (see sketch A)
