BRITISH GLIDING ASSOCIATION

BGA TECHNICAL COMMITTEE

TECHNICAL NEWSHEET TNS 2/4/93

- PART 1** Airworthiness "AGGRO". Please add to the 1993 Blue Pages.
- 1.1. LAK 12 Aft Hook Installation. The factory supplied aft hook modification includes a "look-a-like" Tost type hook, which may fail to release under all backward-release situations. Replace with genuine Tost or otherwise rectify. (Seen at Badger Engineering, Hus. Bos.).

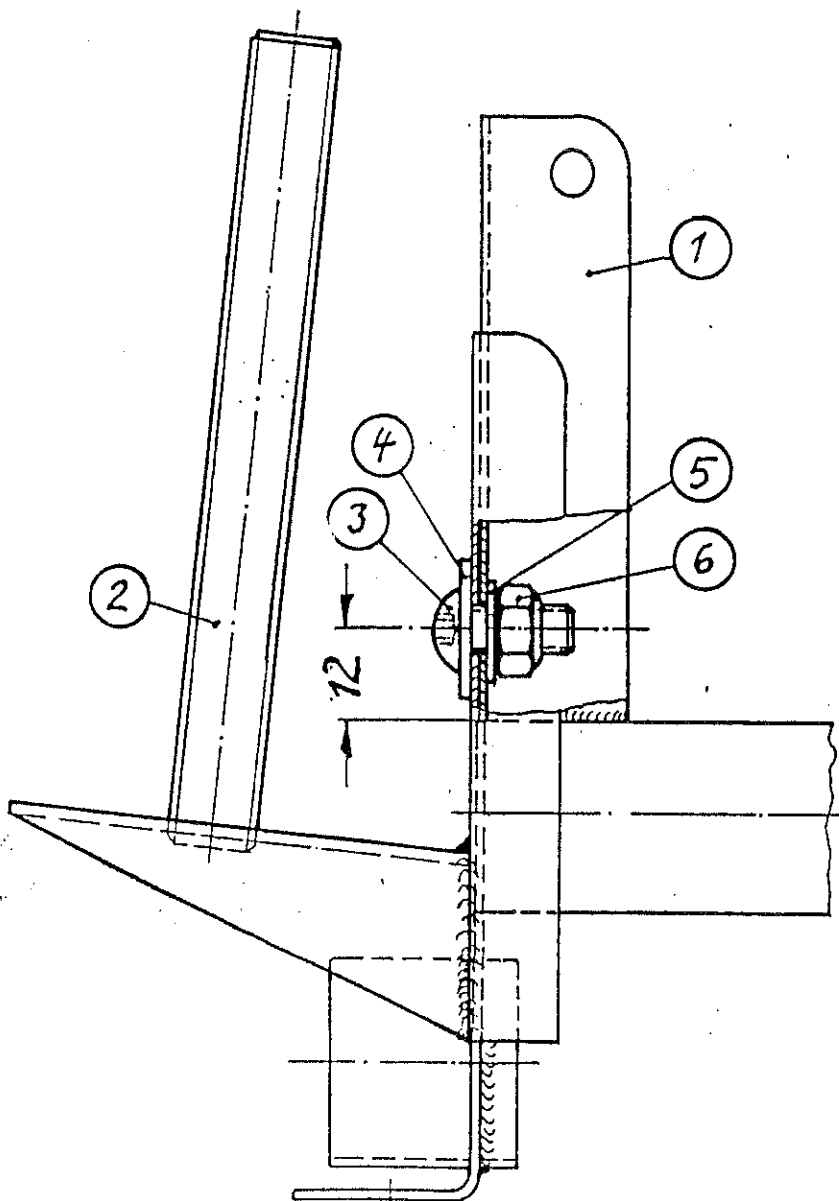
REASON: In several cases the trim weight holder according to drawing 4R8-19a) cracked or disintegrated in the welding region between base plate and fixture bracket

- 1 Pedal guide
- 2 Trim weight attachment bracket
- 3 Oval head screw M6x16 or hexagon head screw with low head
- 4 Washer 18mm outside diameter
- 5 Washer
- 6 M6 locking nut

- INSTRUCTIONS and MATERIALS:
- 1) Visual inspection of trim weight holder for cracks in the welding region between the sheet metal subparts, when cracks are detected, measure 3 must be performed immediately
 - 2) Check sheet metal thickness of trim weight holder
 - 3) Exchange trim weight holder made from 1 mm sheet metal against part no. 4R8-19c until Dec. 31, 1993.

Installation according to drawing 4BR-48 (unchanged)
For LS3 models only:
 Several base plates have been welded directly to the pedal support bracket. Should cracks be detected in this case, contact manufacturer.

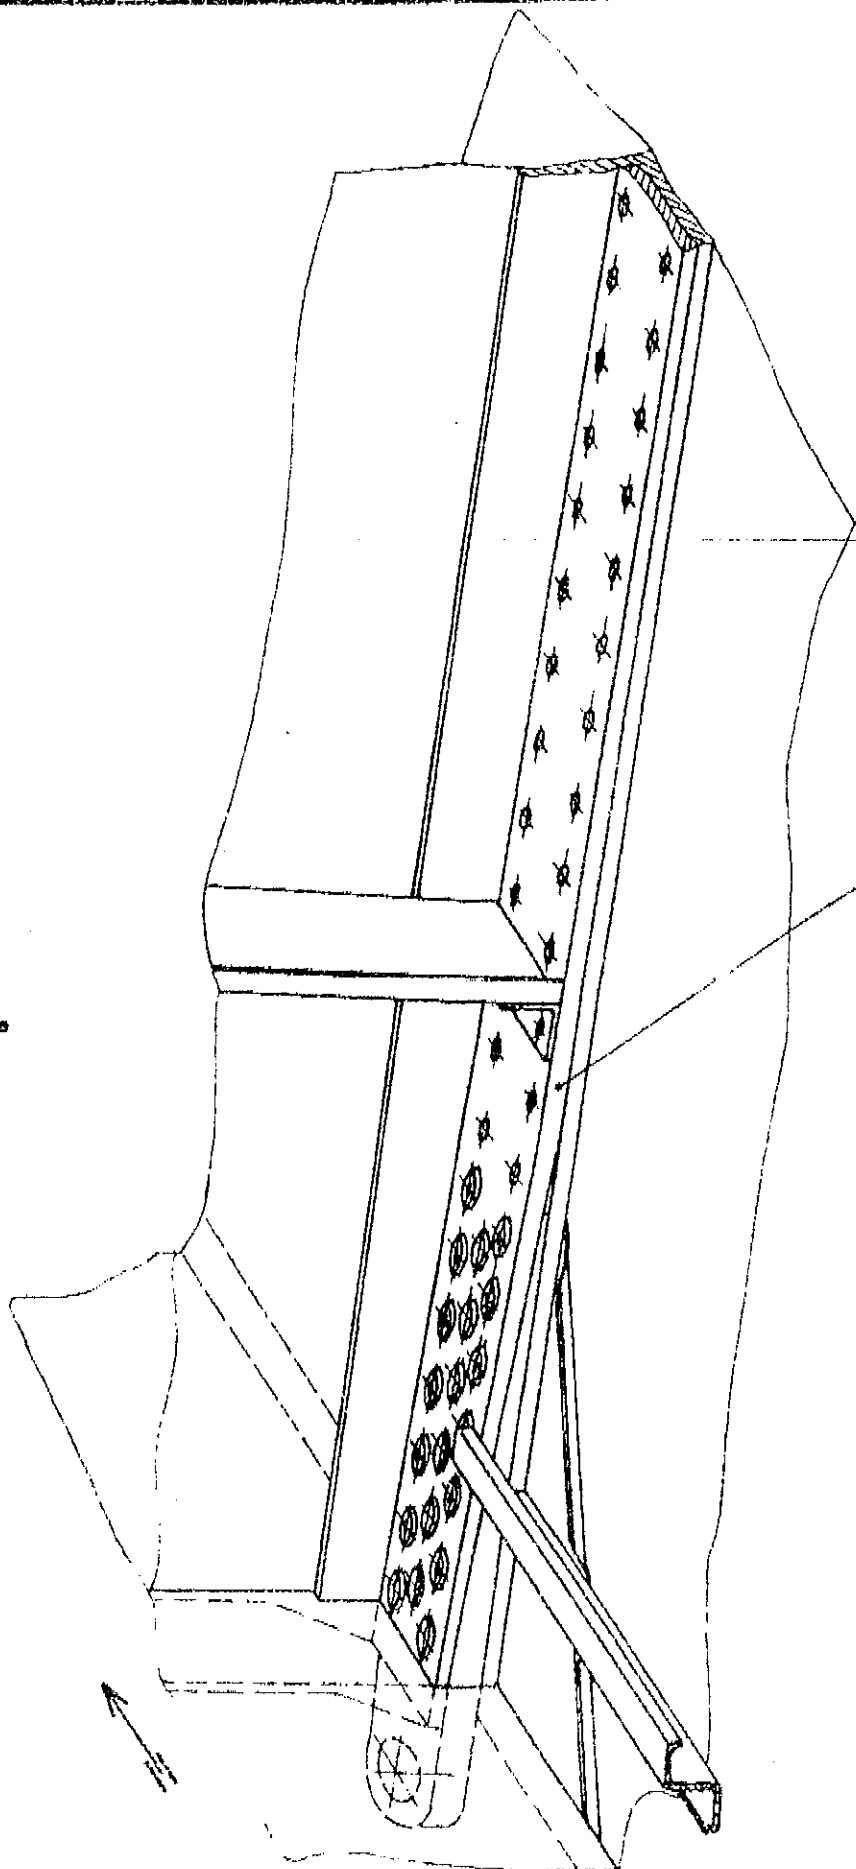
L13/062

Reason: On one glider was during the operation investigate a crack fissure on the flange strap situated on the wing's main spar lower flange in the area of the hinge.

1. Dismantle the wing of the fuselage.
2. Place the wing on suitable stands.
3. During the hole in the rib No. 1 put a lamp into the cavity of the wing behind the main spar.
4. Check the flange strap on the lower flange Dwg. No L13.201-21.12 /L13.202-21.12 for the right side/ and accessible parts of the spar's lower flange in the area between ribs No. 1 - 3 for crack fissures /fig. No. 1/. Especial locate the places around the rivets, from where the crack fissure's direction of propagation to the flange strap is probable.
5. As far as there have not been found any crack fissures, attach the wing back on the fuselage.

In case that you have found crack fissures, stop immediately the operating with the glider, announce this fact to the manufacturer and wait at his standpoint.

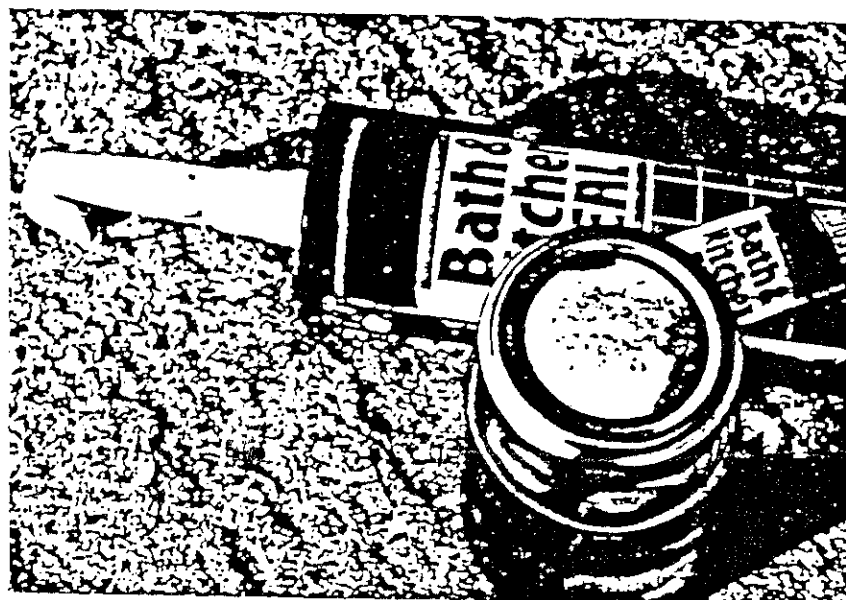
A detailed examination of the aircraft fuel system revealed that the left-hand non-return valve was partially obstructed by a slug of rubbery material and this restricted the flow of fuel through the valve. The material was carefully examined and was found to have the general appearance of a silicone rubber compound which had become softened and swollen by prolonged contact with fuel. Further examination of the fuel system, and blowing the lines through with an air line, resulted in the forcible ejection of further pellets of similar rubbery material.

It was discovered that the left fuel tank gauge unit had been removed and then replaced some two years previously and it had

been sealed with clear silicone rubber sealant, similar to that sold commercially as a domestic bath sealant.

presence of gasoline. A simple test carried out as part of the investigation showed that a disc of silicone rubber immersed in aviation gasoline for a period of 48 hours swelled to approximately twice its original size. Clearly, small beads of silicone sealant which drop off and find their way into fuel pipe work and valves do not only cause immediate obstruction, but the restriction will become more severe as the material swells over a period of time.

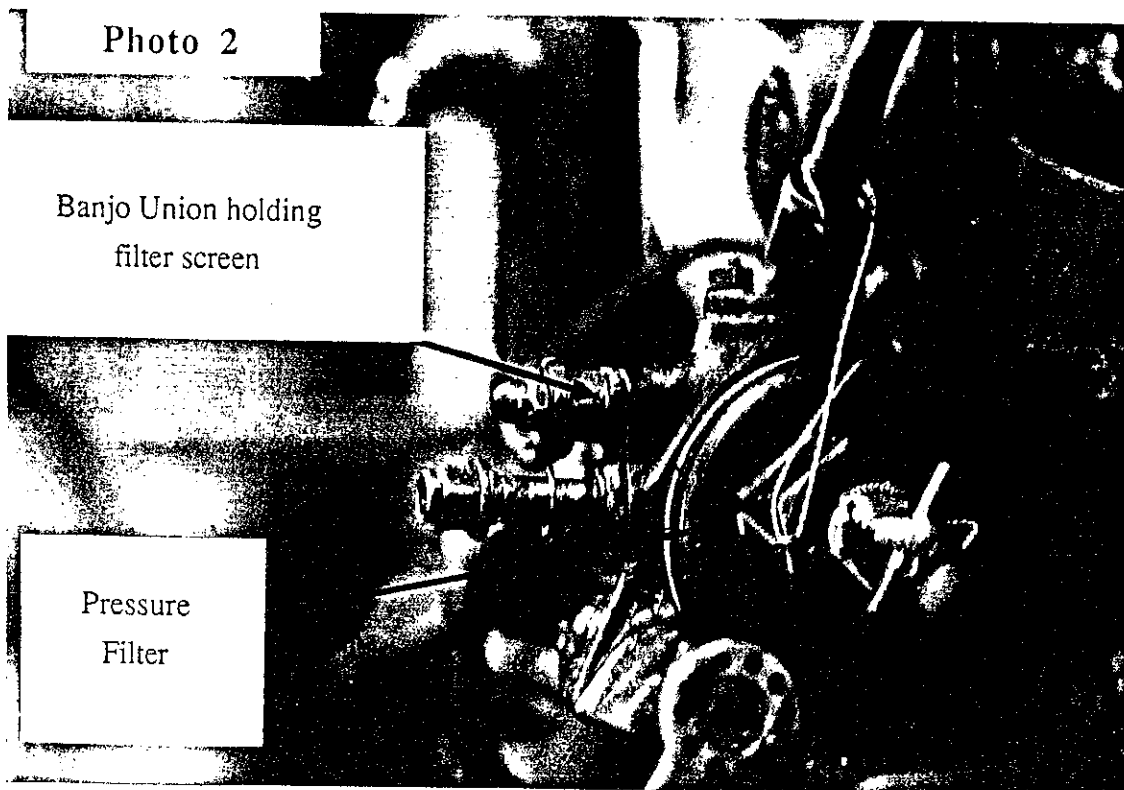
An engine strip revealed that both spiral gears in the magneto drive had worn to the extent that the drive had failed, see photo 1. Oil is fed to the driving spiral gear by jet, and then drops onto the driven spiral gear where it collects in a hollow so that the gear runs in an oil bath. The oil pipe supplying the jet contains a filter screen inside the banjo union on the pressure filter, see photo 2: the filter screen was found to be blocked preventing the supply of oil to the magneto spiral gears. The gauze filter screen is not called up for any scheduled inspection.

Other instances of failure of the oil supply to the magneto gears have been noted due to the blockage of the jet.

93-10 It is recommended that the CAA introduce an inspection of the magneto gear oil supply filter screen and oil jet at the next appropriate inspection and subsequently at intervals to be determined by experience. (Issued 22 February 1993)

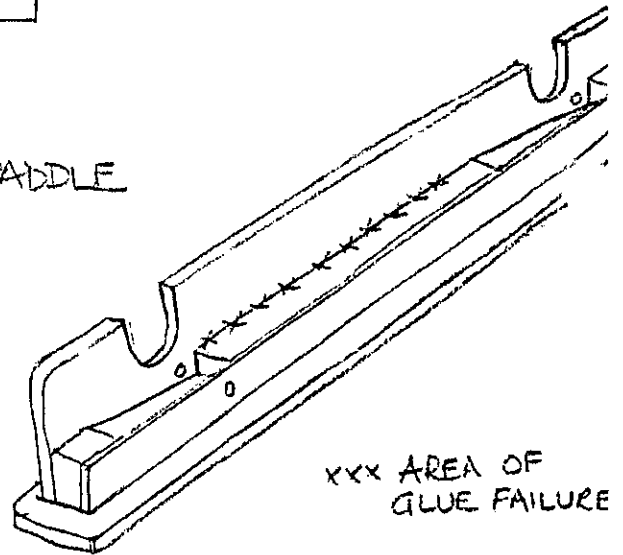
KA.7

Ka 7 Airbrake - glue line failure

Once airborne, the airbrakes function if opened up to half way but some 'stiffness' may be experienced when it comes to closing them. This is caused by the glue failure allowing the plywood to be deformed by the airflow, allowing it to rub against the inside of the brake box.

GLUE FAILURE

XXX AREA OF
GLUE FAILURE
