BRITISH GLIDING ASSOCIATION

BGA TECHNICAL COMMITTEE

TECHNICAL NEWSHEET TNS 1/2/93

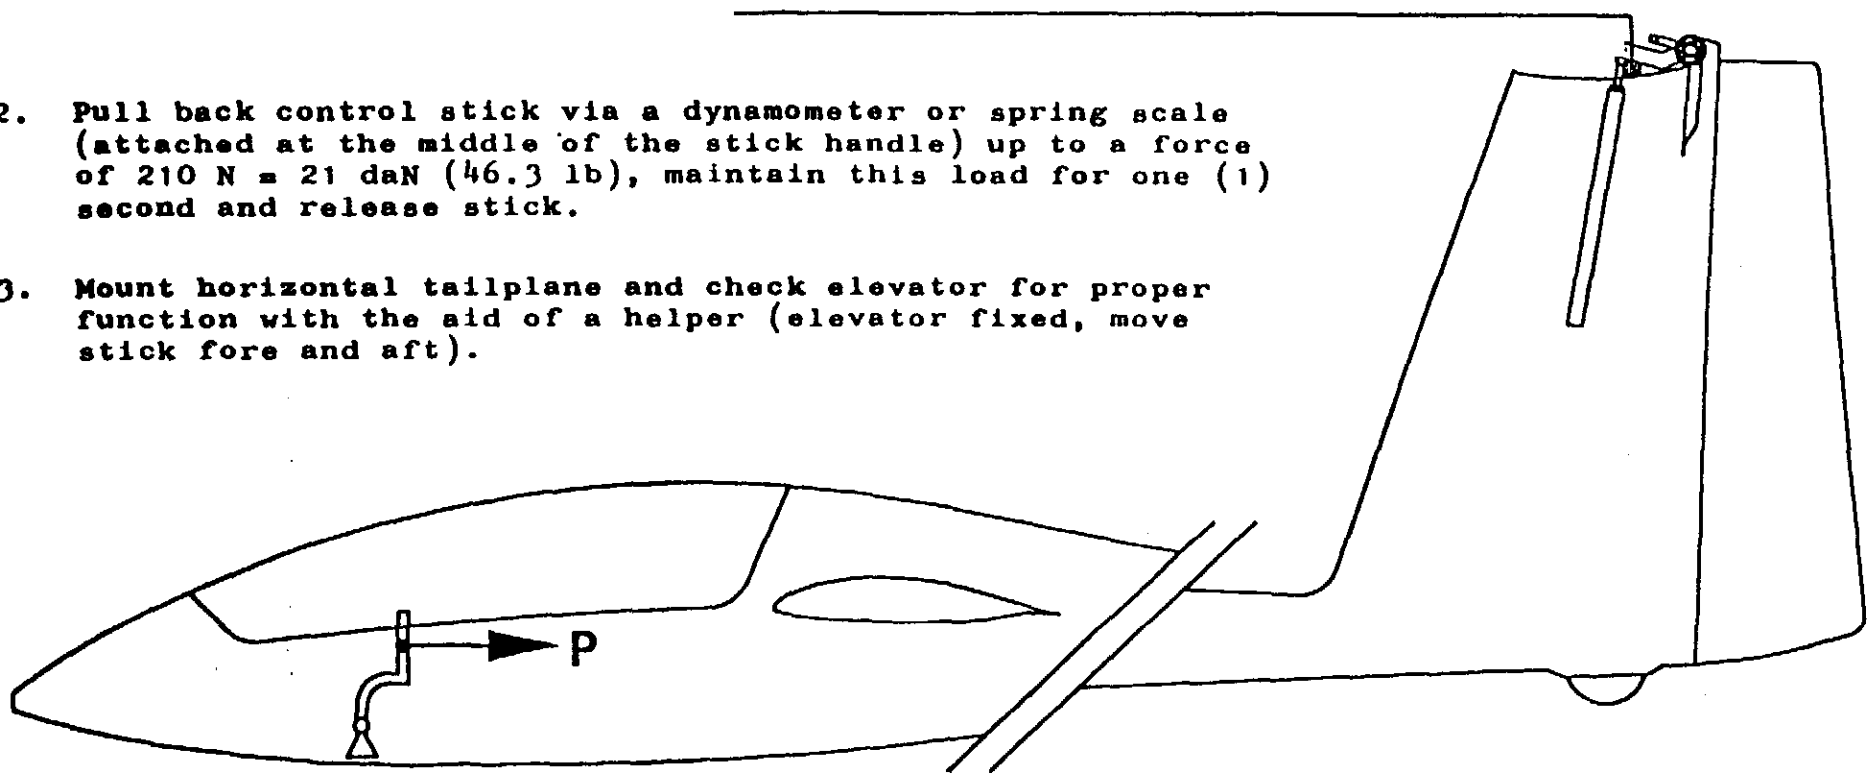
Load testing the elevator control system

Reason : By coincidence of unfavourable circumstances, the rubber bellows in the upper end rib of the fin (sealing the control rod opening) may become filled with water, which - with the elevator secured in "fully up" position - may seep through the bolt verification hole in the vertical elevator actuating tube and accumulate at its lower end.
 A failure of this tube due to corrosion - directly above the welded seam of the U-shaped rod end - is therefore possible.

1. Position a solid steel rod or a steel tube (ϕ 12 to 16 mm/ 0.47 to 0.63 in.) between the elevator actuating lever and the skin of the fin projecting above the end rib.

2. Pull back control stick via a dynamometer or spring scale (attached at the middle of the stick handle) up to a force of 210 N = 21 daN (46.3 lb), maintain this load for one (1) second and release stick.

3. Mount horizontal tailplane and check elevator for proper function with the aid of a helper (elevator fixed, move stick fore and aft).

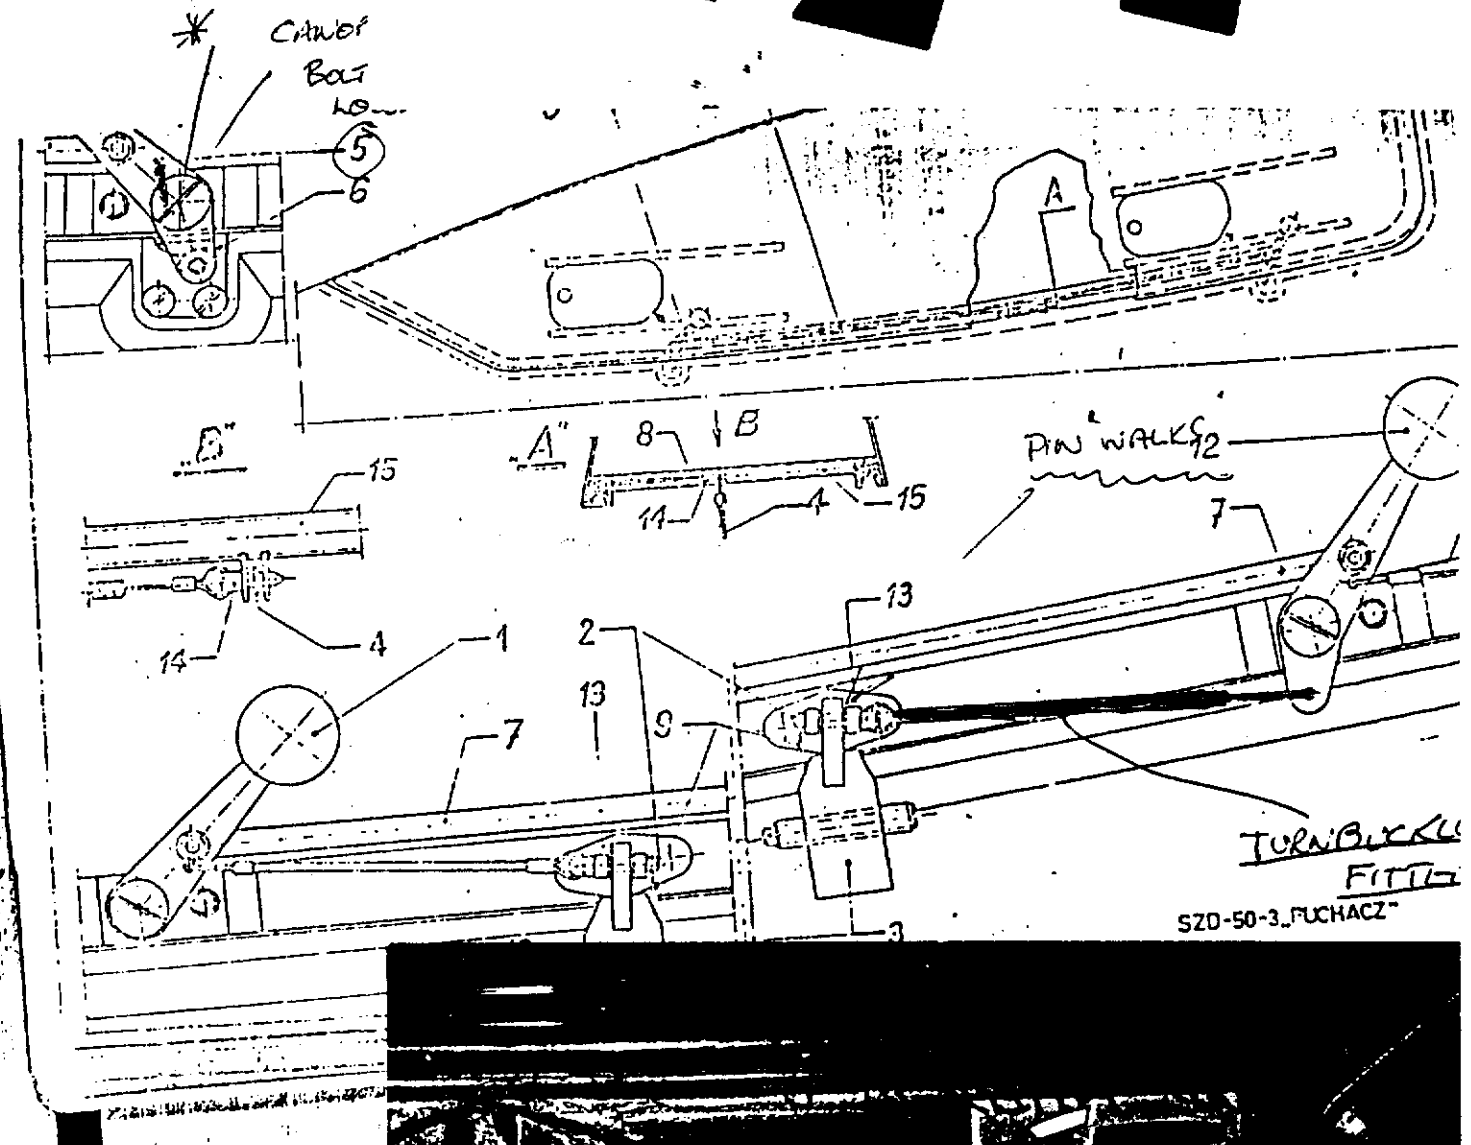
Puchacz
Canopy
Mods.

- 1.3. Puchacz - Canopy Jettison pins migrate out-of-safety. Southdown G.C. have fitted a Turnbuckle to the rear canopy operating lever, and have also introduced an external handle. (Ron King).
