BRITISH GLIDING ASSOCIATION

BGA TECHNICAL COMMITTEE

TECHNICAL NEWSHEET TNS 5/6/93

PART 1 Airworthiness "AGGRO". Please add to the 1993 Blue Pages

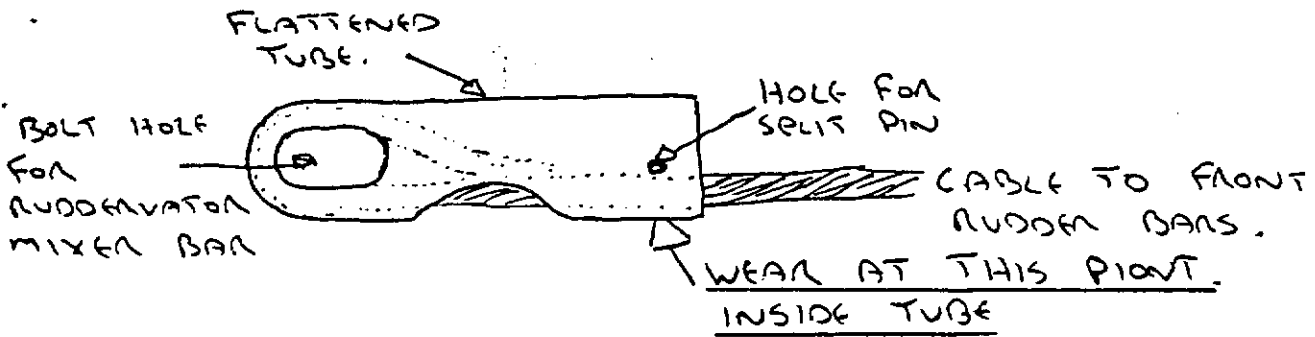
- 1.11. SHK Rudder Cables badly worn at the attachment to the Rudder Vator Mixer. Inspect as soon as possible adjacent to the split-pin hole in the end fitting (Derek Taylor - North Yorkshire Sailplanes).

Seeing the initial stages of wear is not that visible and i feel all SHK's should be looked at as soon as possible and a TNS should be included in the next TECHNICAL NEWSHEET.

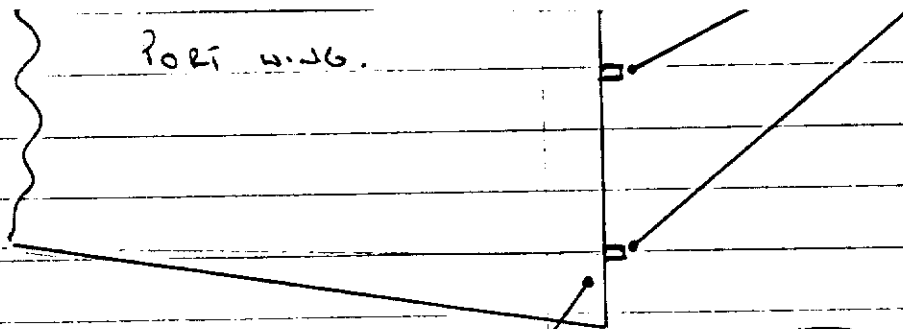
T.21 ROOT END FITTINGS.

1.10. SLINGSBY T21B (Sedburgh). Cracks found in the wing root welded brackets (3 off). Repair as required (M.E. DeToore - Dukeries G.C.).

T.21 B WING
ROOT FITTINGS
CRACKED.

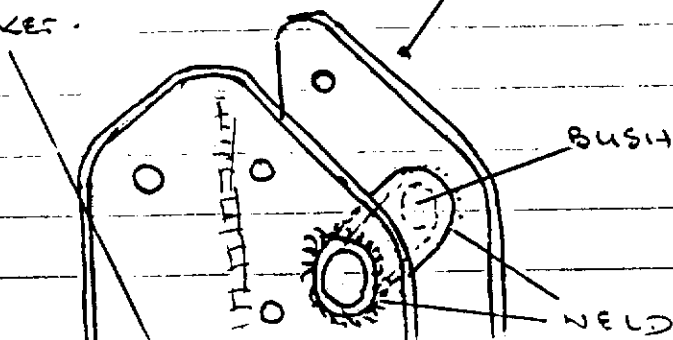
BRACKET.

THE WELD HAD FAILED
ON BOTH SIDES

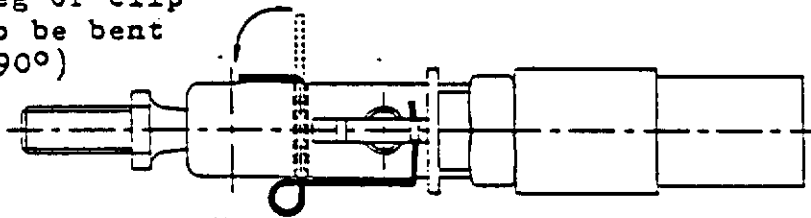
Slide long leg of safety clip through the hollow roller pin of the swivel joint until its loop contacts the latter, then bend protruding end as shown in the sketch (90°).

leg of clip
to be bent
(90°)

3. If necessary, rebend safety clip such that its position complies with the sketch showing the secured locking slide.

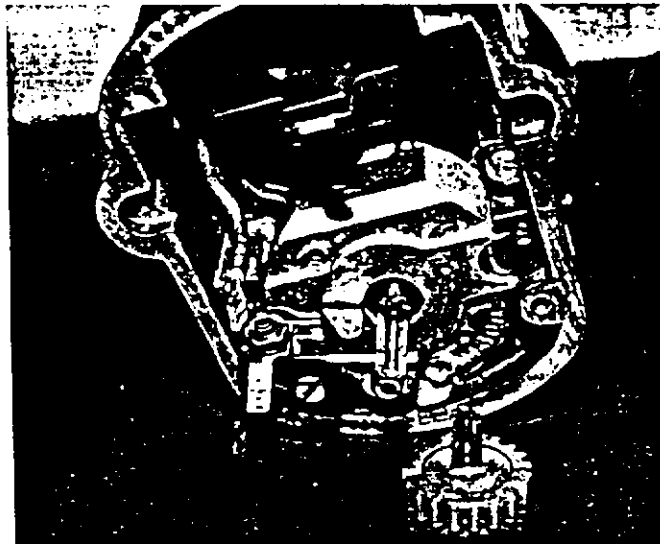
E4. MAGNETO CAMSHAFT CRACKED Slick. 500 hr Inspection

During the course of a routine check, the Manufacturers recommended 500 hours inspection was carried out on the magnetos. When the right magneto was removed for inspection, the camshaft was

found to be cracked 50% through. As the shaft is fork shaped to take the plastic cam, it was possible to remove the drive cog complete with half the camshaft. This occurrence

reinforces the need for the 500 hour inspection, as this was the first one due on this magneto.

The photo shows the extent of the deterioration.

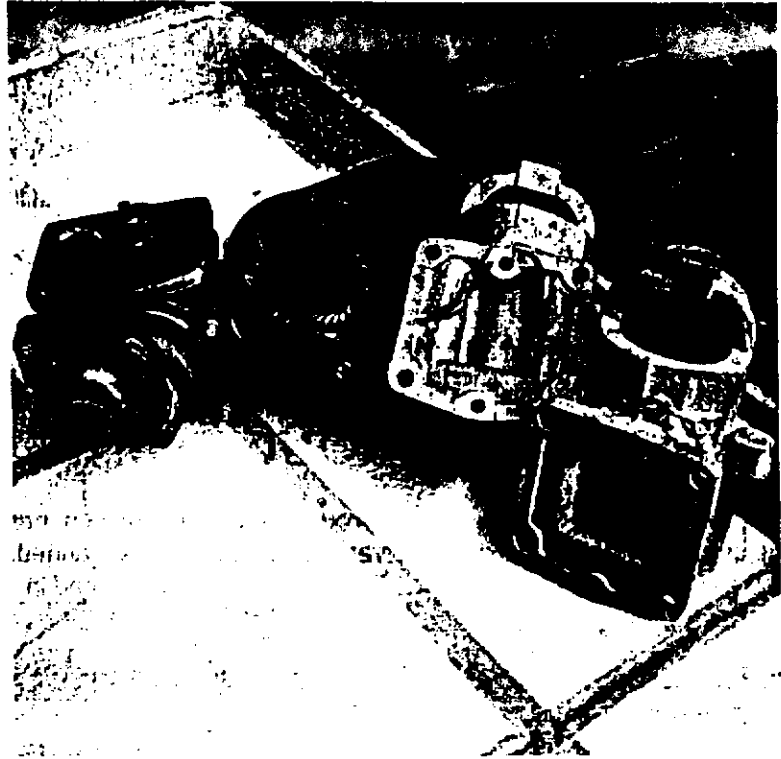
12. STARTER MOTOR FAILURES

"In clearing out a collection of scrap components, I thought that you may be interested in the three starter motor mountings that have failed on the Club Pawnee.

On this type of starter, if the battery is low, the starter engages but fails to start the engine and the Bendix cannot then be dis-engaged before the engine is hand swung. If a hand start is then attempted with both magnetos selected instead of just the impulse, then the engine will rotate backwards when it fires and destroy the starter bracket. This was certainly the cause of the two failures at the top flange.

Where the failure occurred at the front plate of the motor, the engine was turning on the starter, but slowly. However it was subsequently found that the Impulse Mag was defective.

In the photograph, two of the brackets have subsequently been used as practice pieces for a welding course - there being no intention to return these to aviation use, their simply being a useful piece of scrap cast aluminium which could be used for training purposes.

GASIL item herewith, illustrates the problem, which can be resolved by fitting a Bendix key combined IGNITION/STARTER Switch, which isolates the non-impulse Magneto during starting.

BGA COMMENT! Why NOT fit a BENDIX KEY

Switch?
