BRITISH GLIDING ASSOCIATION

BGA TECHNICAL COMMITTEE

TECHNICAL NEWSHEET    TNS 7/8/93

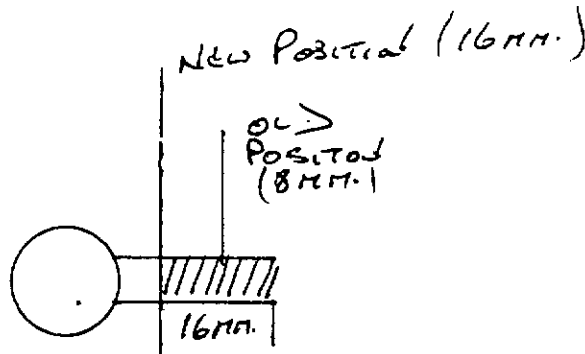
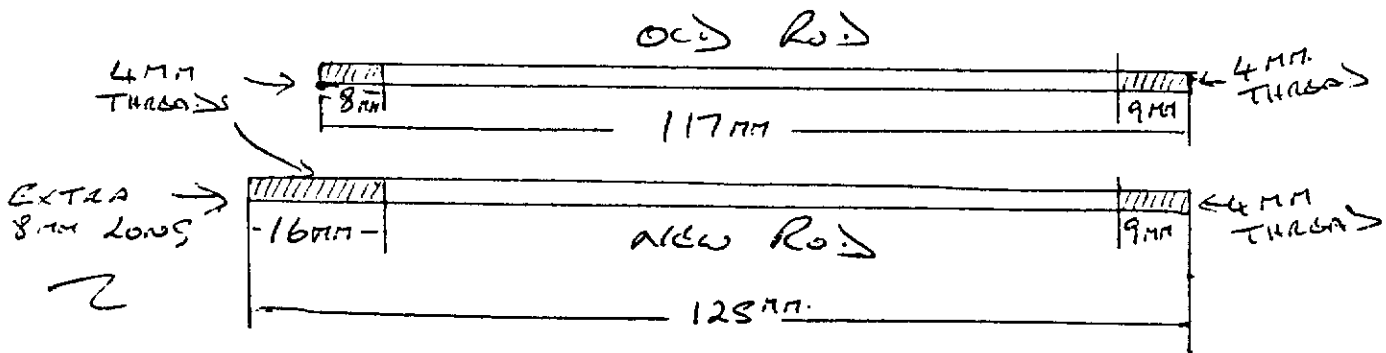
Subject: Under-Carraige handle locking pin

The above glider landed with its under-carraige held retracted due to the locking mechanism knob becoming detached from its rod. On inspection it was found that the thread in the knob was stripped. The knob had only been threaded for 8mm but drilled to 20mm. Due to the way this part flew around the cockpit followed by a long spring there was a real danger of the pilot being seriously hurt. The above glider has been modified by fitting a new rod 16mm longer and the knob internal thread tapped to suit. Recommend check and mod if required

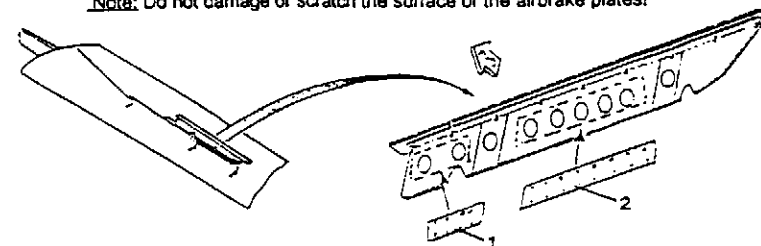
**Procedure:** Airbrakes with holes in the airbrake plates are installed in the sailplanes with the above S/N's, contrary to the type specification. To assure the airbrake efficiency in the speed range of  $V_{NE}$ , a modification to the airbrakes is mandatory.

**Actions:** The airbrake plates must be modified as follows (hole blanking):

- Extend airbrakes fully, lock airbrakes and secure against unintentional retraction.
- Position blanking plates from the front (smaller [1] inboard, larger [2] outboard) on the airbrake plates (10 mm below and 10 mm left or right of the edge of the holes) and secure blanking plates (note the countersunk holes in the blanking plates face forward).

- Drill the airbrake from the holes in the blanking plates using a 3.1 ø drill. Remove blanking plates and clean.
- Rivet the blanking plates with aluminium countersunk rivets, size 3x8.
- Clean airbrake box from swarf and all foreign objects.
- Perform function test of airbrake control.

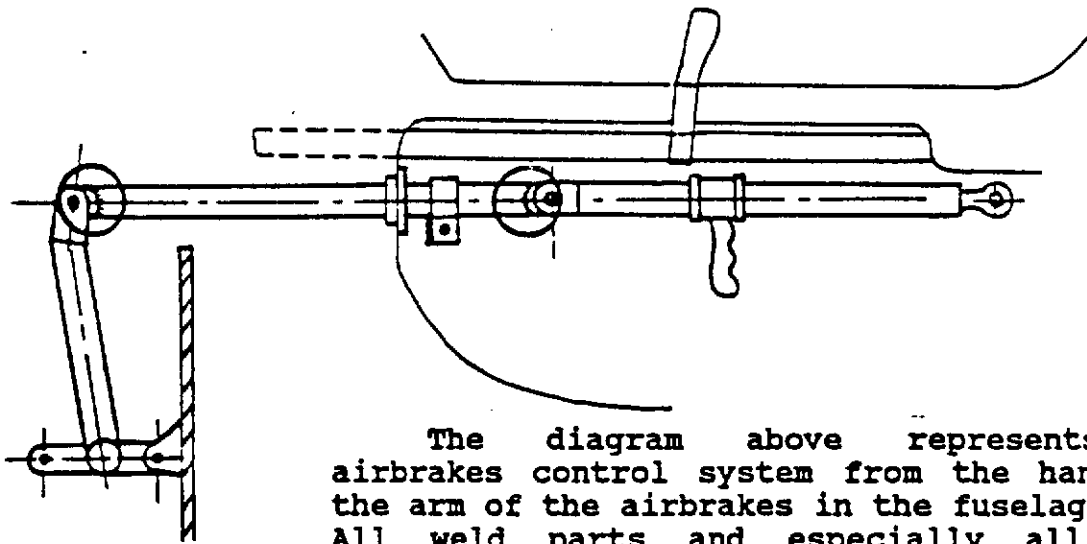
The pilots attention is drawn to the importance of these inspections, especially to the airbrakes control sequence in the fuselage which is particularly sollicitated.

The diagram above represents the airbrakes control system from the handle to the arm of the airbrakes in the fuselage. All weld parts and especially all above encircled parts should be very carefully eye-checked. If necessary and after cleaning, use a mirror or a lamp to check if there is any crack starts.

- To inspect each glider as it is described above during the next small maintenance inspection.
- To contact SN CENTRAIR in case of cracks.

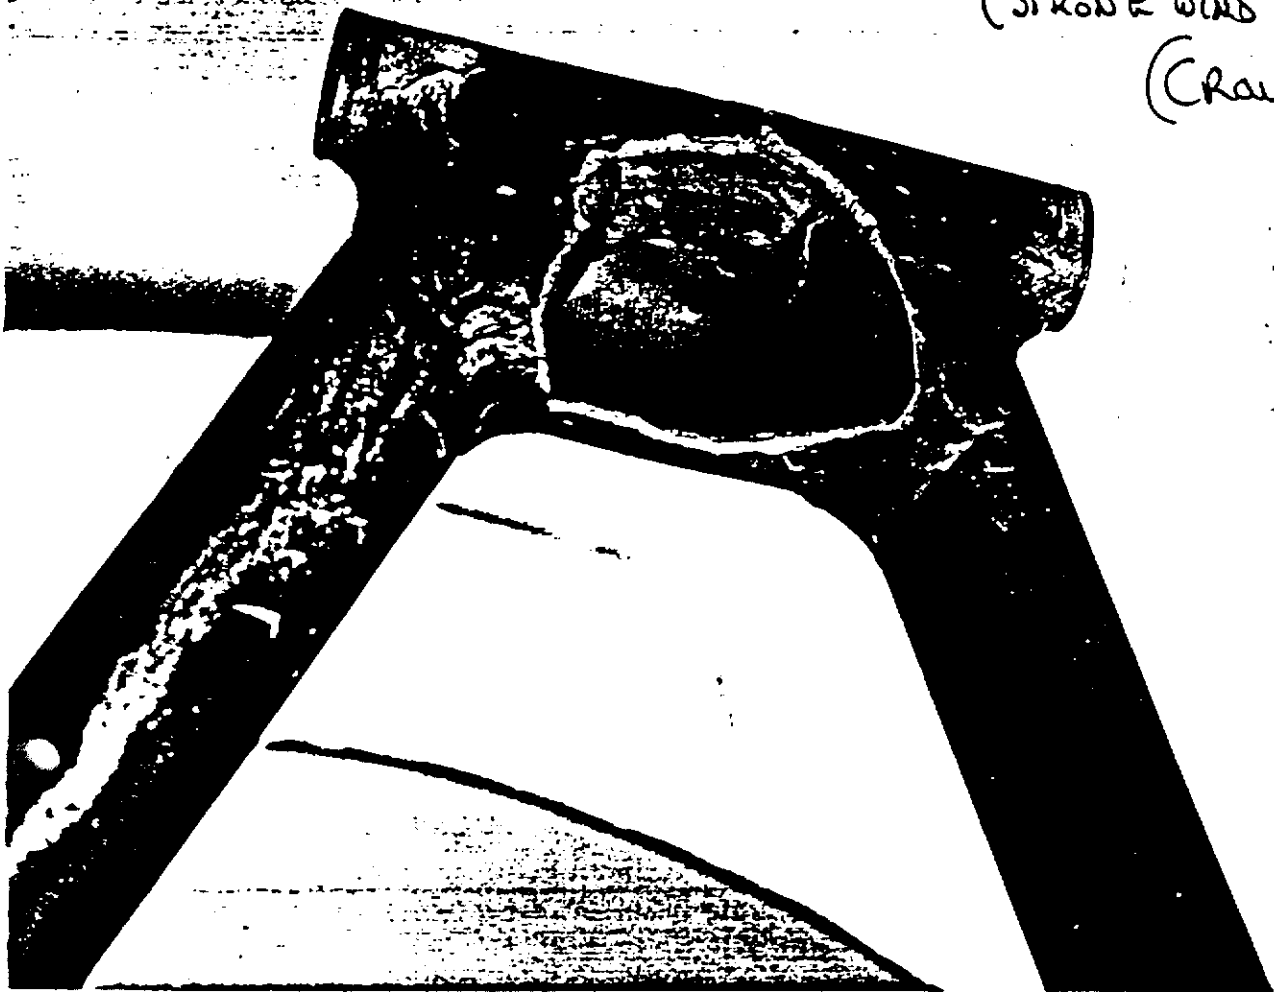
KA 21. Support  
(STRONG WIND Damage?)  
(Crawwell)

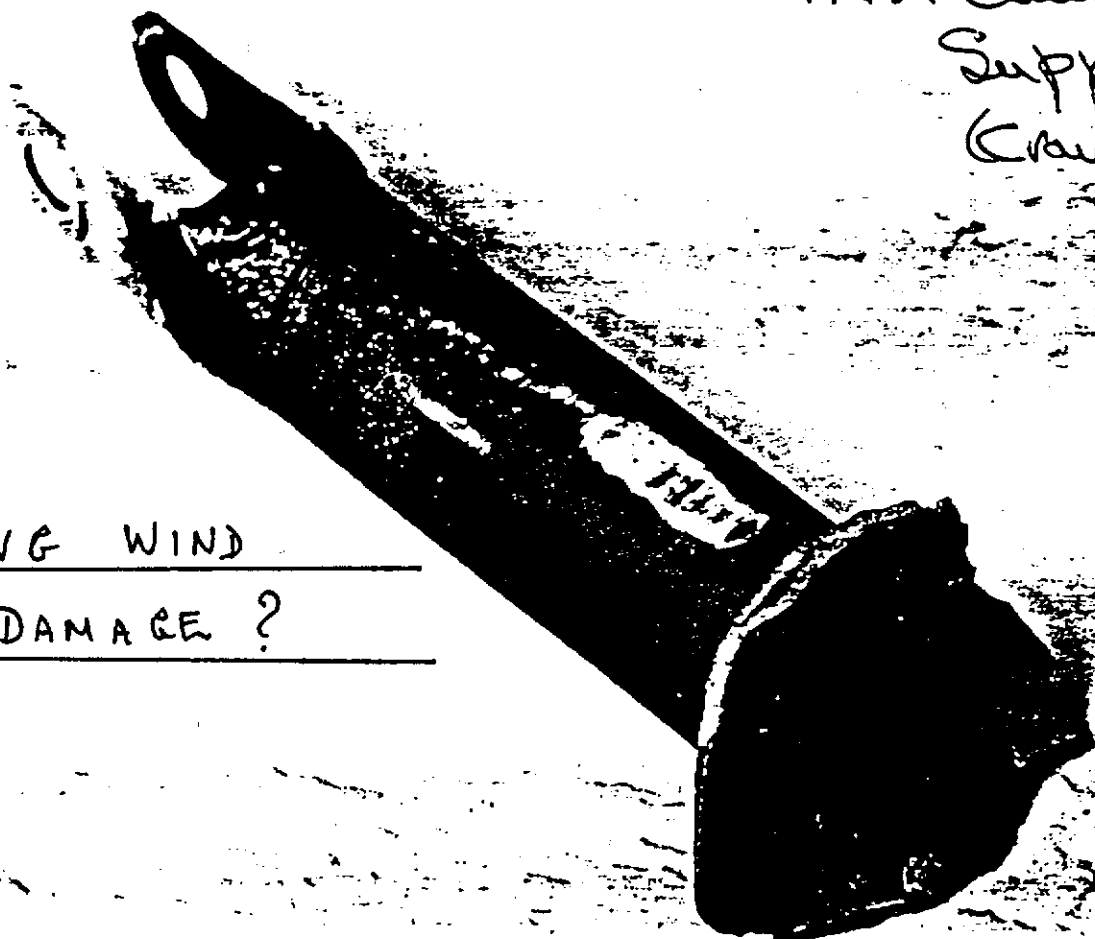
KA 21 Canopy  
Support  
(Crawwell)

STRONG WIND

DAMAGE ?
