BRITISH GLIDING ASSOCIATION

BGA TECHNICAL COMMITTEE

TECHNICAL NEWSHEET TNS 9/10/93

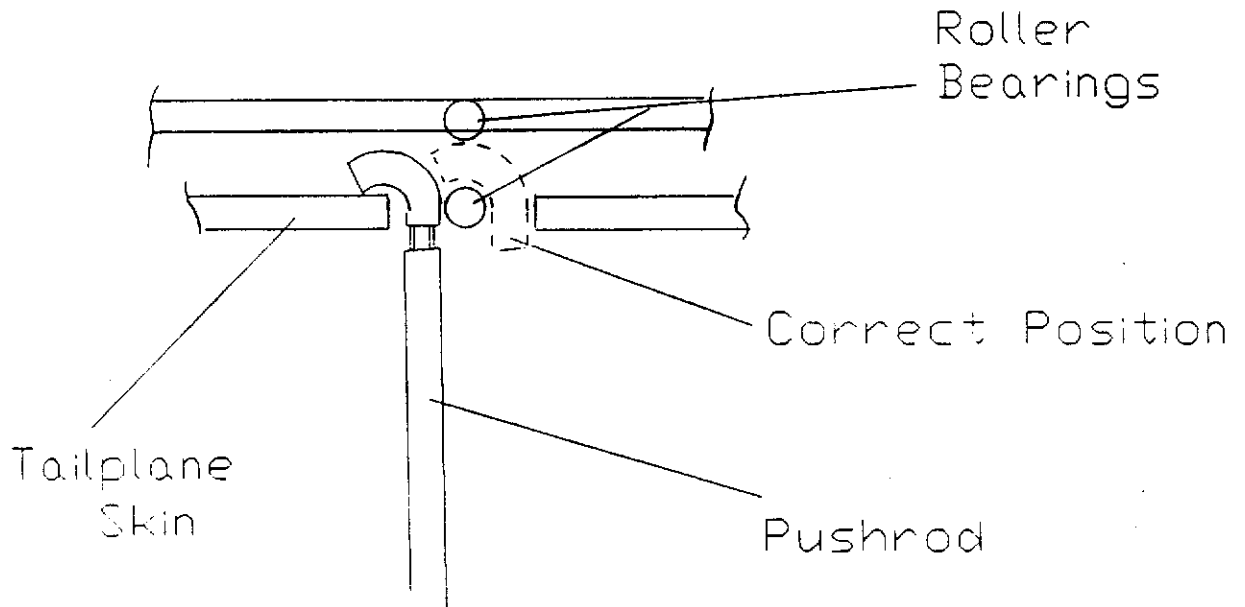
STANDARD CIRRUS ELEVATOR CONNECTION

The pilot of a Standard Cirrus found that he was unable to reduce speed below 45 Kt following a winch launch, after landing it was found that the Elevator Pushrod to tailplane connection had been incorrectly fitted as shown in the diagram below.

This fault could not be detected by a positive control check and was difficult to observe visually, it also proved impossible to reproduce this fault on refitting the tailplane.

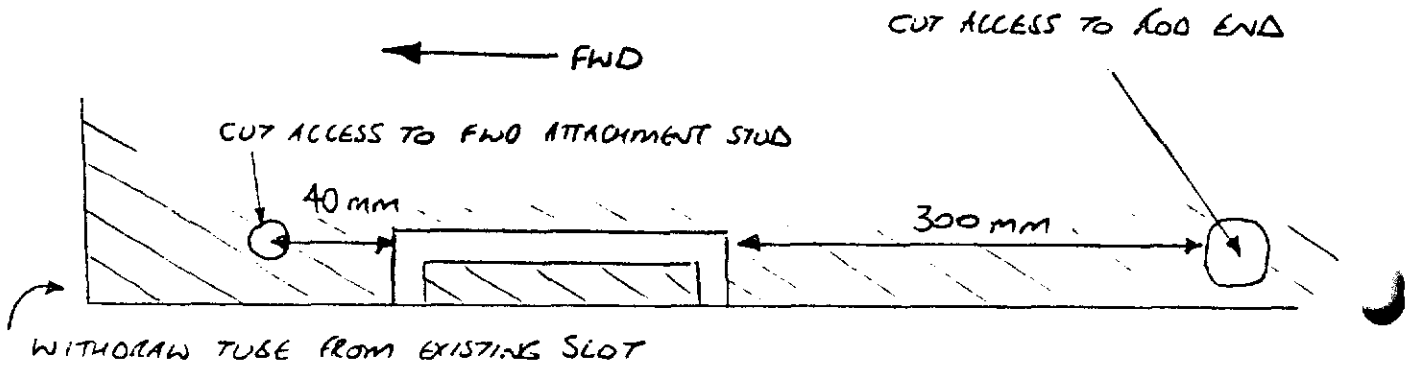
JANUS C. UNDERCARRIAGE LEVER.

WHILE ATTEMPTING TO LOWER THE U/D ON A 10 YEAR OLD JANUS C, THE OPERATING LEVER SEPARATED FROM THE DRIVE ROD. THE FAILURE OCCURRED AT THE WELD BETWEEN THE LEVER AND THE DRIVE ROD TUBE WALL.

THE FOLLOWING DIAGRAM MAY BE OF USE TO OTHER JANUS OR NIMBUS II OPERATORS WHO MAY NEED TO REMOVE THE U/D RETRACTION DRIVE ROD.

SKETCH OF RA FRONT COCKPIT WALL U/D LEVER SLOT (NOT TO SCALE)

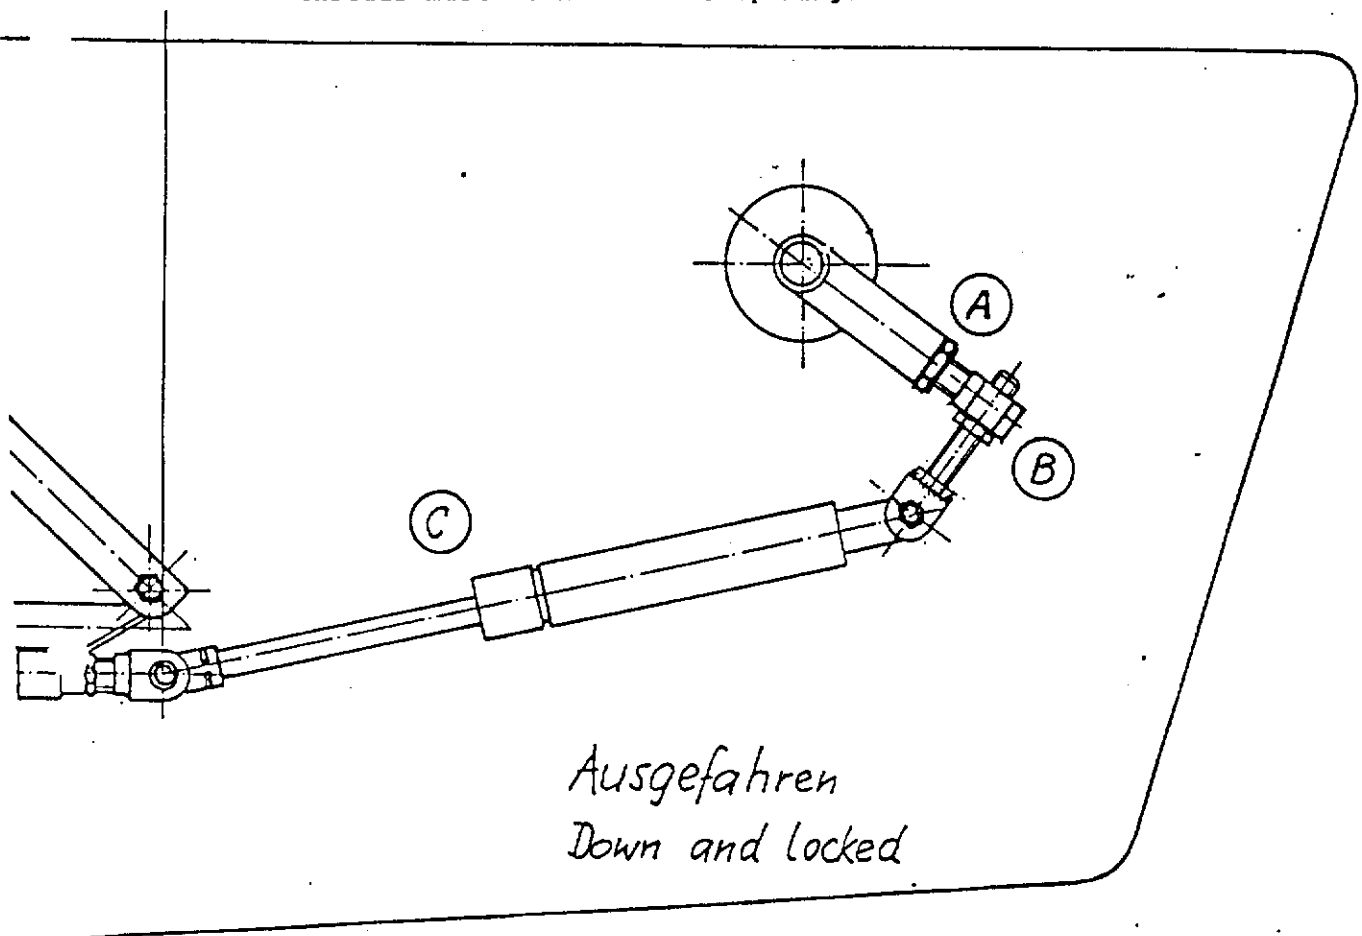
LBA-AD 93-157

REASON : Landing gear locking failed due to improper locking of nuts.

Drawing of landing gear drive at the left side of the landing gear box, adjustments at A and B, accessible after removal of the baggage compartment cover. When fitting a new gas strut C the following must be checked: During locking the gas strut must be compressed by about 5 to 8 mm (0.2 to 0.3 in) to ensure total strut force acting as preset load for locking.

- <A> Stellschraube mit Mutter, Gewinde M10
adjuster with nut, M10 thread
- Stellschraube mit Gabel, Gewinde M8
adjuster with fork, M8 thread

MATERIAL and INSTRUCTIONS : Check locking of nuts in the landing gear drive:
A) Thread M10, Width over flats 19 mm, torque 45 Nm (33 lb*ft)
B) Thread M8, width over flats 17 mm, torque 25 Nm (18 lb*ft)
Additional safety by applying thread securing fluid (for example: Loctite)

Additional safety by applying thread securing fluid (for example: Loctite). For later adjustments, these secured threads must be heated for opening.

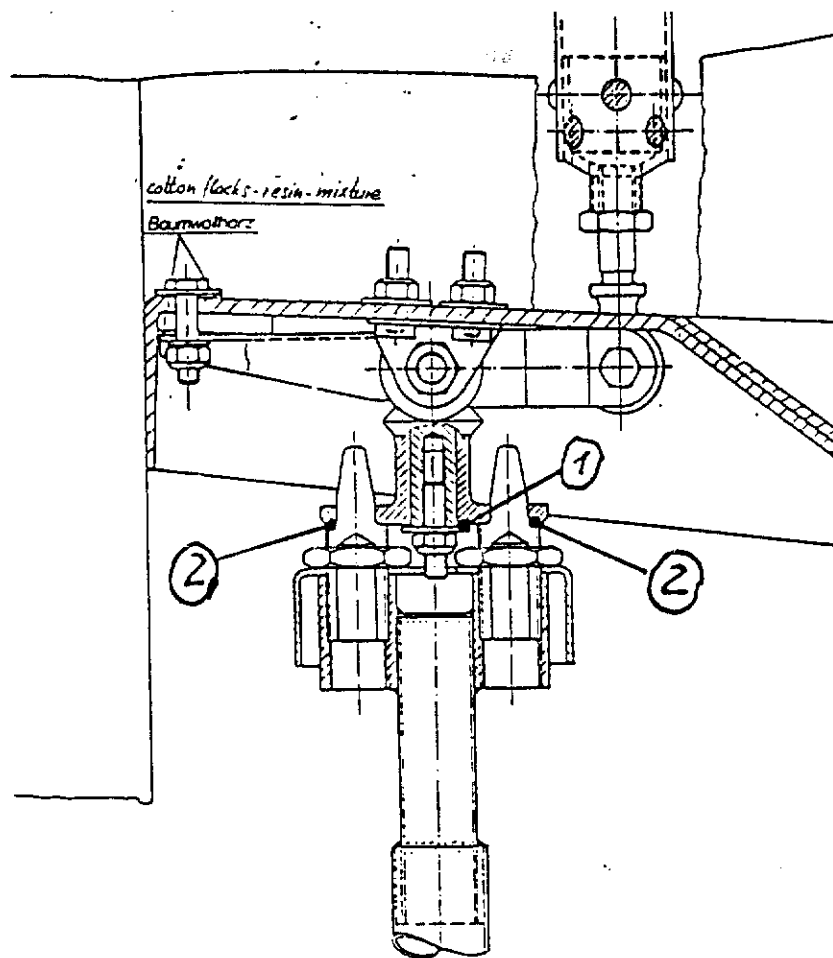
LBA-AD 93-756

REASON : With excessive play in bevel gear drive at root rib or at fuselage drive between root ribs, the retaining bolt of the gear drive plate may fail.

Drawing of root rib and air brake drive, indicating regions for adjustment of
play:

- <1> Teller des Kegelradgetriebes
bevel gear drive plate
- <2> rumpfseitige Antriebsbolzen
fuselage drive pins

MATERIAL and INSTRUCTIONS : 1) Check play in bevel gear drive at root ribs:
The bevel gear drive plate must be axially free from play, but should be unbraced. Compensation of play by shims 16*12 mm (When this play is excessive, the plate may skip over one or more teeth, resulting in air brake being either not completely retractable or extendable). See also drawing on page 2.

2) After rigging the plane - check spanwise play of fuselage air brake drive between bevel gears with air brakes not locked. Also, this value must be free from play, but unbraced.
Compensation of play by shims 14*10 mm.
(When this play is excessive, the root rib is being deformed during locking, resulting in possible failure of the bevel gear plate retaining bolt and also air brake being either not completely retractable or extendable).

3) Modification of the air brake bevel gear unit to version "a" (Drawing 1DF-4a), identifiable by locking nut M8, width over flats 13 mm at the gear drive plate, instead of locking nut M6, width over flats 10 mm.
Disassembly of bevel gear units as follows:
a. Mark bevel gear meshed using permanent marker, eventually after degreasing with white spirit.
b. Mark gear unit with serial number of plane and R or L for left or right unit.
c. Dismount units from wings and send them to the manufacturer for modification.

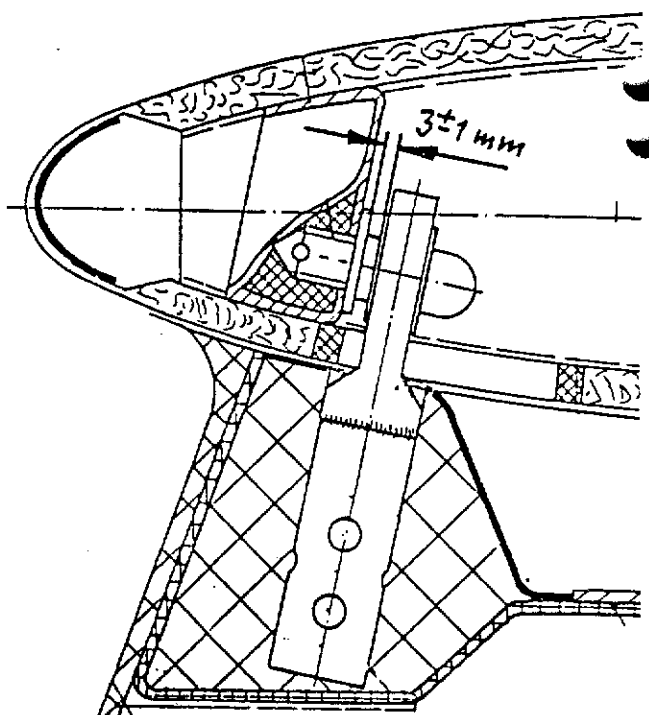
LBA-AD 93-155

REASON : In one case the forward elevator mounting bracket on the vertical tail fin became loose.

MATERIAL and INSTRUCTIONS : Check the forward elevator mounting bracket for the following:
: Fixture of the bracket by applying a torque 15 Nm (max. 6 kg (13 lbs) at lever arm 0.25 m (10 in)) at the bracket housing, without applying load to the bonded-in ball.
Cracks in paint around bracket may indicate a loose mounting.

If the bracket is loose, repair with a new bracket 4R4-7c according to Instruction BA-4. When the bonding of the ball is loose, re-bond with elevator fitted.

- 1) Losen Beschlag aus der Bohrung in der Seitenflossen-Abschlußrippe ziehen.
Extract loose bracket from vertical tail fin.
- 2) Rippenbohrung innen mittels Schleifer auf volle Länge aufrauhen, aber nicht vergrößern.
Sand mounting orifice in rib internally along whole length using a grinder, but do not enlarge diameter.

- 7) Nach Aushärten des Harzes Leitwerk abbauen, Leimgutüberschuß entfernen, bei 55°C 15 Std. den Beschlagsbereich tempern. Verleimbereich mit Lack grau streichen.
Remove horizontal tail after curing of resin, remove surplus resin, heat treat bracket region at 55°C (131°F) for 15 hours. Finish bonding region using light grey paint.

- 8) Kugel des Beschlags mit Benzin oder Aceton reinigen. Harz oder Loctite an Kugelaußenfläche geben, Leitwerk mit gefettetem vorderen Bolzen montieren. (Bei loser Kugel ist die Montage wegen fehlender Ausrichtung schwierig).
Clean ball of bracket using acetone or white spirit. Apply epoxy resin or Loctite to outer ball surface. Assemble horizontal tail with forward pin greased. (With ball loose, assembly is difficult due to missing alignment)

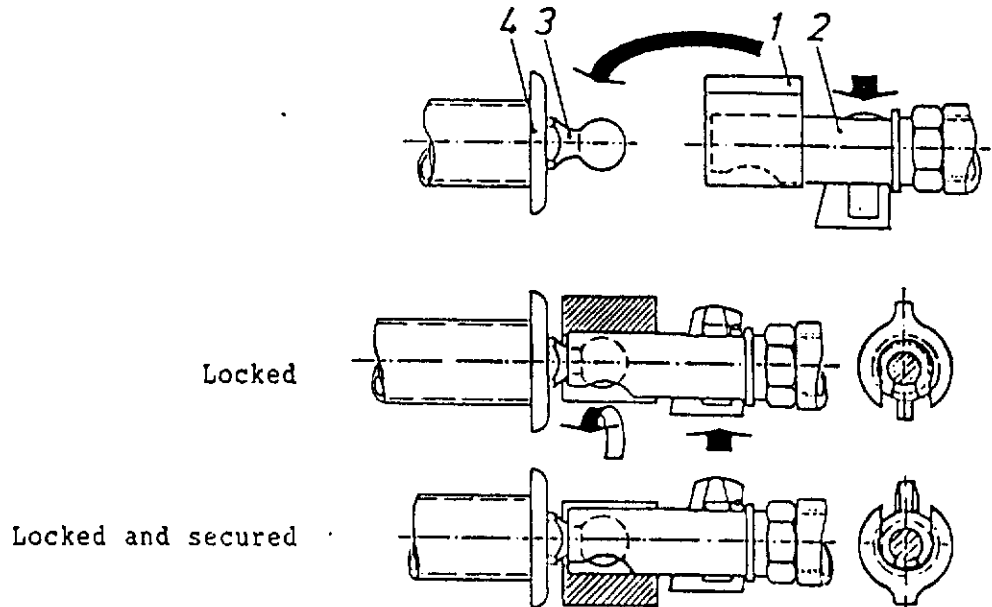
Hotellier Control System Connectors

Prior to assembly, everybody should be familiar with the functioning of the Hotellier control system connectors (a.k.a. ball snap joints or clip and ball coupling). With the locking plate fully pressed, each connector (2) must be engaged fully on the ball (3). During securing, the locking plate moves slightly backwards. Using the securing sleeve (1), installation is possible only with the slot facing down, respectively the rib facing up. After proper connection and turning the sleeve by 180 degrees, the joint is secured, see also sketch below.

Warning: With connectors unsecured, the locking plate may open under load temporarily ! The locking plate should never be greased !

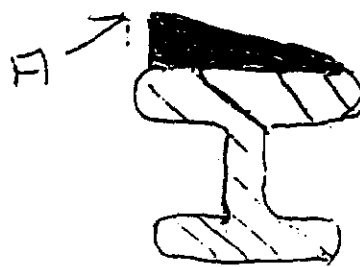
End view of harness slide

When the harness strap slides (that part which moves up and down during adjustment) were manufactured there was a rough face from the casting of the aluminium. With time this rough face has worked smooth and the straps slide over it freely.

To prevent this I had the tops of the slide built up with MIG welding by about 3mm and then milled back at 45 degrees to give a raised face on the strap release side.

Dark portion is built up by MIG welding and then milled to 45 degrees

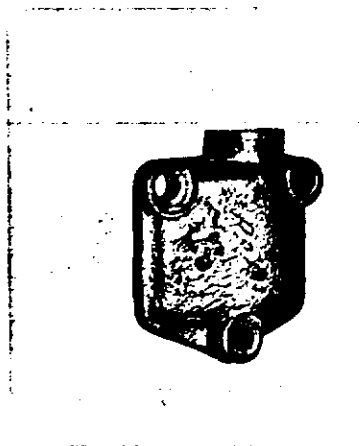
The aircraft and engine had been unused for 3½ years and the engineers were carrying out maintenance to restore it to flight condition. The lower casting from the fuel pump body clearly showed excessive corrosion. The component was full of general engine oil and sludge which prevented major leakage. After cleaning, the photographs show the extent of the corrosion.
