BRITISH GLIDING ASSOCIATION

TECHNICAL NEWSHEET TNS 1/2/94

PART 1 Airworthiness "AGGRO". Herewith the BGA 1994 Compendium of Airworthiness Directives, Mandatory Modifications and check list of Special Inspection and Defects.

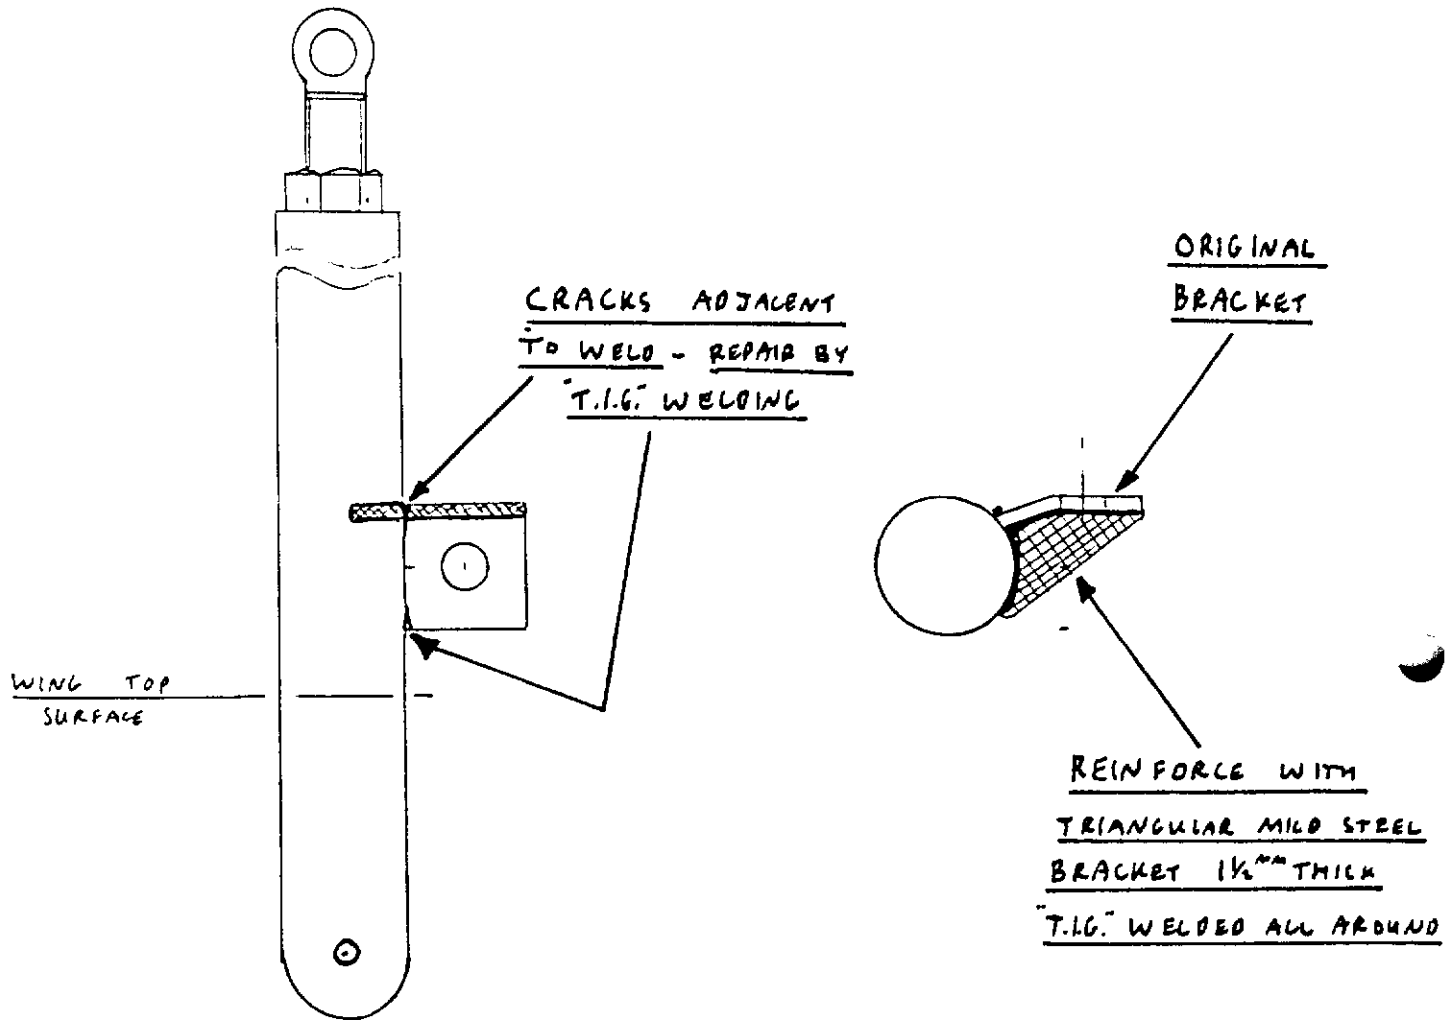
LS 6 CRACKS IN LOWER AIR BRAKE PADDLE MOUNTS

- 1.4. ASK 23 - Inspection of Main Bulkhead II. A/D 93-196 herewith explains the problem. Refer also to Tech. Note 6.
- 1.5. LS6 (LS7?) Lower Airbrake Paddle Cracked. Sketch herewith from Tim Macfadyen.

REPAIR AND REINFORCEMENT SCHEME (- ALSO LS 7?)

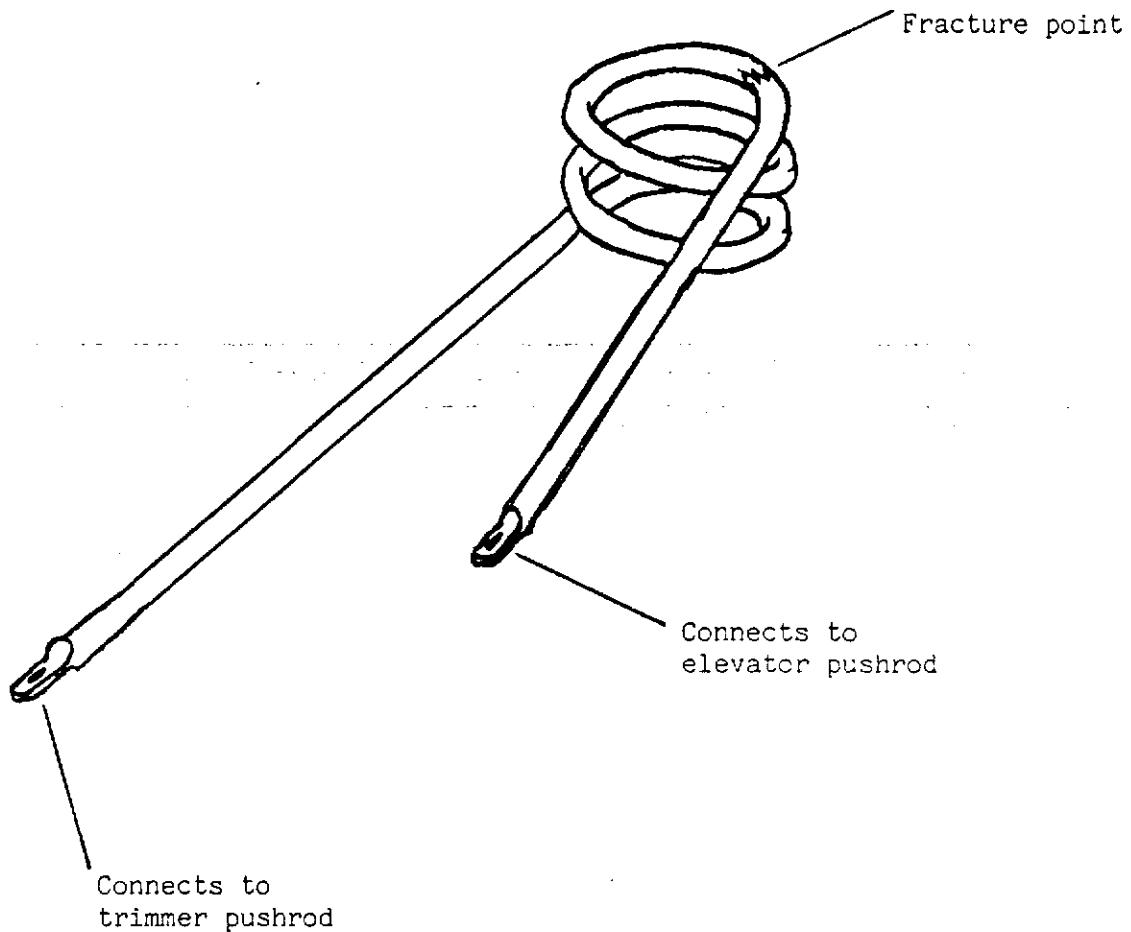
- c) PIK 20E Fuel Tank damaged by the seat-back cable tube clamps. (Reported by John McWilliam).
- 1.3. "JUNIOR" Trim Spring Failures - as illustrated herewith, a recurring defect.

Complete failure of trimmer mainspring occurred after only 18 months service, fortunately during pre-flight checks. Fracture occurred as illustrated below. Recommend inspection.

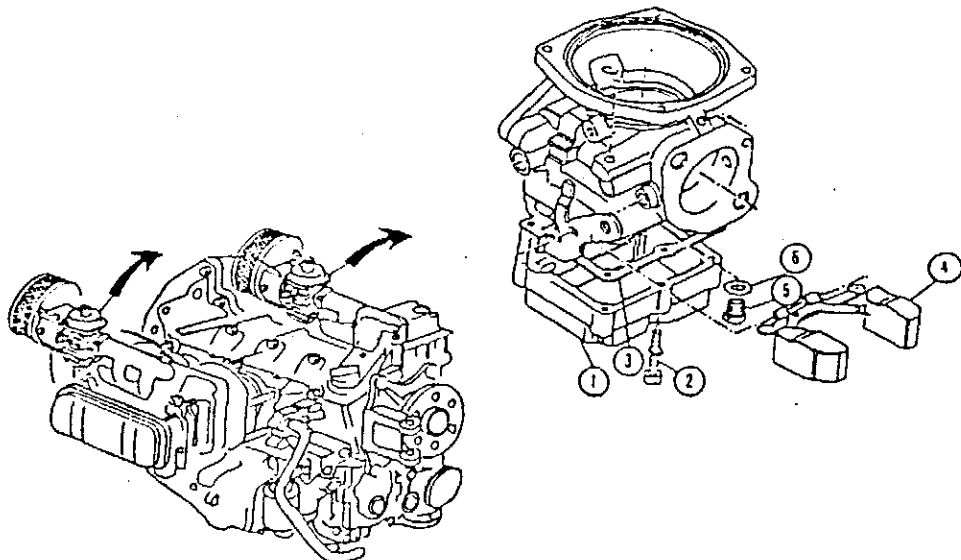
**Procedure:** The aircraft engine GROB 2500 is equipped with two Solex 150 CD3 carburettors. Due to spare parts delivery, unintentionally different types of float needle valves have been installed in the carburettors. Only one specific type is permissible. The use of a none permitted type could cause rough running engine or even engine failure. Therefore an inspection and, if necessary, an exchange of needle valves is mandatory.

1. Ensure, that the Battery Master Switch is "OFF", and the Ignition key is removed.
2. Remove upper and lower engine cowling.
3. Remove floatchamber (1) by removing 6 screws (2) with spring washer.
4. Remove floatchamber and gasket (3) downwards and drain fuel from the floatchamber.
5. Pull down float (4).
6. Remove needle valve (5) and gasket (6) (refer also to the "Assembly and Repair Manual GROB 2500")

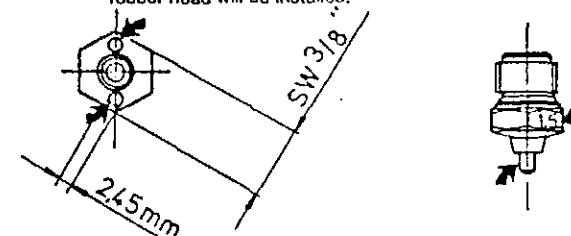
7. Check that the needle valve has the following characteristics:

- 2 drill holes of 2.45 mm dia
- 1.5 marking on hexagon flat
- the valve needle may have 2 colors (both are permitted):
  - yellow: valve needle is made of yellow brass material with rubber head
  - silver: valve needle is made of steel material

**Note:** During exchange, only valve needles from brass material with rubber head will be installed.

8. If the needle valve has the stated characteristics, it can be reinstalled using a new gasket.
9. If the needle valve has other characteristics as stated in workstep 7, a new needle valve P/N B.19052 and a new gasket must be installed.
10. Install float and adjust float to 16.5 mm (refer to "Assembly and Repair Manual GROB 2500").
11. Install float chamber using a new gasket P/N REF.28.
12. Install upper and lower engine cowling.
13. Perform an engine ground run and, if necessary, perform adjustments according to "Assembly and Repair Manual GROB 2500" and "Operations Manual GROB 2500".
