BRITISH GLIDING ASSOCIATION

BGA TECHNICAL COMMITTEE

TECHNICAL NEWSHEET TNS 11/12/93

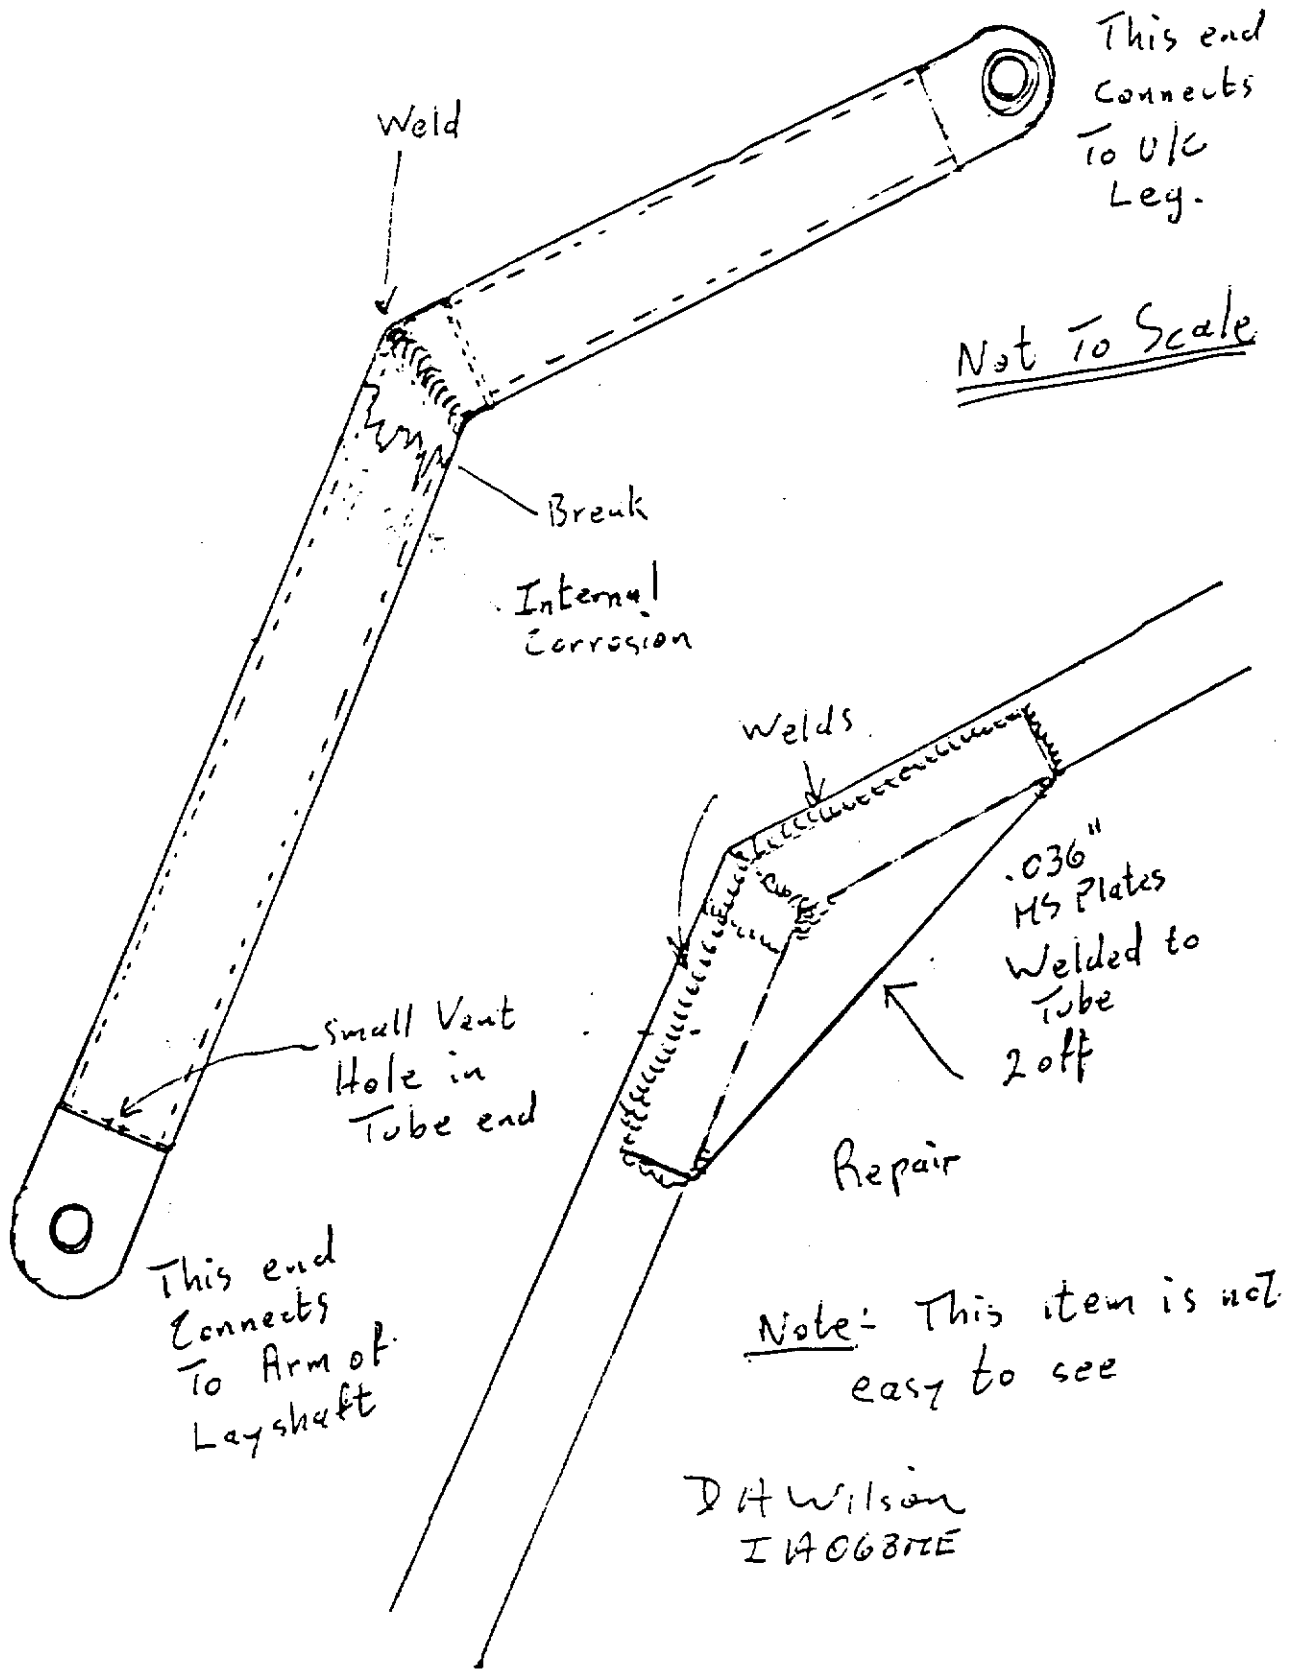
Vega Undercarriage Link Rod.

- 1.6. **VEGA Undercarriage Link Rod Failure.** Sketch is self explanatory. (D.A. Wilson - Prudhoe).
 - 1.7. **BG 135 - (Fatal Accident).** Tailplane not correctly installed and locked.

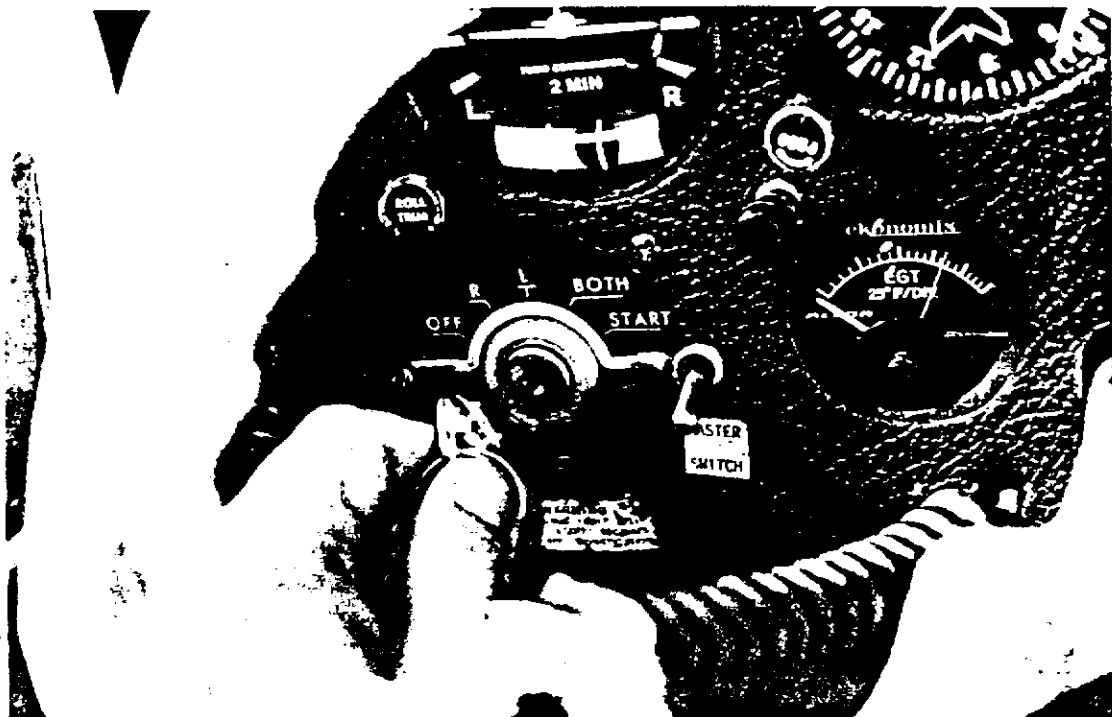
"A review of the SDR database indicates that reports are still being received about Bendix 'key actuated' type magneto switches. In many cases, although the switch was in the OFF position the key could be removed, yet the switch would not ground (disable) the magneto. If the propeller was then hand-turned and a 'hot' magneto condition existed, the engine could fire and cause injury to someone or damage to property.

GASIL Editor decided to check an aircraft which he flies regularly and, with no effort at all, the key could be removed from any position, as the photograph shows. The aircraft concerned had flown less than 70 hours

since the Airworthiness Directive mentioned in the Canadian item was complied with. Fortunately, in this case, the aircraft was due for maintenance the following day and a replacement Bendix

switch, at considerable expense, was fitted which returned the aircraft to its airworthy status.

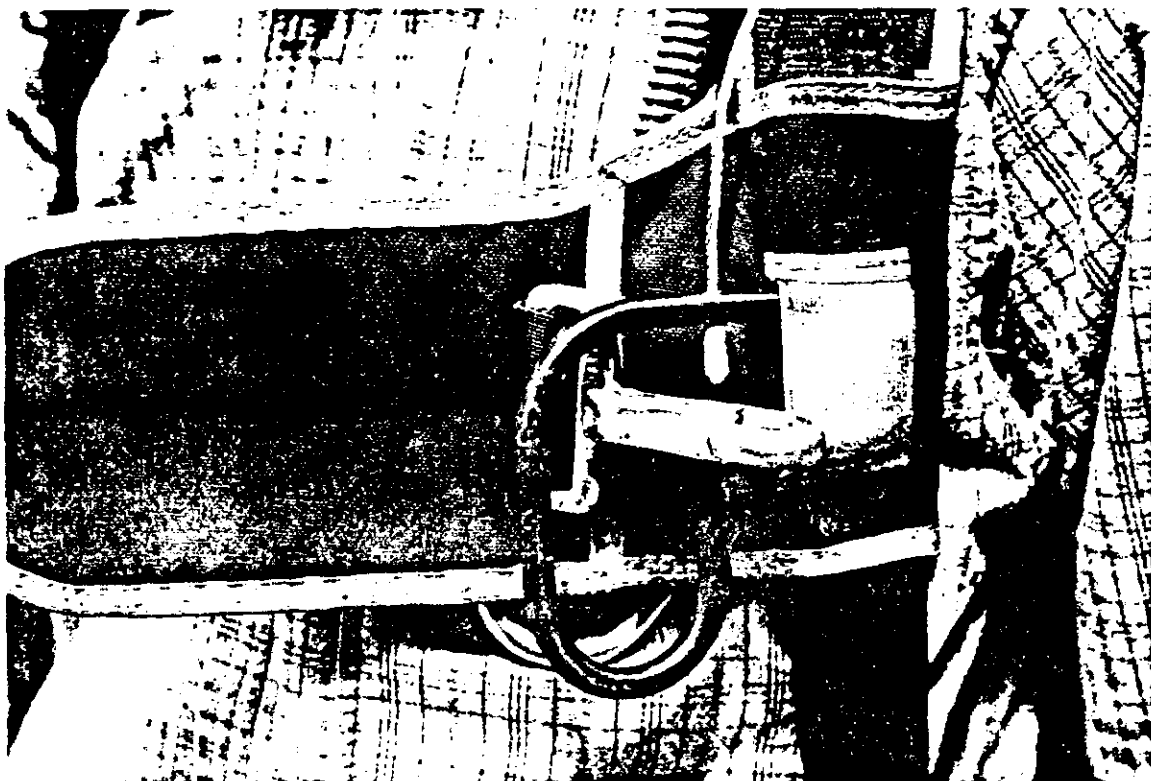
FIGURE 6 IN-CORRECT ROUTING OF CHEST STRAP THROUGH MARTIN BAKER HANDLE

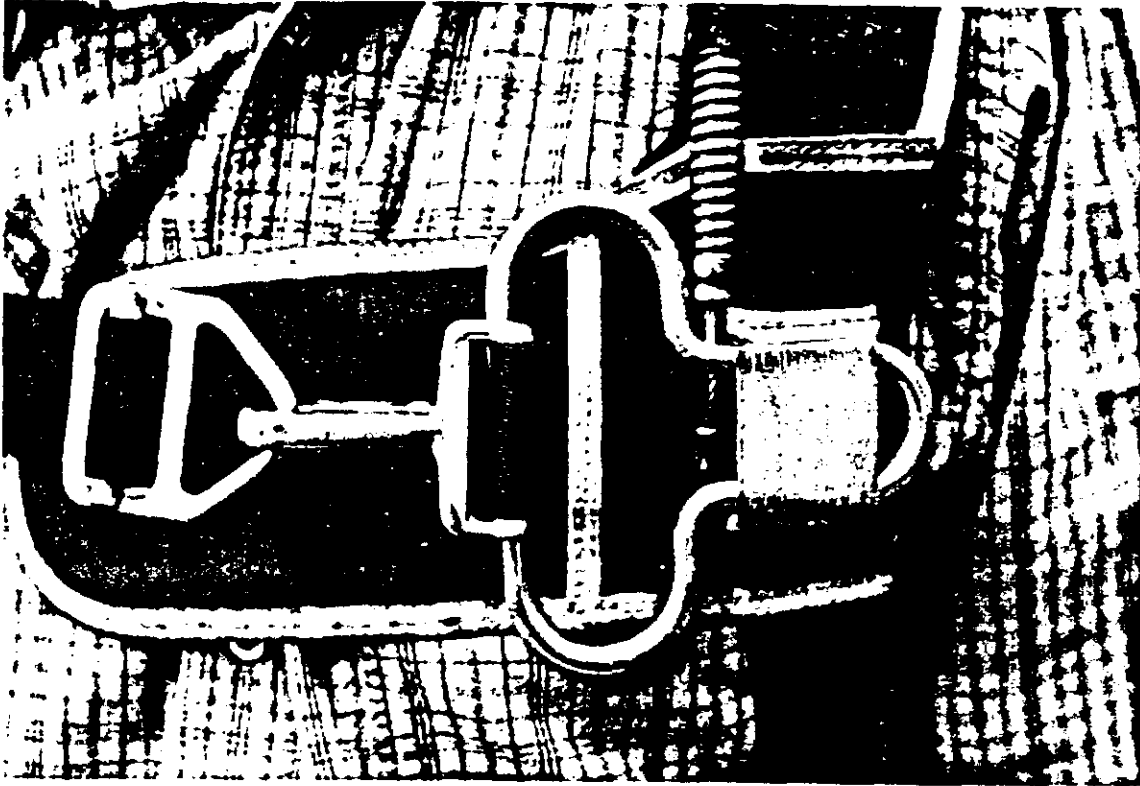
FIGURE 3 IN-CORRECT FASTENING OF RQ PARACHUTE CHEST STRAP

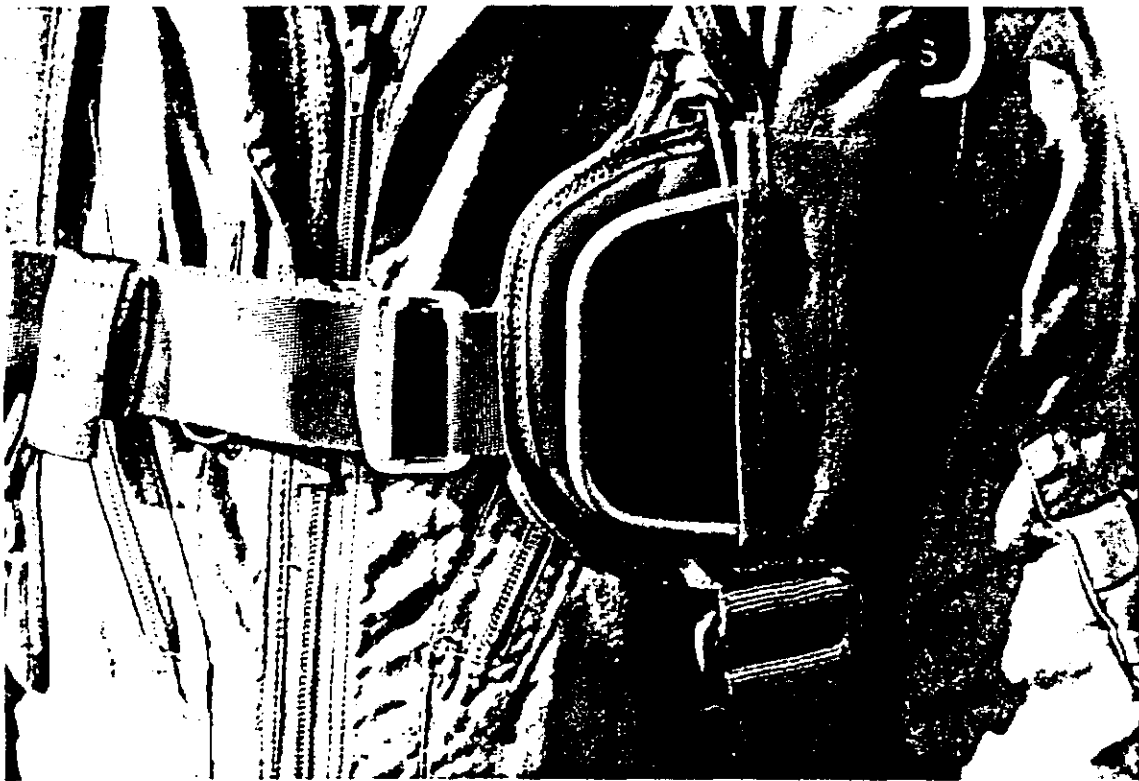
FIGURE 5 MARTIN BAKER HANDLE FITTED TO AN RO PARACHUTE

FIGURE 4 DESIGN OF CHEST STRAP IN USE WITH THE AIR TRAINING CORPS

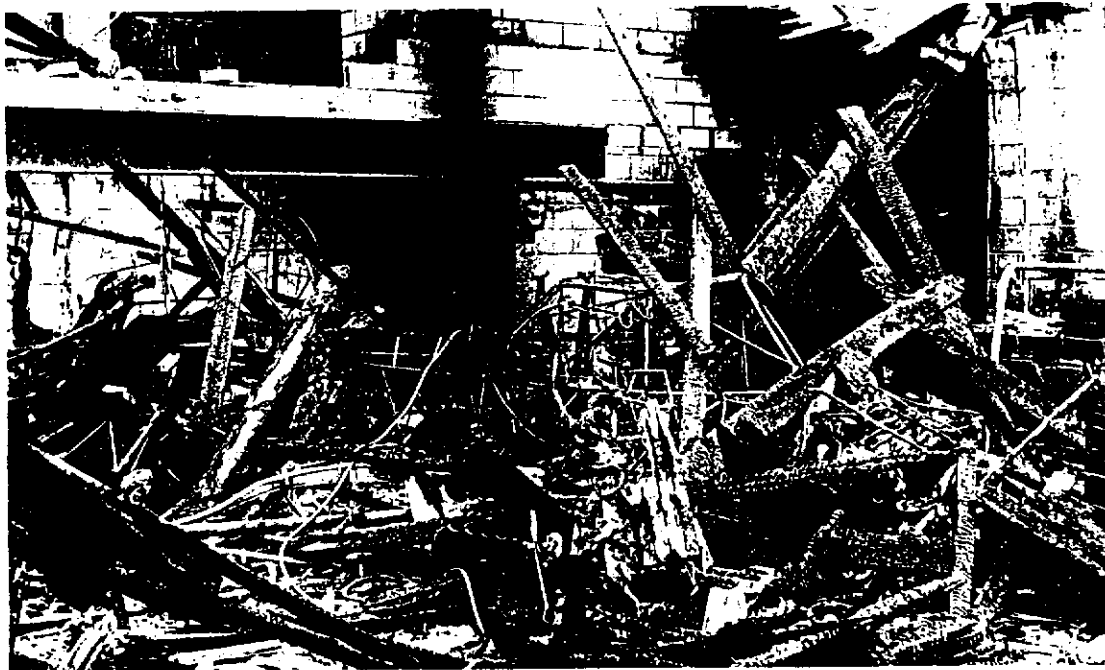
The aircraft was in the hangar, and the pilot was operating the elevator trim control to check range of movement. The indicator cable snapped, and, unknown to the pilot, the broken end flew back along the fuselage and draped across the unprotected live terminal on the outside of the battery box. The cable soon glowed to red heat and another part of the cable, which was touching the aircraft's

fabric, ignited the fabric. In under two minutes, the entire aircraft and the hangar was engulfed in flames and in less than seven minutes the building and its contents were totally gutted. The photograph illustrates all that remains.

to put rubber protective boots over the terminals of a battery or the battery box and to maintain them in good condition. Whilst this was a very unusual occurrence, the fact that it has happened once is a warning to all. A review of three Super Cubs revealed that only one of them had an intact rubber boot protecting the positive, (live), terminal.
