BRITISH GLIDING ASSOCIATION

BGA TECHNICAL COMMITTEE

TECHNICAL NEWSHEET TNS 3/4/94

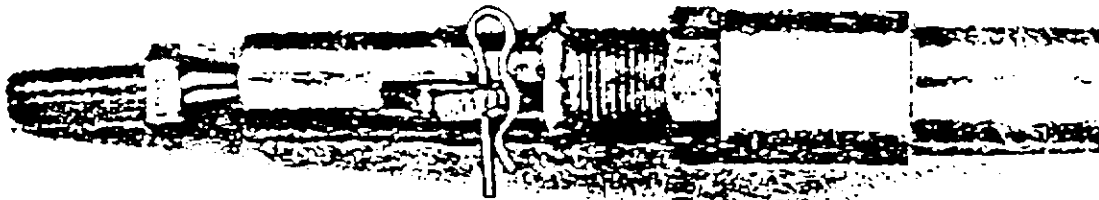
Hotellier Ball and Swivel Joints

The swivel is to be slid completely over the ball on the rod with the locking cam pulled back. During locking the locking cam moves back slightly so that in a correct joint the hole on the averted edge of the locking cam becomes visible.

Unsecured ball and swivel joints may open automatically in flight !

The safety pin is to be inserted in this hole thus securing the ball and swivel joint.

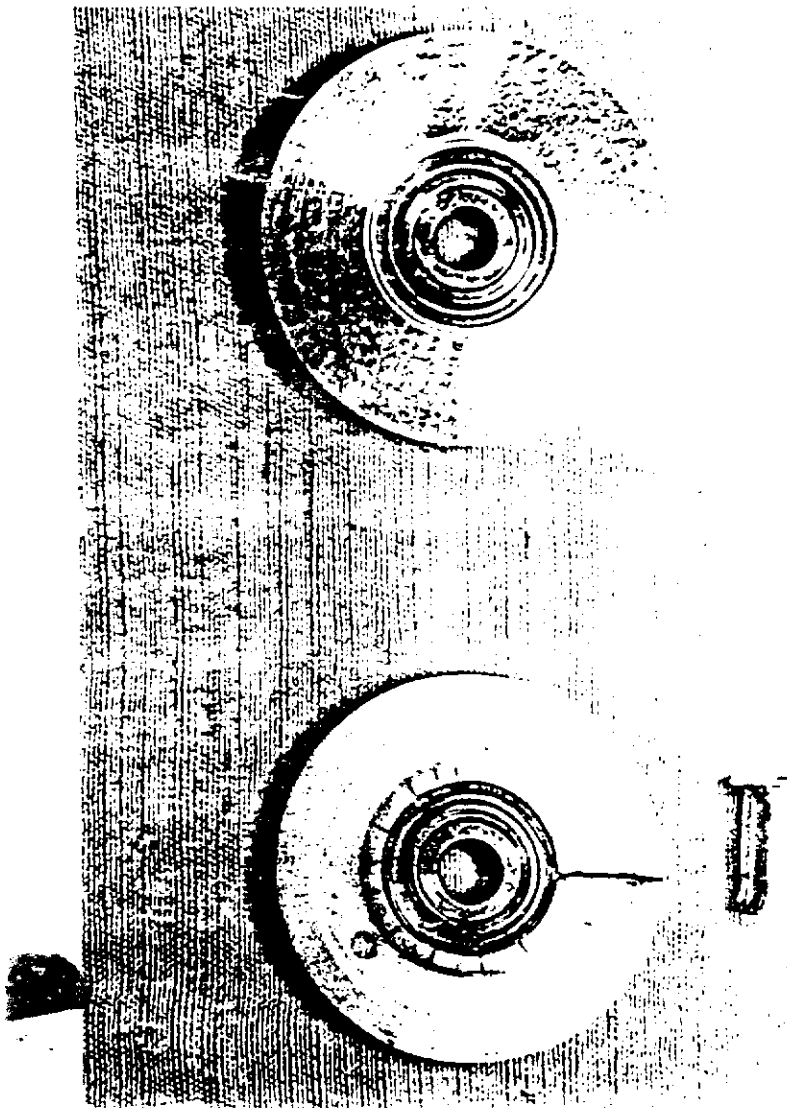
PROB G. 109.
WHEEL BRAKE PULLEYS (NYLON)
CRACKED.

- 1.3. L'Hotellier Connectors with Locking Cams. LBA AD 94-001 dated 03-02-94 herewith - requires action.
 - 1.4. Grob G.109 Wheel Brake Pulleys (Nylon) Cracked. Replaced in aluminium. (Photo herewith).

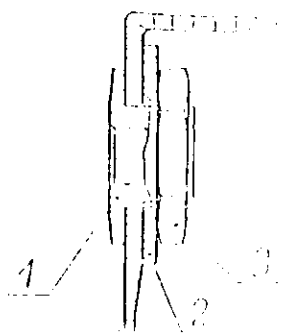
STRENGTHENING OF THE FILM WALL:

On the first production series of the SZD-51 "JUNIOR" gliders, the premature appearance of the play on the fitting of dove-shaped sleeve has been found. This Bulletin allows to remove this fault.

The substitution provided by sleeve should be executed. The tin wall strengthened and the sleeve fixed with nut installed.

5. Complete the eventual wall diminations, put the inside strengthening of 3 x 92125 "X" fabric about 60 x 70 mm folded on the ledge.
6. After the initial curing drill the ϕ 14 hole and then ream for ϕ 10 H7 axial with the old hole.

7. Wash the sleeve, washer and nut with the extraction gasoline. Insert the sleeve into the wall using the composition thicked with screw 11, put on the washer, screw in the nut and secure it by potting in four places.

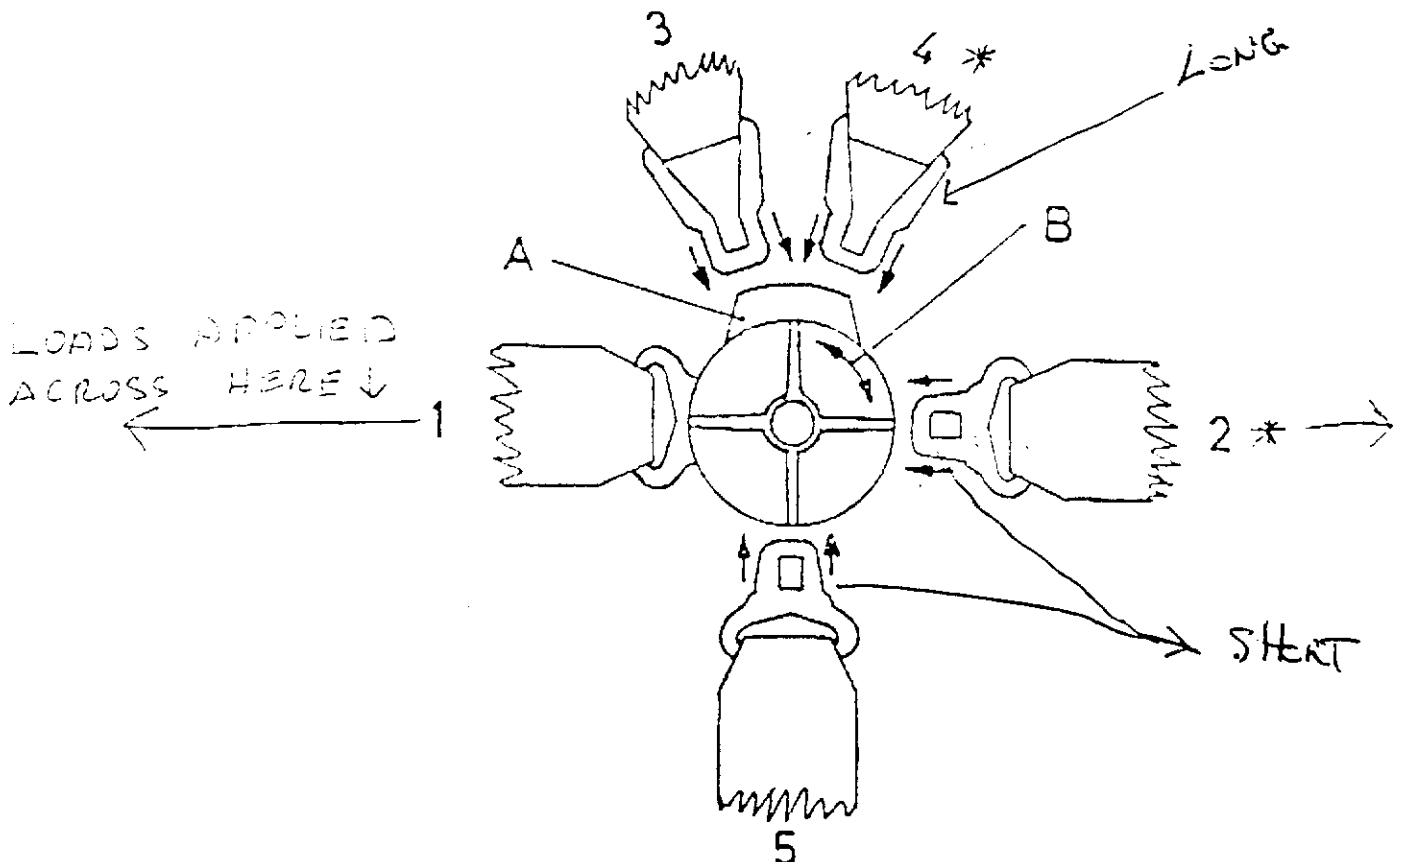
GADRINGER
HARNESSES

- 1.5. Gadringer Harnesses must be installed with the straps orientated as illustrated. Incorrect assembly will cause the straps to let go under negative loadings. (London Sailplanes).

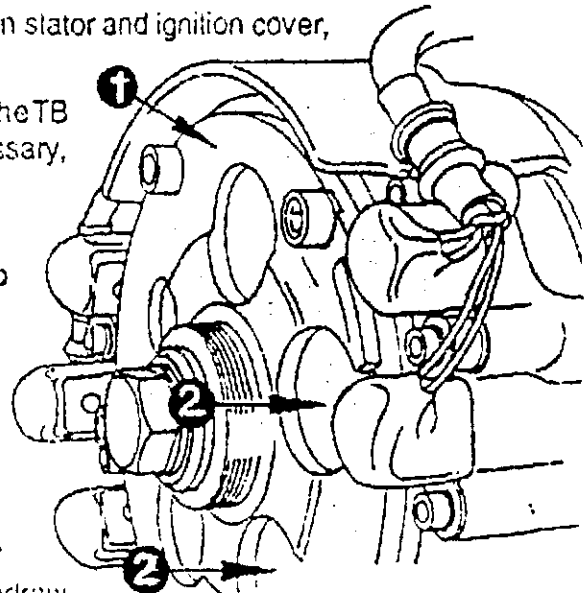
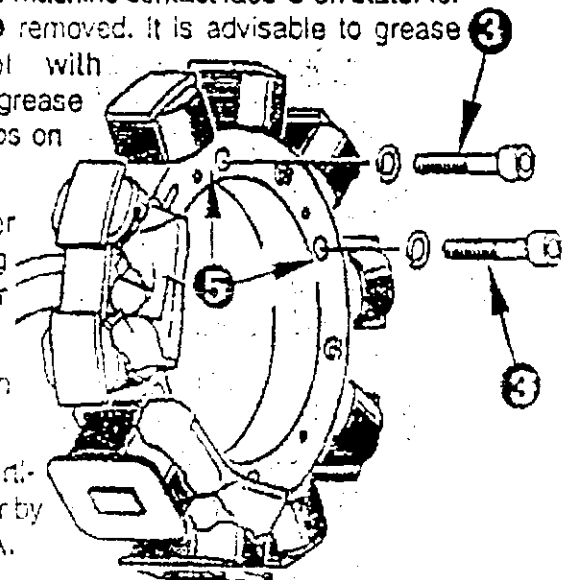
AD 75

Subject: As known from experience, inadequate ground connection could arise between stator and ignition housing on the engine type 912 A.

Reason: Isolated formation of corrosion between stator and ignition cover, respectively at attachment screws.

Reconnect battery and carry out ignition check.
