BRITISH GLIDING ASSOCIATION

BGA TECHNICAL COMMITTEE

TECHNICAL NEWSHEET TNS 7/8/94

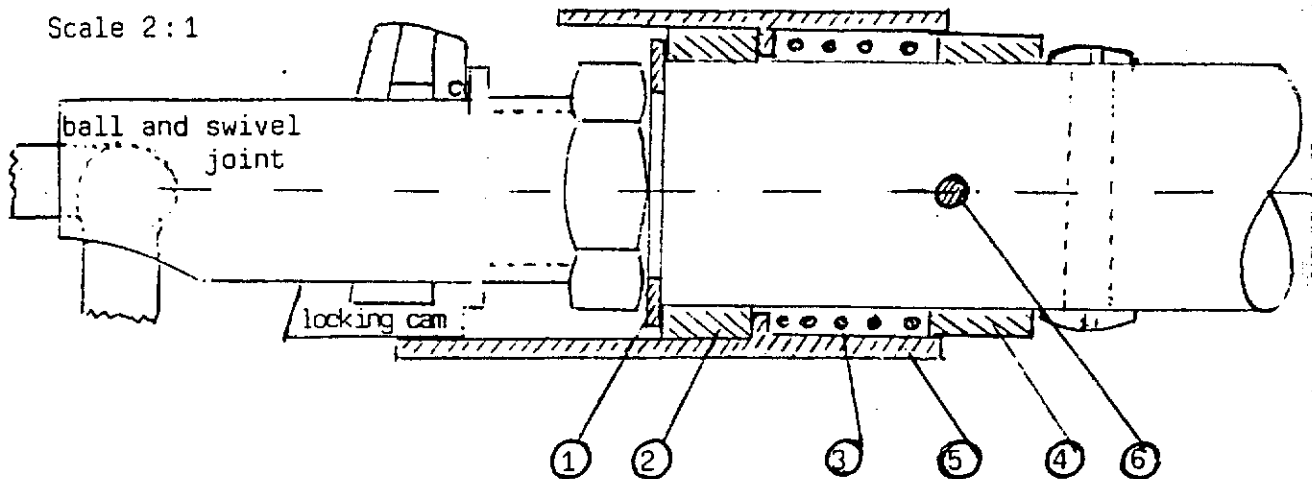
Scale 2:1

Only the coupling ball fully home in the swivel joint, the WEDEKIND safety sleeve (5) will slide over the lower end by the wedge-shaped locking cam and secures the latter from being released unintentionally. The safety sleeve is held in the "secured" position by a compression spring (3) with a force of 1,5 N.

The WEDEKIND safety sleeve is also a protection against improper control connections as it will not slide over the lower end of the wedge-shaped locking cam if the coupling ball is not fully home in the swivel joint.

With the "L'Hotellier" swivel joint unscrewed from the control rod (be sure to measure the length of engagement reach of its threaded shaft in the rod as otherwise a re-adjustment of the control surface is required), slide the components of the safety sleeve on the free end of the rod in the following order: ④, ③, ⑤ and ②. Re-install the swivel joint - with lock washer No. ① fitted to the threaded portion of the shaft - and screw it into the control rod until the correct length of engagement is obtained, then tighten lock nut.

Slide bushing No. ② 2 mm into the safety sleeve No. ⑤. Hold the bushing No. ④ in the position by fixing with an adhesive compound, e.g. Cyanoacrylate. Drill a 2 mm hole through the bushing and body of the "L'Hotellier" connector, at 90 deg. relative to the wedge-shaped locking cam and 19 mm from hole center to outer face of washer No. ①, as shown in the drawing. Drive the roll pin No. ⑥ into the hole to secure bushing No. ④ in position, leaving 1 mm protruding on either side. This 19 mm distance ensures that projecting ends of the roll pin are situated between the cut-outs of the safety sleeve with the latter in "locked" position - thus preventing the sleeve from rotating and becoming dislocated.

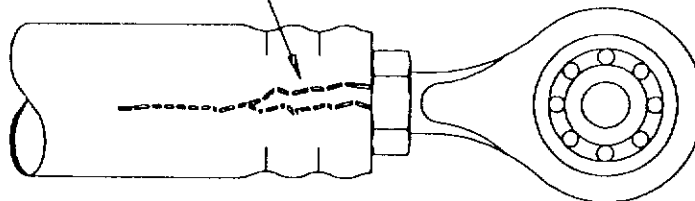
FIGURE 1

BACKGROUND: On a SZD-48-1 Jantar Standard 2 the swaged pushrod end split open under the pressure caused by exfoliation corrosion.

Corrosion of internal fitting causes splitting.

ACTION REQUIRED: 1. Before next flight examine all swaged pushrod ends for signs of corrosion and splitting. (see figure 1 for details.) Note: some of these swages are difficult to access and special care must be taken to ensure that all fittings are inspected. The use of a mirror is highly recommended.
