BRITISH GLIDING ASSOCIATION

BGA TECHNICAL COMMITTEE

TECHNICAL NEWSHEET TNS 5/6/94

PART 1 Airworthiness "AGGRO". Please add to the BGA 1994 Red Pages.

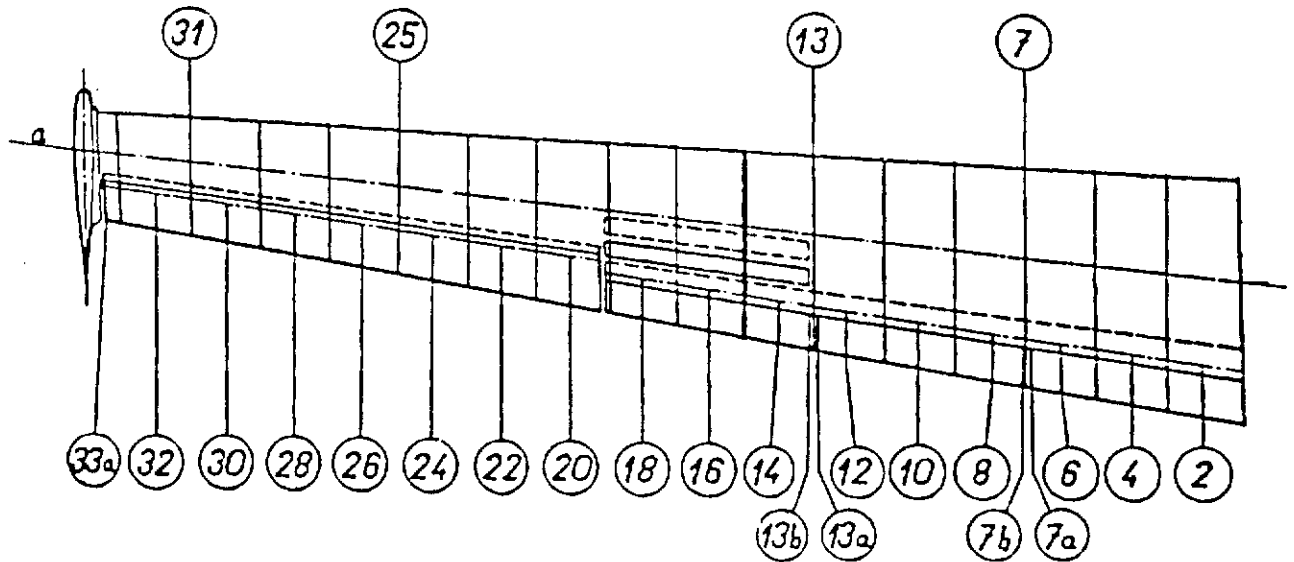
FIGURE 1
LOCATION OF FLUSH SKIN JOINTS

BACKGROUND: During a routine inspection cracking was noted in the flange of the wing rib and the stiffeners at the flush skin joint at station 13.

Further inspection of other Blaniks showed that 7 out of 9 inspected gliders had cracking of some degree at this station. Inspection of the ribs at other stations with flush skin joints also showed minor cracking at station 7.

The Flush Joints at Stations 25 and 31 are the same detail design as stations 7 and 13 and so are possible cracking sites.

The extent of the cracking was such that the worst wing was very near to failure.

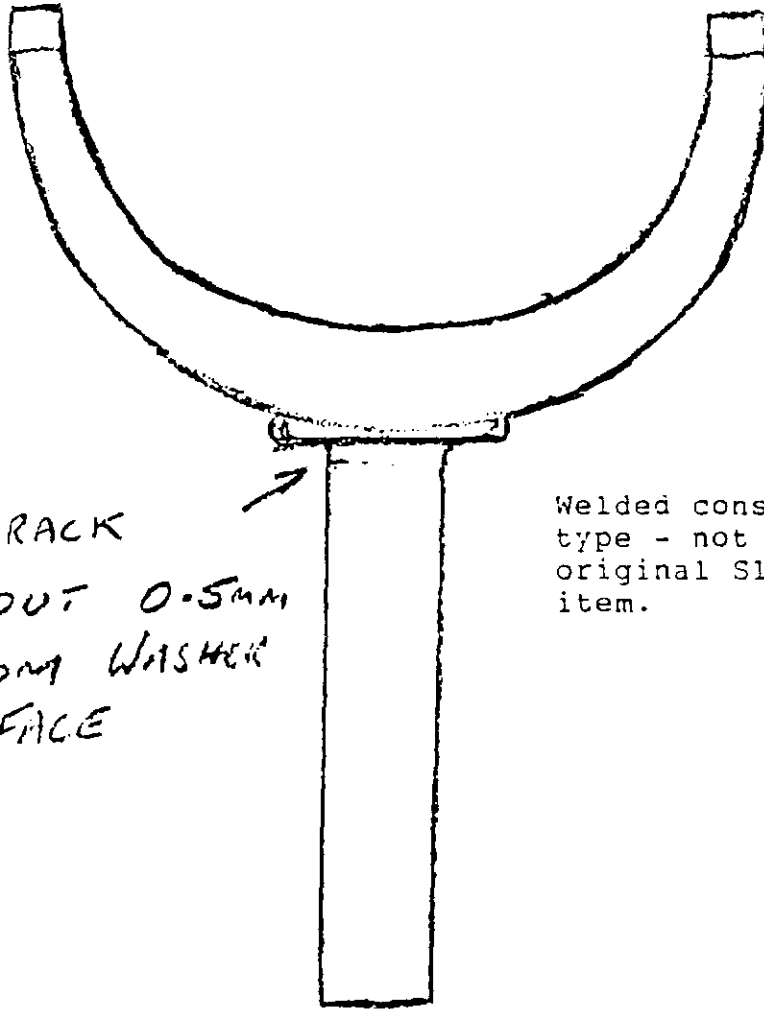
KESTREL RUDDER DRIVE

- 1.5. M-T Propellers Erosion Strips - not secured. LBA AD/94-098 (herewith) requires ACTION. (Fitted to some SF25E's, Dimona's etc).
- 1.6. Kestrel Rudder Drives continue to crack at weld. Sketch from Stu Hoy - herewith.

CRACK
ABOUT 0.5MM
FROM WASHER
FACE

Welded construction
type - not the
original Slingsby
item.
