BRITISH GLIDING ASSOCIATION

BGA TECHNICAL COMMITTEE

TECHNICAL NEWSHEET TNS 9/10/94

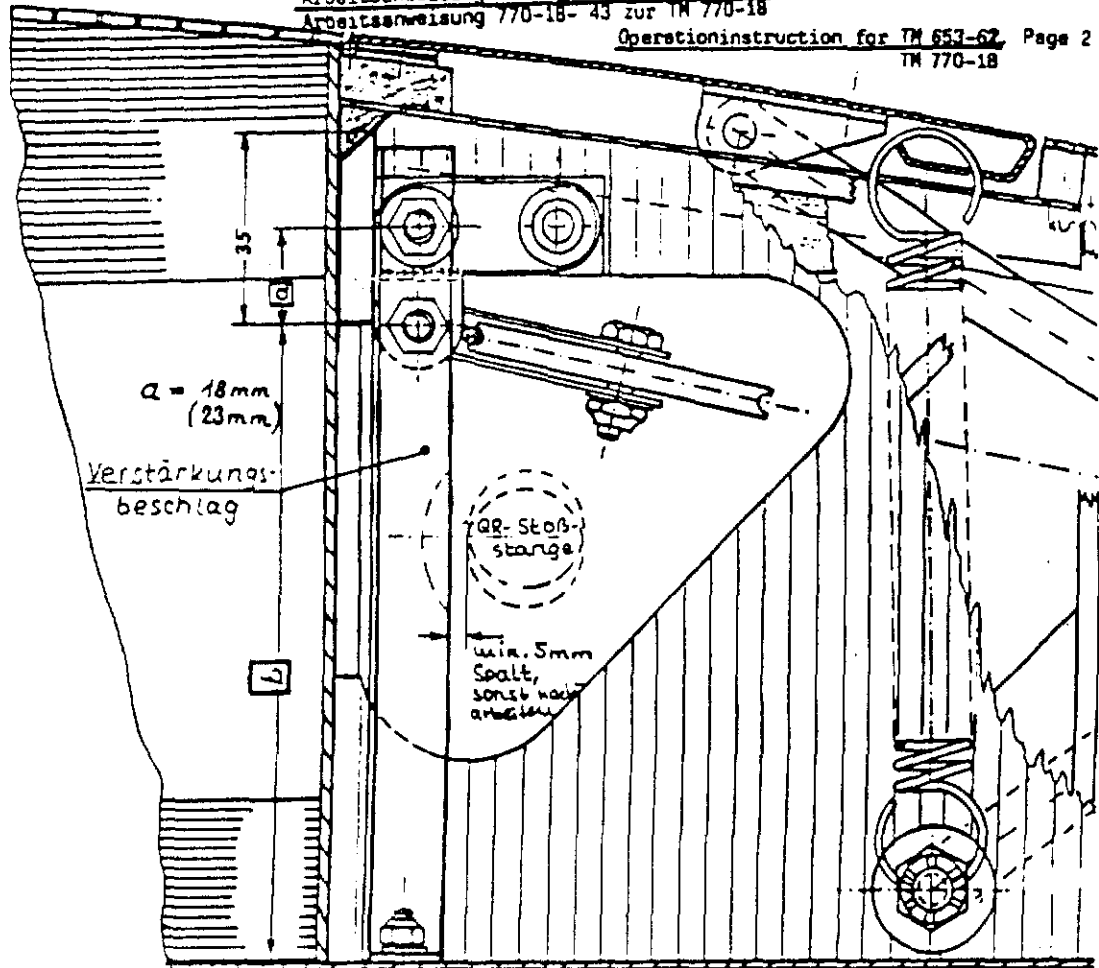
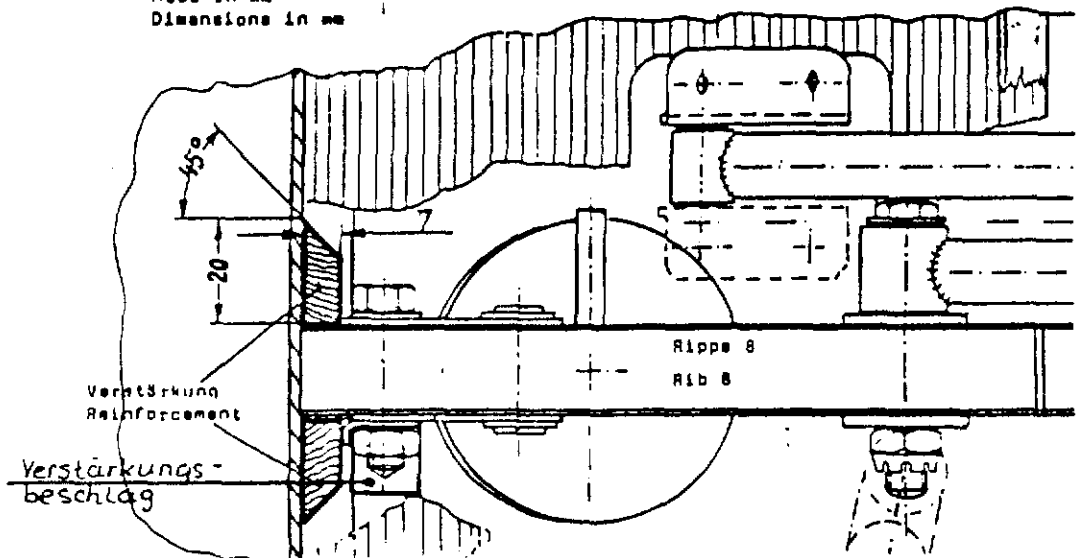
Operationinstruction for TM 653-62 Page 2
TM 770-18

Maß a = 23 mm für:

- SF 25 B ab S/N 46257
- SF 25 C ab S/N 4474
- SF 25 D ab S/N 46256-0
- SF 25 E alle S/N
- SF 25 K alle S/N
- SF 28 ab S/N 5743

Maß b = jeweils angepaßt (abhängig von Maß a)

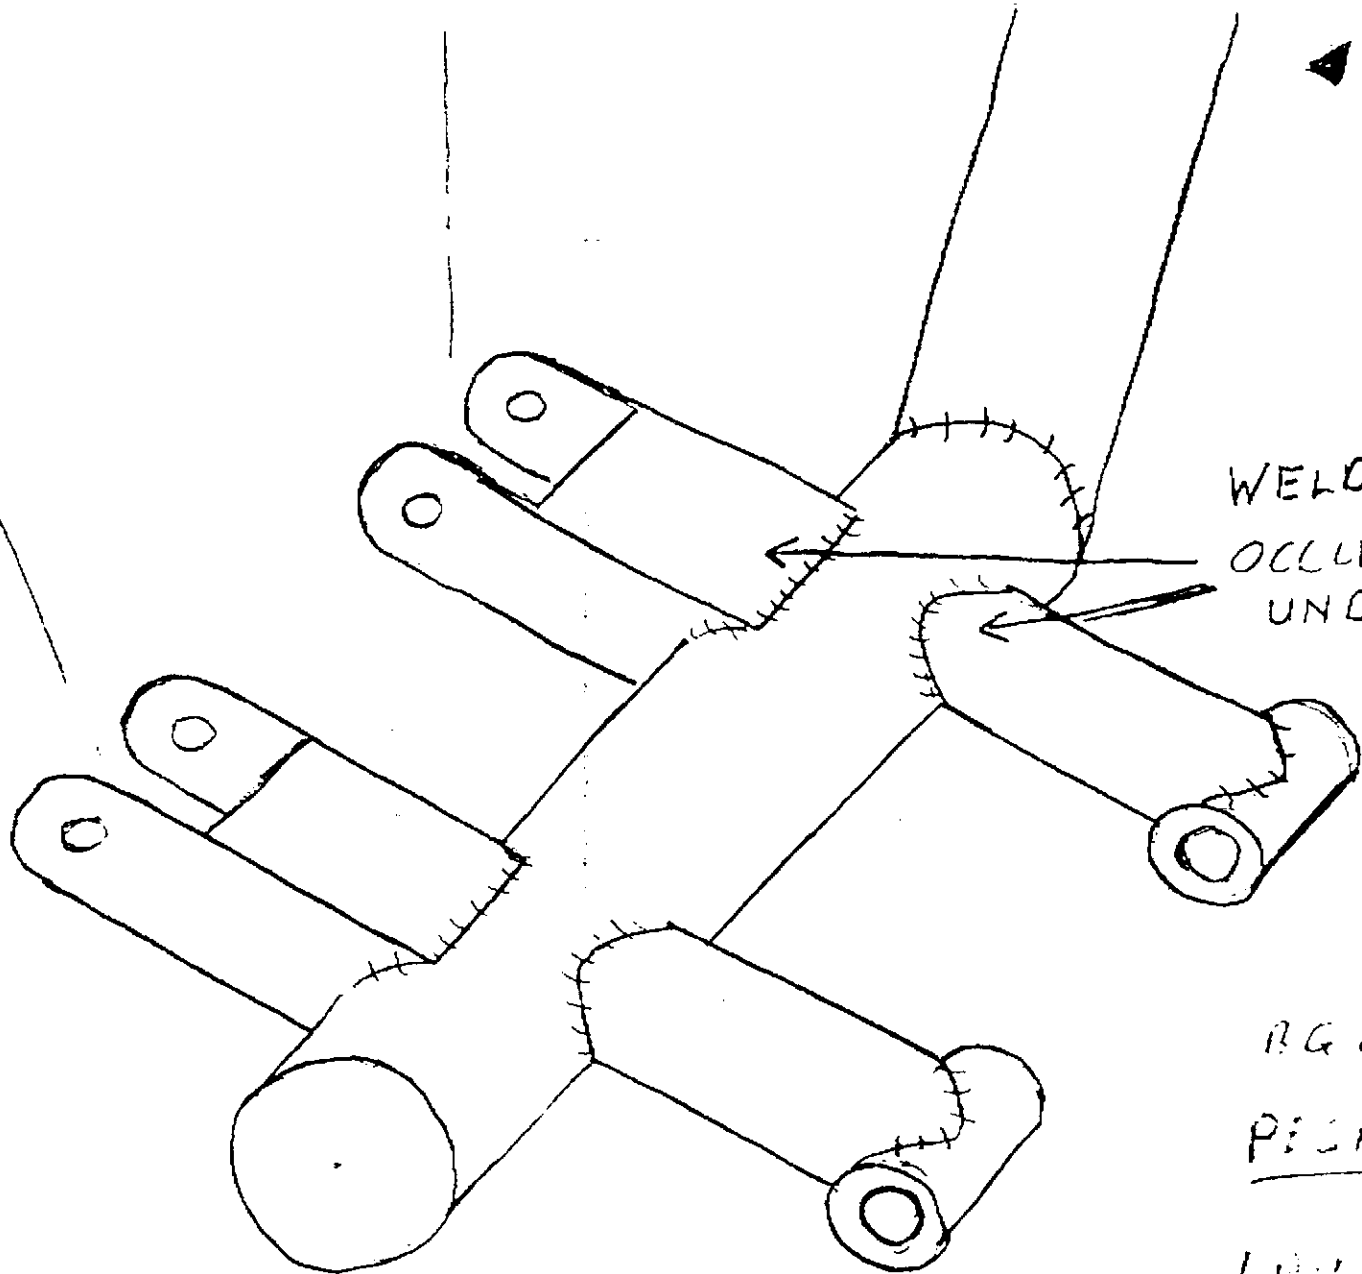
PEGASUS WELD FAILURE

Subsequent investigation showed that a weld had failed on a torque tube. There was evidence that this failure had been progressive, and another weld on the same tube was also showing signs of failure.

BRAKES
OPEN

WELD FAILURES
OCCURRED ON
UNDER SIDE
OF THESE
TWO LUGS
