BGA TECHNICAL COMMITTEE

TECHNICAL NEWSHEET (TNS) 11/12/94

PART 1 AIRWORTHINESS "AGGRO"

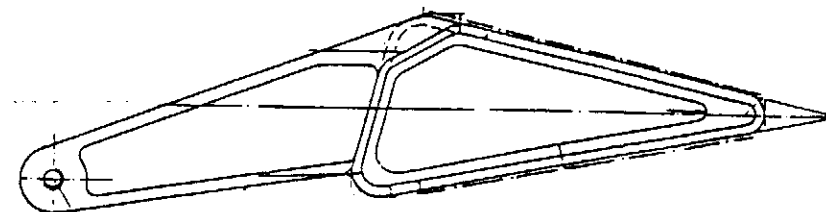
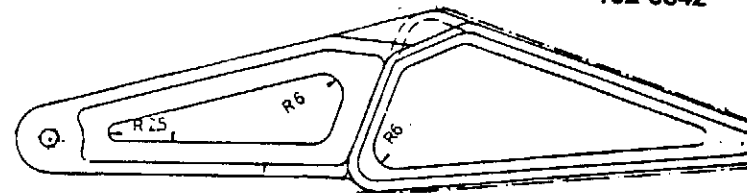
Abb. 1

The elevator lever P/N 102-3542 (aluminum castings, Fig. 1) has to be checked for cracks using a proper test procedure (i.e. magnifying glass). If cracks are found, the elevator lever has to be exchanged according to the Installation Instructions No. 306-30/1, before the next flight.

If no cracks have been found during the inspection according to Action 1, the castings elevator lever and all other lever models have to be exchanged by the elevator lever P/N 102-3543, made from aluminum sheet (refer to Fig. 3, page 3) according to the Installation Instructions No. 306-30/1 not later than 31.12.1994.

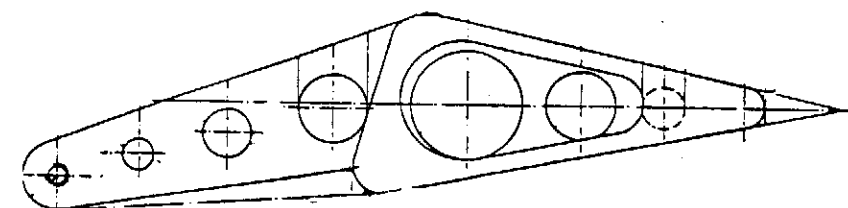
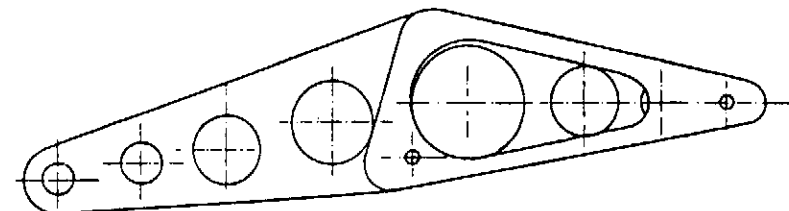
Abb. 2

Procedure: The exchange of the elevator lever P/N 102-3542, made from aluminum castings (refer to Fig. 1, page 2) or made from aluminum sheet with openings/ lightening holes P/N 102-3541 (refer to Fig. 2, page 2), is already anticipated within the course of extension of the service life before reaching 3000 flight hours (refer to Service Bulletin TM 306-30). Now an inspection and an advanced exchange of the elevator lever by the elevator lever P/N 102-3543, made from aluminum sheet (refer to Fig. 3, page 3), is mandatory as a precautionary measure.

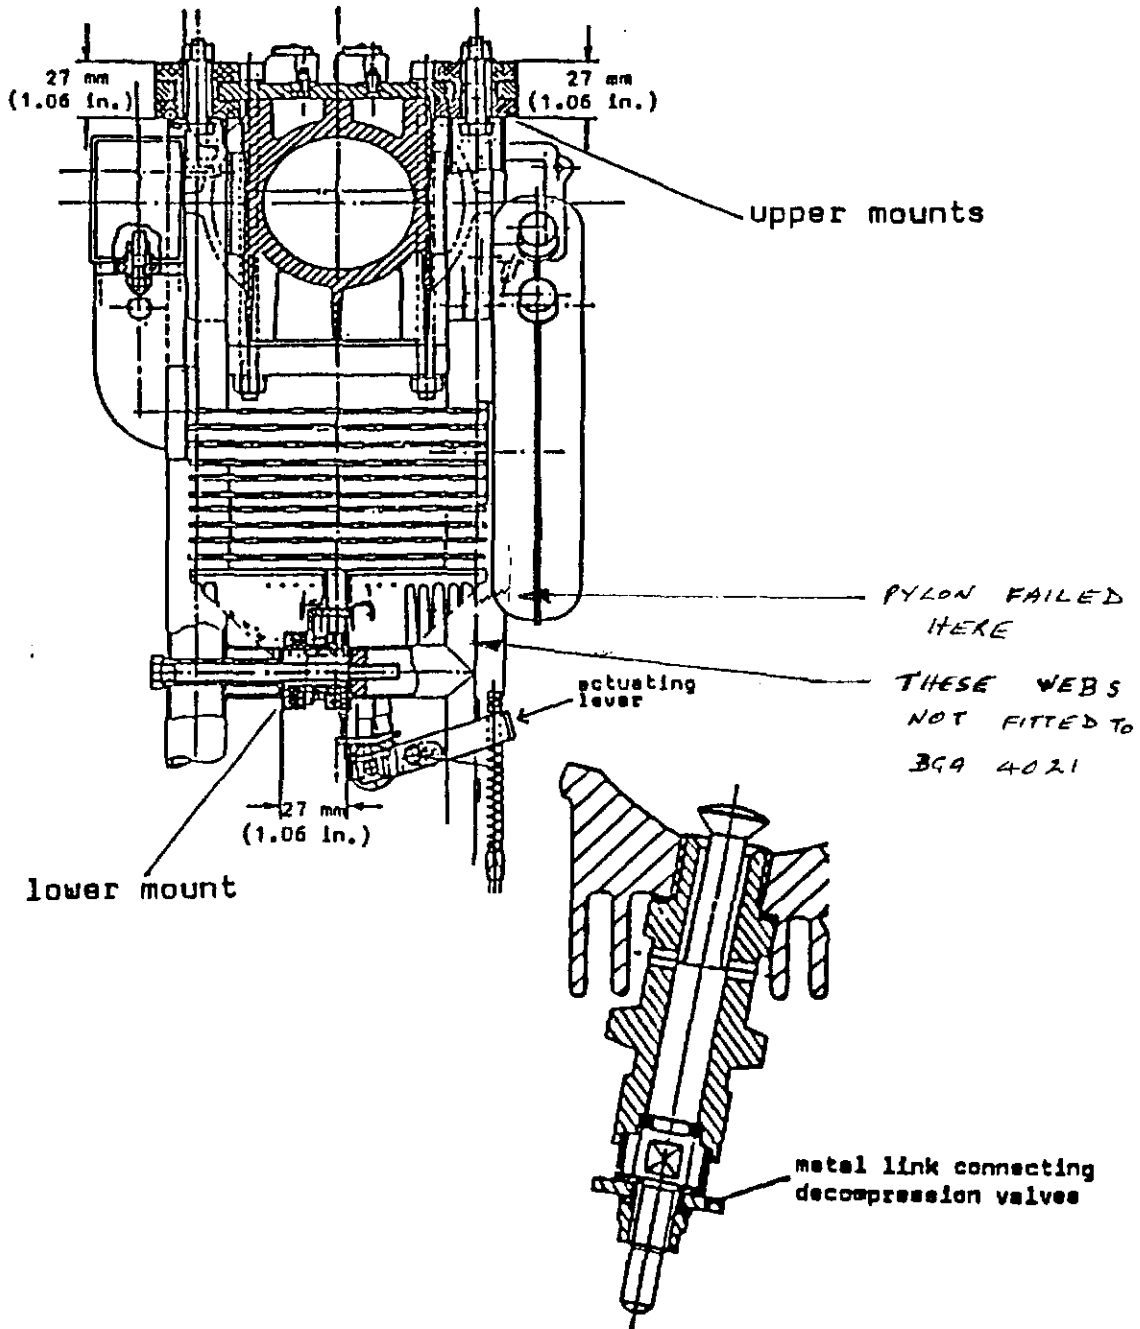
CRACKS in DISCUS BT ENGINE FRAME

- 1.2. DG500 Elan Trainer LBA AD 94-295 and Tech Note 348/4T (herewith) restrict negative "G" manoeuvrers.
- 1.3. Discus bT - cracks in the engine mounting frame have been identified by Jim Tucker, Southdown G.C. (sketch herewith).

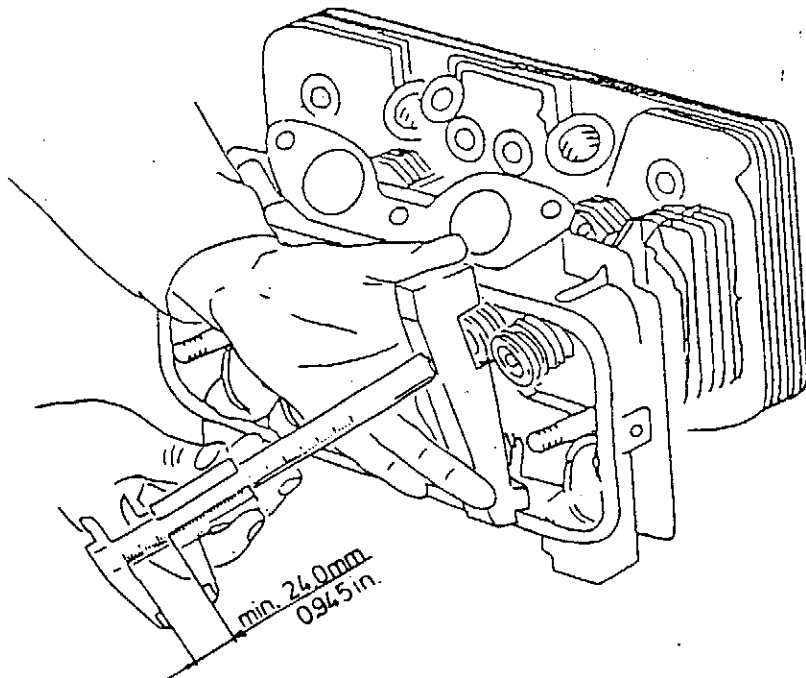
Subject: Inspection of the cylinder head valve seat

Procedure: After 500 to 600 hours operation time, it may occasionally occur, that the valves or the valves seat rings are pounded. To prevent excessive wear or damage, a regular inspection of the cylinder head valve seats is provided as a precautionary measure.

1. Remove cylinder head covers from both sides.
2. Measure valve play at all cylinders (nominal value: inlet and outlet valves 0,15 mm - 0,20 mm/ 0.006 - 0.008 in.) and note measured values.
3. Remove L/H and R/H rocker arm assemblies.
4. Position measurement device (P/N G2500-W1-630) above each valve as shown in the sketch below and measure distance to the end of the valve shaft using a depth gauge. This distance must be minimum 24,0 mm / 0.945 in. for inlet and outlet valves. If the minimum distance is reached, the affected cylinder heads have to be exchanged immediately.

5. Install L/H and R/H rocker arm assemblies.
6. Repeat valve play check at all valves and adjust according to "Operations Manual GROB 2500", if necessary.
7. Install cylinder head covers on both sides. If necessary, install new gaskets for the cylinder head covers.
8. Perform an engine ground run.
